## ARBORICULTURAL ASSESSMENT TREE RISK ASSESSMENT & TREE PROTECTION PLAN

**Baaka Cultural Centre**  
**42 Reid Street**  
**Wilcannia NSW *(the site)***

Prepared 17 February 2022  
for  
Department of Regional NSW  
Reference 24043  
Revision.02

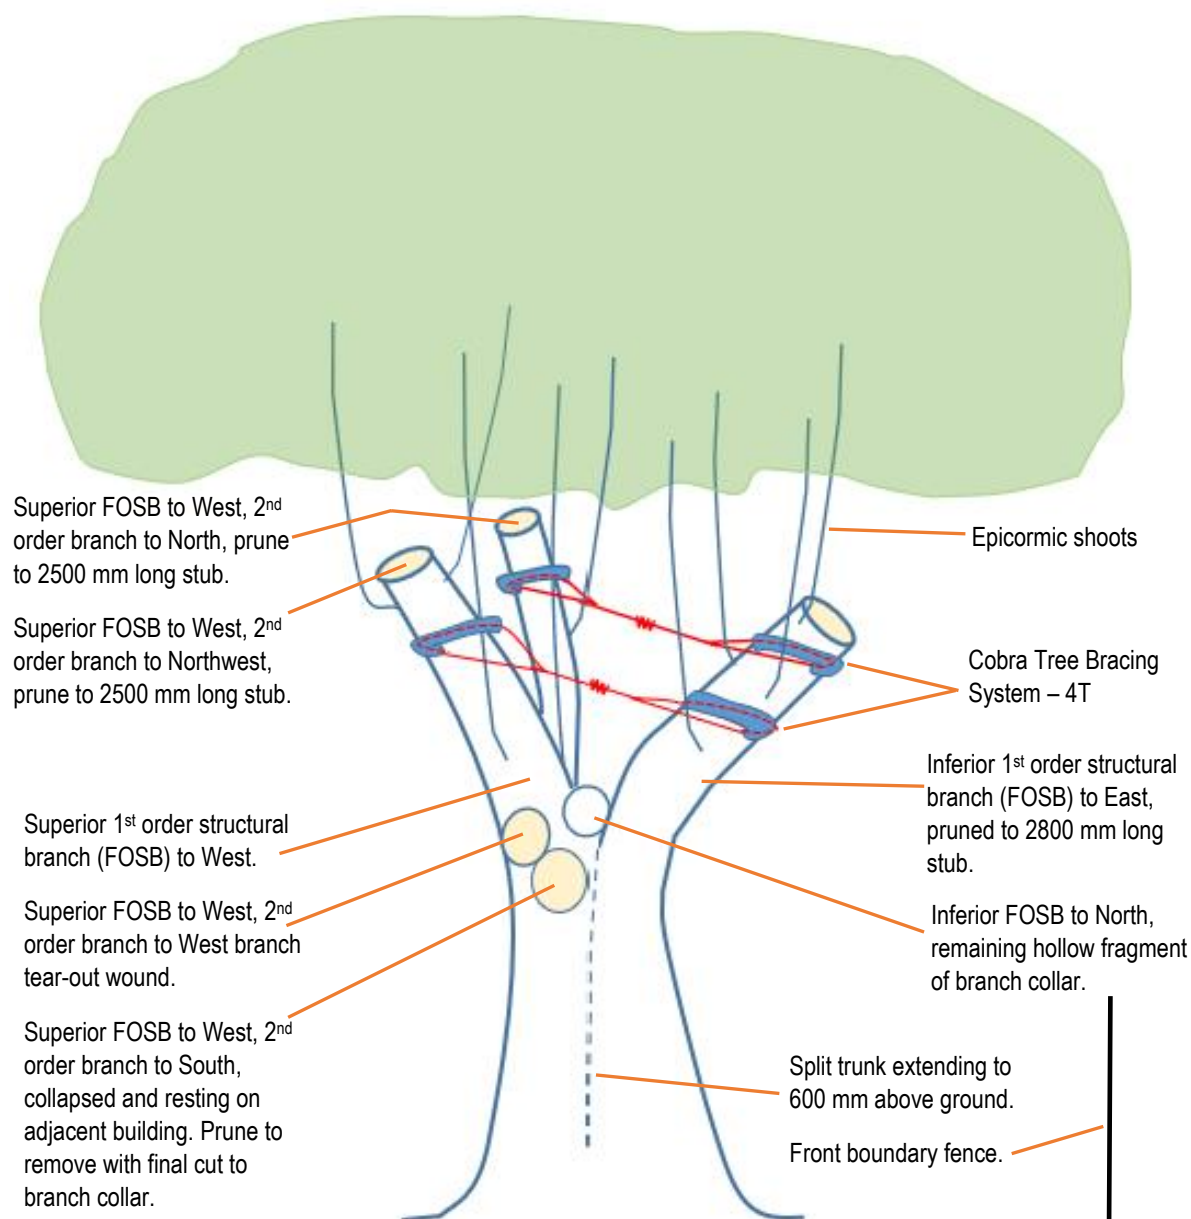
**Figure 1.0** View to North of Tree 1 *Jacaranda mimosifolia* – Jacaranda, showing structural branches, remedial pruning works and indicative location of bracing cables to protect the trunk from splitting.

The structural branches are to be braced to protect the trunk from collapsing (Figure 1.0). If after Deadwooding and during branch bracing installation the tree is found to be too brittle to sustain the branch bracing system, the structural integrity and stability of the tree will require this Tree Risk Assessment to be updated, to determine the tree's viability and suitability for retention, or consideration of alternative remedial works for its retention, or removal and replacement with an advanced specimen.

The Tree Bracing System is to be monitored annually and adjusted as required and replaced at a duration as specified by the manufacturer. The Tree Bracing system is to be installed per the manufacturers specifications (Cobra Tree Bracing System, <https://youtu.be/vCqVi5J1Y8M?t=20>). It is recommended that the Cobra Tree Bracing System - 4T Complete Kit (4 Tonne capacity), be applied to utilise its flexible supports and shock-absorbing mechanisms which allow low-resistance oscillation in the trunk and branches for the tree to develop beneficial adaptive growth in response to the loading stimulus. We suggest the Cobra Tree Bracing System – 4T, be professionally installed by an experienced Arborist with minimum qualification AQF Level 3 in Arboriculture.

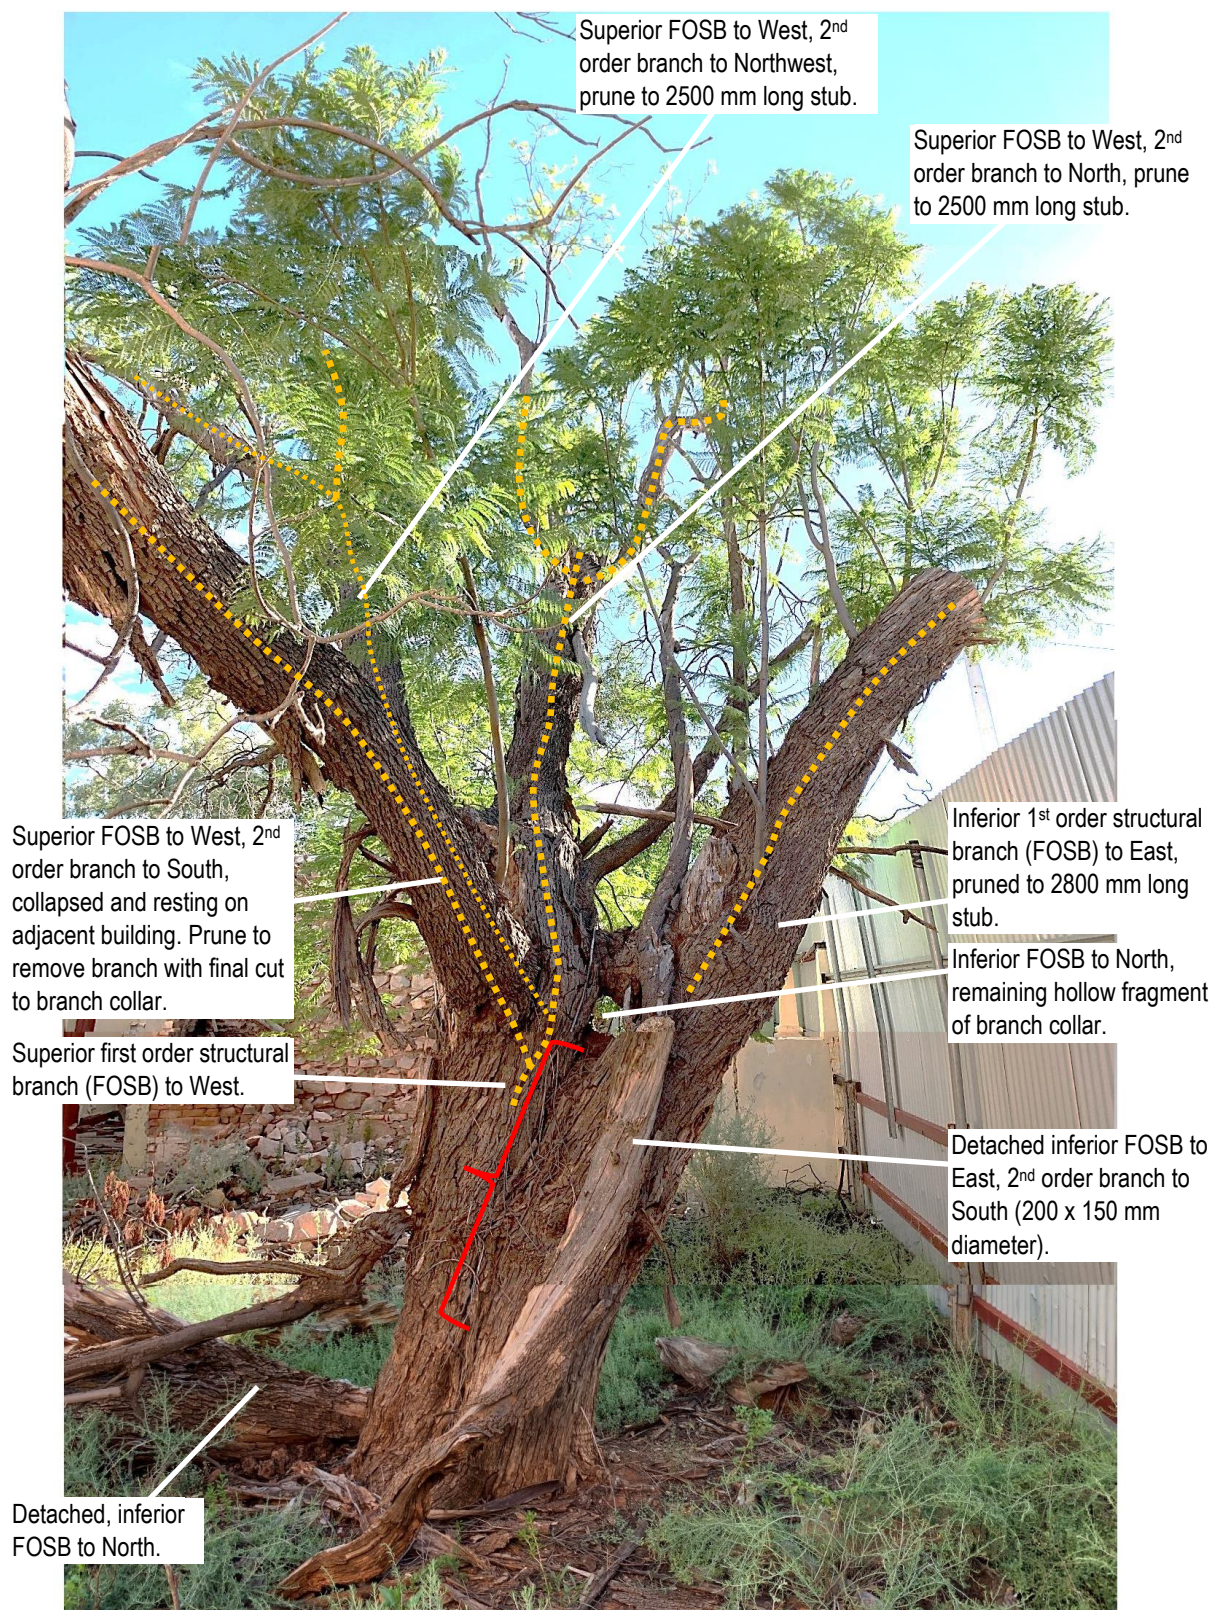
Due to the tree having a split at the union of the first order structural branches (FOSB) extending down the trunk, the 2 remaining FOSB will require branch bracing with a proprietary system to support the tree and its crown and trunk. The tree will require Deadwooding and Remedial (restorative) Pruning to reduce the Superior first order structural branch (FOSB) to West, 2<sup>nd</sup> order branch to North, (500 x 350 mm diameter) and 2<sup>nd</sup> order branch to West (300 mm diameter) to 2.5 m above branch union, while protecting epicormic shoots to be retained. The epicormic shoots on the 2 remaining FOSB will require ongoing remedial works as pruning annually, to maintain the crown height at 5 m and the radial crown spread at 5 m (crown projection) to ensure the fragile trunk is not overloaded, reducing the centre of mass of the tree as the crown grows. With the application of the tree protection works and ongoing remedial and risk assessment works detailed in this report, including ongoing maintenance, the tree could be retained for up to 10 years or more.

**Photograph 1.0** View to North of Tree 1 *Jacaranda mimosifolia* – Jacaranda, showing structural branches. The red brace shows extent of split in the trunk. Orange dotted lines showing approximate centre of structural branches.

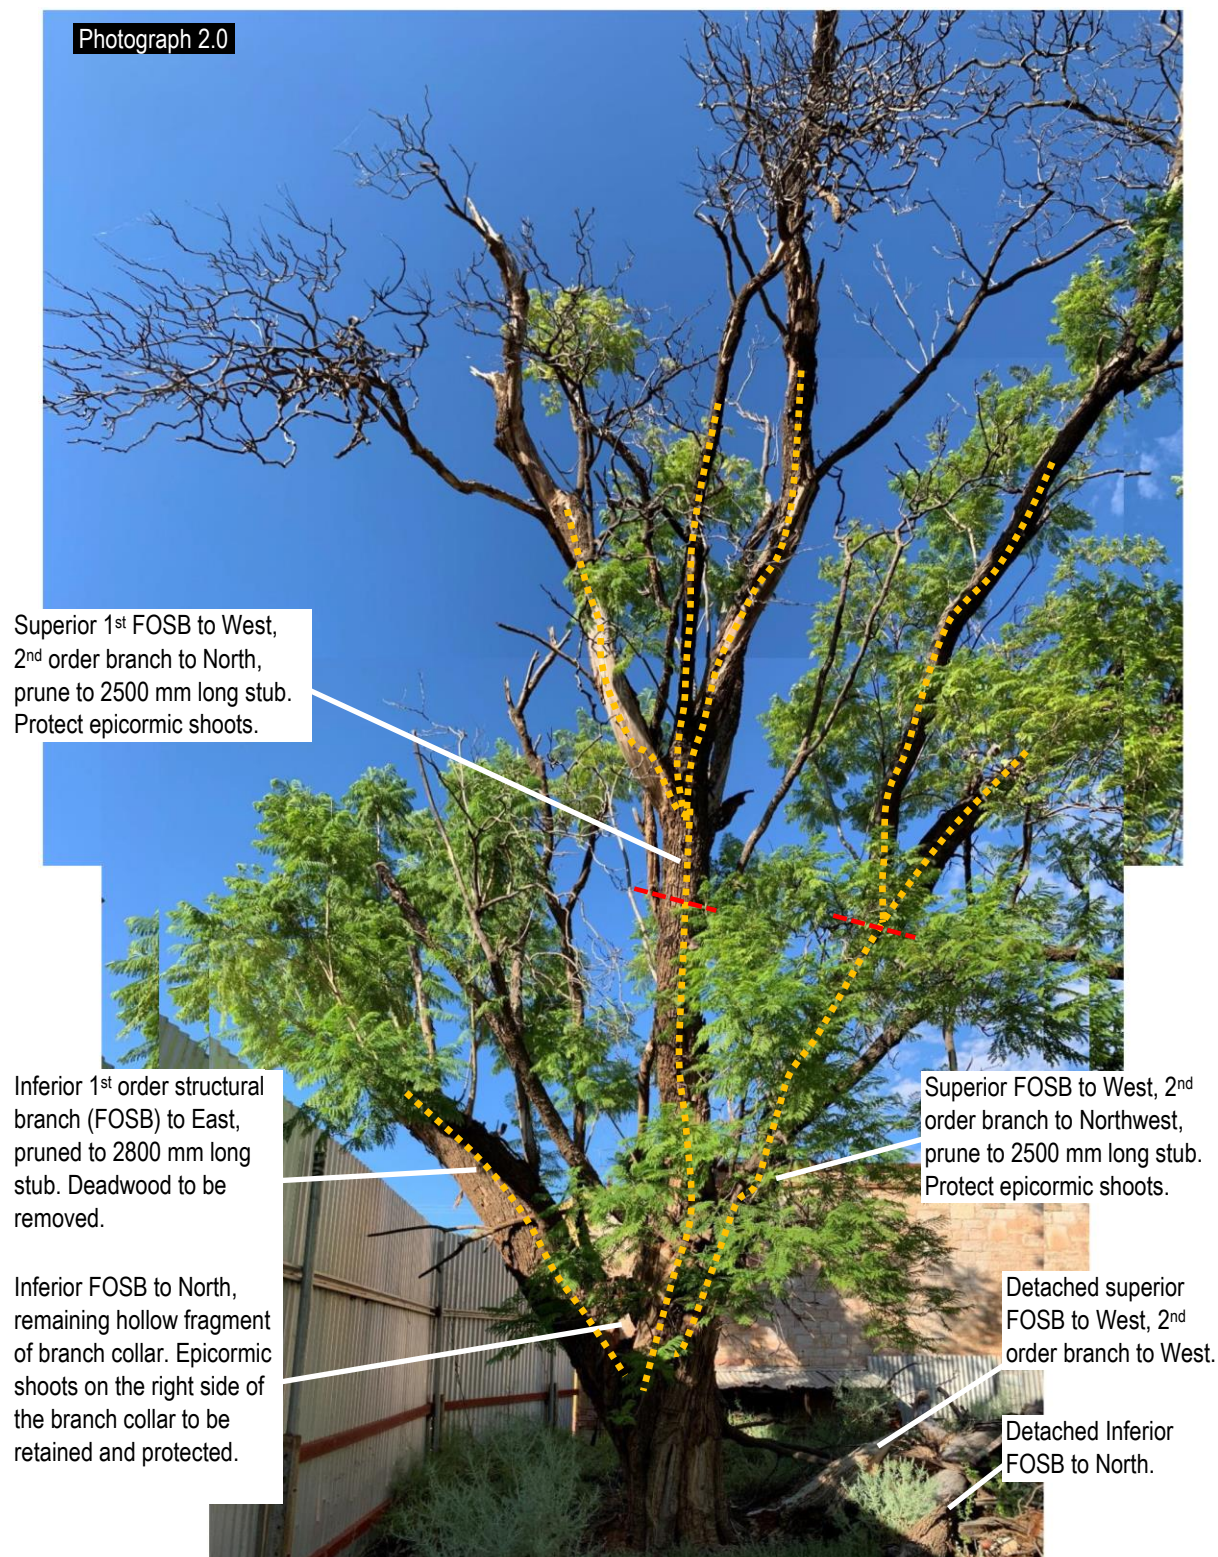
**Photograph 2.0** View to South of Tree 1 *Jacaranda mimosifolia* – Jacaranda, showing structural branches. Red dotted lines show approximate locations of final cuts at 2500 mm above the branch union of the Superior FOSB to West, 2<sup>nd</sup> order branch to North, and Superior FOSB to West, 2<sup>nd</sup> order branch to Northwest, while protecting epicormic shoots. Orange dotted line showing approximate centre of structural branches.

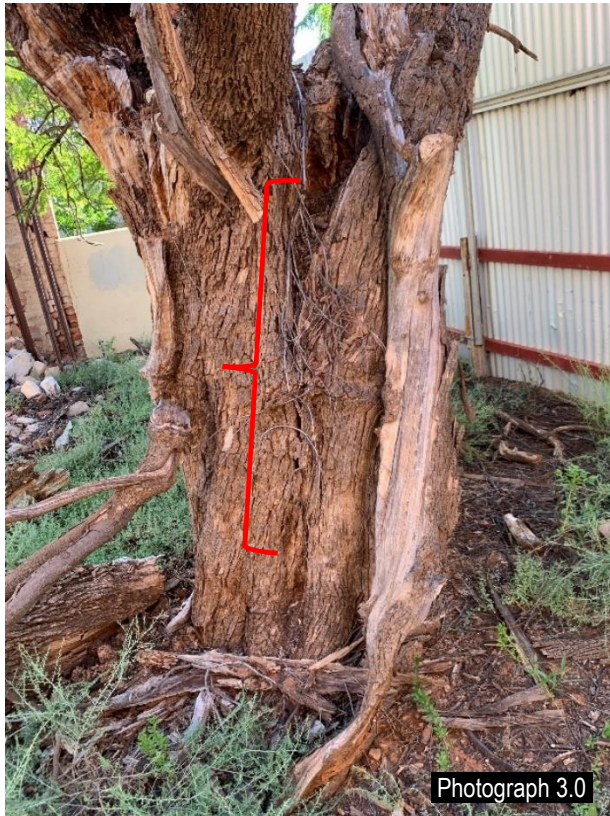
**Photograph 3.0** View to North with red brace showing split in trunk extending to 600 mm above ground.

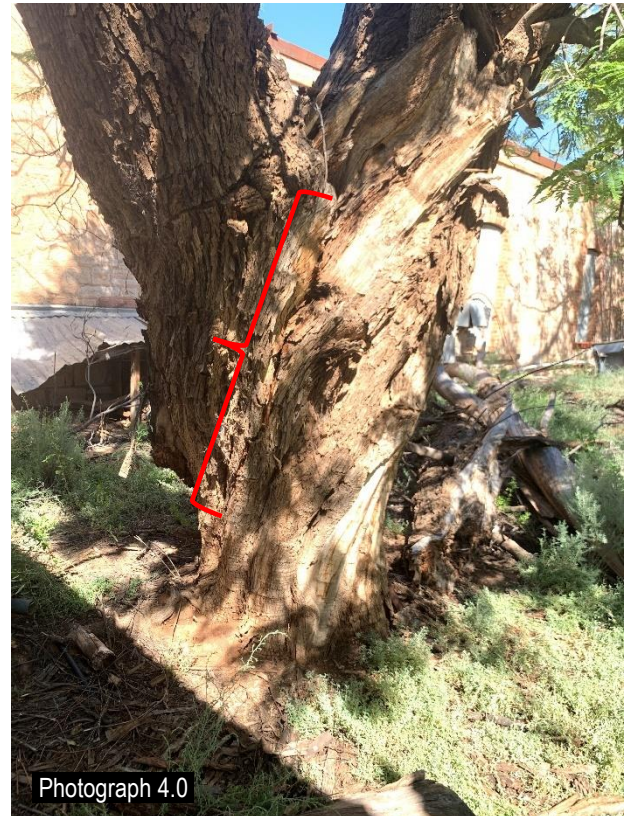
**Photograph 4.0** View to South with red brace showing split in trunk extending to 400 mm above ground.

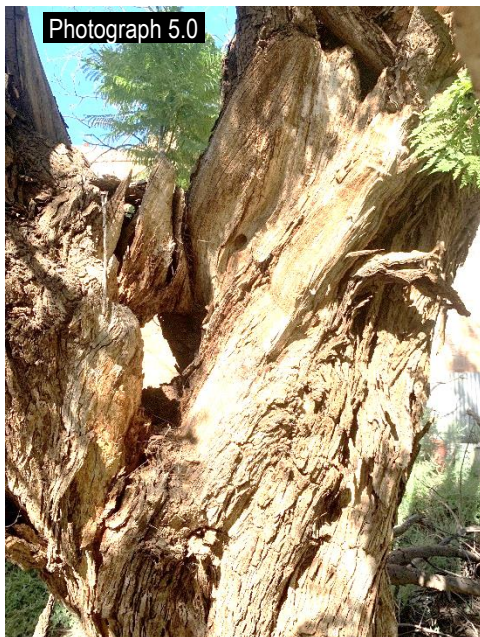
**Photograph 5.0** View to South of Inferior FOSB to North, showing a circular fragment of the branch collar (centre) and remaining torn branch section (right) extending from 1650-2300 mm, supporting 2 epicormic shoots 70 mm and 40 mm diameter, approx. 2 m long at the end of the branch. Epicormic shoots on the right side of the branch collar to be retained and protected.

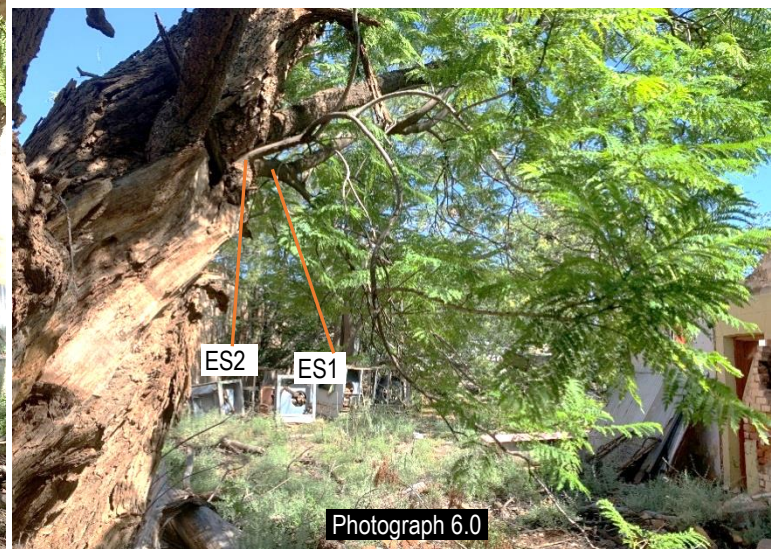
**Photograph 6.0** View to West of Inferior FOSB to North, showing a fragment of the branch remaining, extending from 1650-2300 mm, supporting 2 small live branches 70 mm (ES1) and 40 mm (ES2) diameter, approx. 2 m long exhibiting vigorous and typical foliage. Epicormic shoots to be retained and protected.

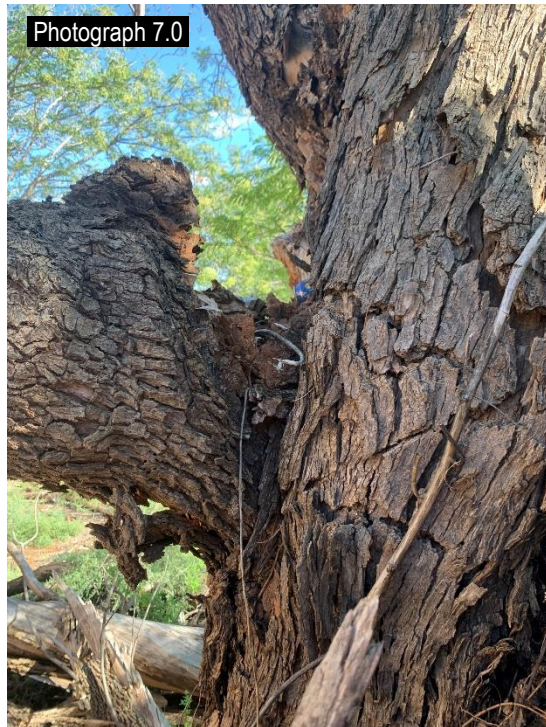
**Photograph 7.0** View to West of Superior FOSB to West, 2<sup>nd</sup> order branch to South, collapsed and resting on adjacent building. Prune to remove branch with final cut to branch collar.

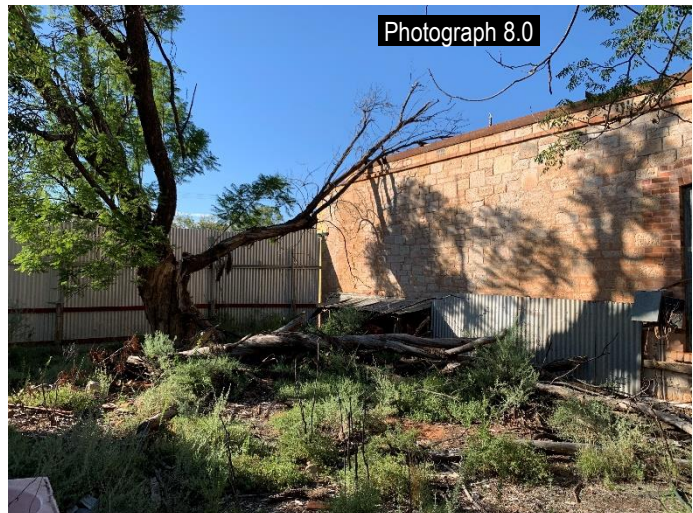
**Photograph 8.0** View to Southeast of Superior FOSB to West, 2<sup>nd</sup> order branch to South, collapsed and resting on adjacent building. Prune to remove branch with final cut to branch collar.

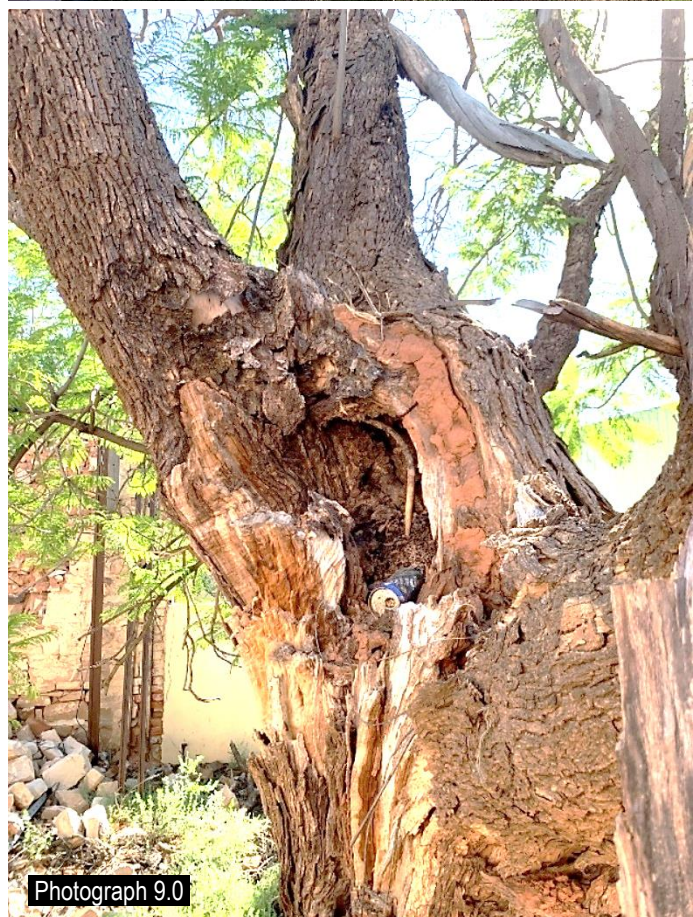
**Photograph 9.0** View to North of Superior FOSB to West, 2<sup>nd</sup> order branch to West, branch tear-out wound (centre) showing termite mud and decayed heart wood and trunk hollow.

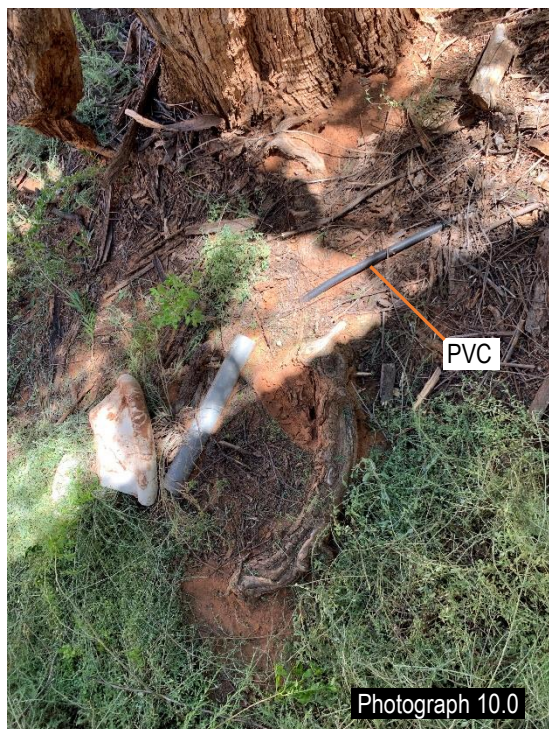
The tree was previously supported by irrigation which assisted its vigour but likely reduced its resilience (Photograph 10.0) and is expected to have contributed to its decline once the water supply to the tree was stopped. To continue the resilience currently exhibited by epicormic growth, the tree should only be watered occasionally during prolonged hot weather and not supported by regular irrigation. The root system is expected to have died back corresponding to the crown dieback and is now likely to be concentrated within approximately 3 m of the trunk. The tree has the propensity to continue to grow once the dead wood is removed. This will require root protection from soil compaction as a Root Protection Zone for a 3 m radius from the center of trunk. Protection works are described further in the Tree Protection Plan (Appendix C).

**Photograph 10.0** View to West of 1 structural root to East, 100 mm diameter at trunk, extending 1400 mm where it appeared to descend. Also showing black PVC irrigation pipe (PVC) that was likely once used to support the tree but contributed to its decline once the water supply to the tree was stopped.

**PVC Irrigation Pipe** – The existing PVC irrigation pipe is to be removed from within the TPZ by cutting the exposed pipe section at the at each end and removing that material. Buried sections should remain buried to prevent root disturbance by its extraction.

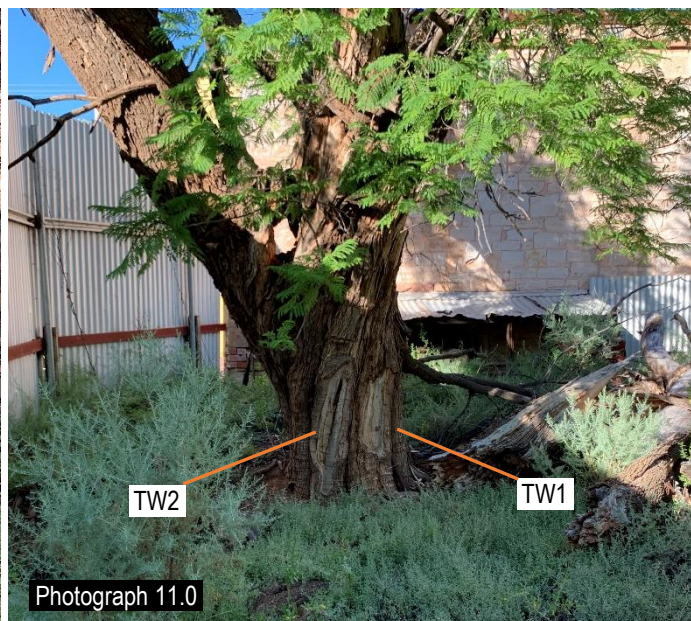
**Photograph 11.0** View to South of trunk wounds 1 (TW1) (right) to Northwest and 2 (TW2) (left) to North.

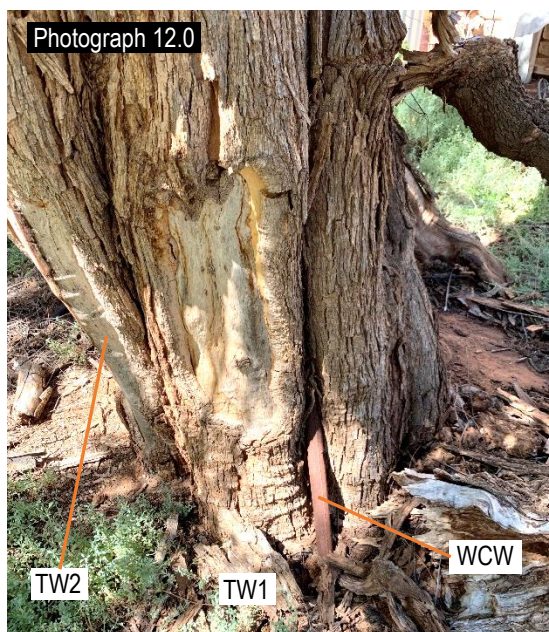
**Photograph 12.0** View to South of Trunk Wound 1 (TW1) (centre). Trunk Wound 1 (TW1) on a buttress to Northwest extending from 350-900 mm and was 160 mm at widest at centre. Dieback as cambial dysfunction evident as dry peeling bark continued distally past the wound apex adjoining the right wound margin. Likely associated with dieback of roots and crown. To the immediate right side of the buttress was a cylindrical piece of cast iron 40 mm diameter and 400 mm long (a window counterweight - WCW) imbedded in the ground 90 mm from the trunk and leaning into the trunk where a crevice in the trunk (the inter-buttress zone) with the buttress to West had grown around its top.

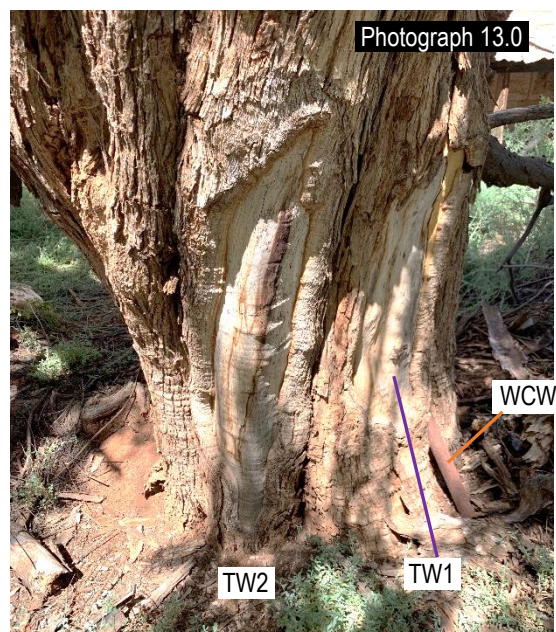
**Photograph 13.0** View to South of Trunk Wound 2 (TW2) (centre), extending from 50-1000 mm, and 180 mm at widest at 200 mm. Wound margins appear well-developed and vigorous.

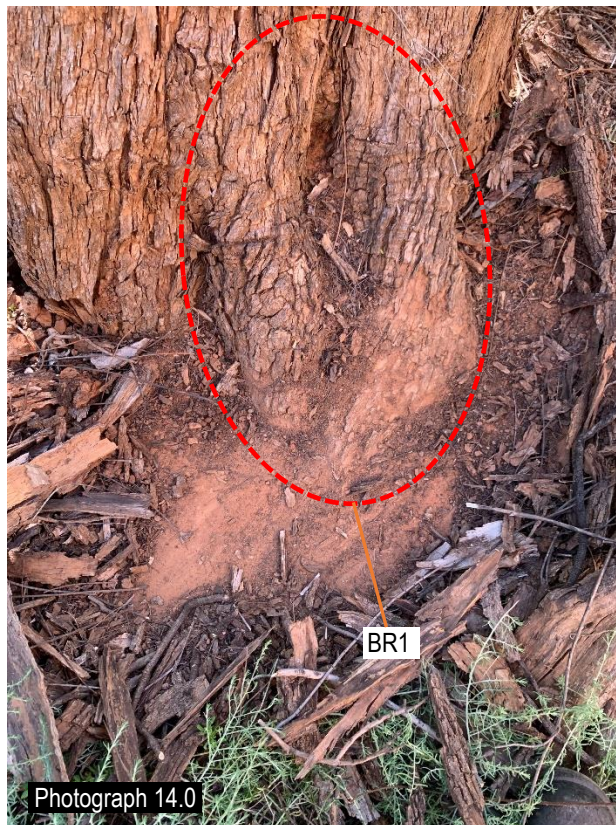
**Photograph 14.0** View to North of a Buttress Root 1 (BR1) to Southwest, (centre with red dotted oval) 350 mm wide extending 400 mm.

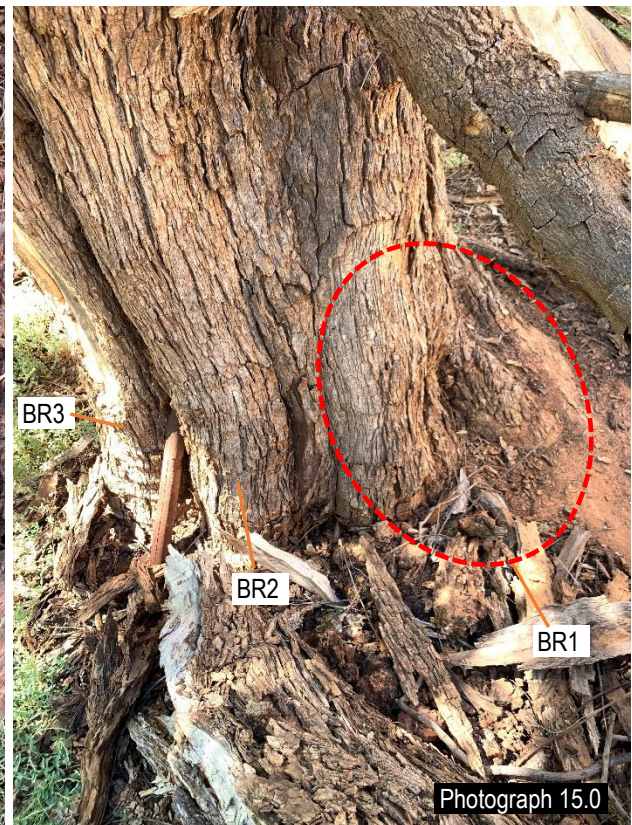
**Photograph 15.0** View to Northeast of a Buttress Roots 2 (BR2) to West and 3 (BR3) to Northwest, (centre). Buttress Root 2 (BR2) to West, 500 mm wide, extending 190 mm with a vertical crease in the centre. Buttress Root 3 (BR3) to Northwest, 300 mm wide, extending 250 mm. Buttress Root 1 (BR1) to Southwest shown with a red dotted oval.
