Residential Site Investigation Report

Client: Desim Pty Ltd

Site Address: 65-67 Columbus Street
Ivanhoe, NSW 2878

Our Reference: 41903-GR01_A

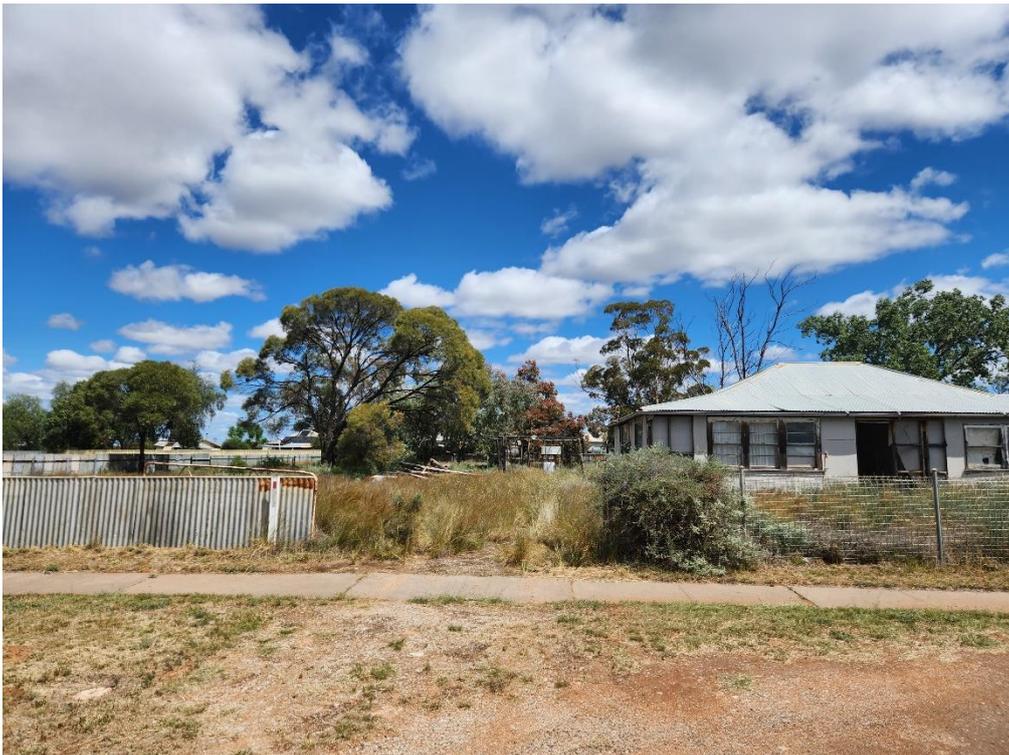
Plate 1 – West facing view

The site is relatively flat. The block has existing buildings and vacant blocks in the vicinity.

Any trees noted to be within the building zone, should be removed and the excavation remaining should be backfilled with natural material and reinstated in layers to a minimum of 95% Standard Maximum Dry Density

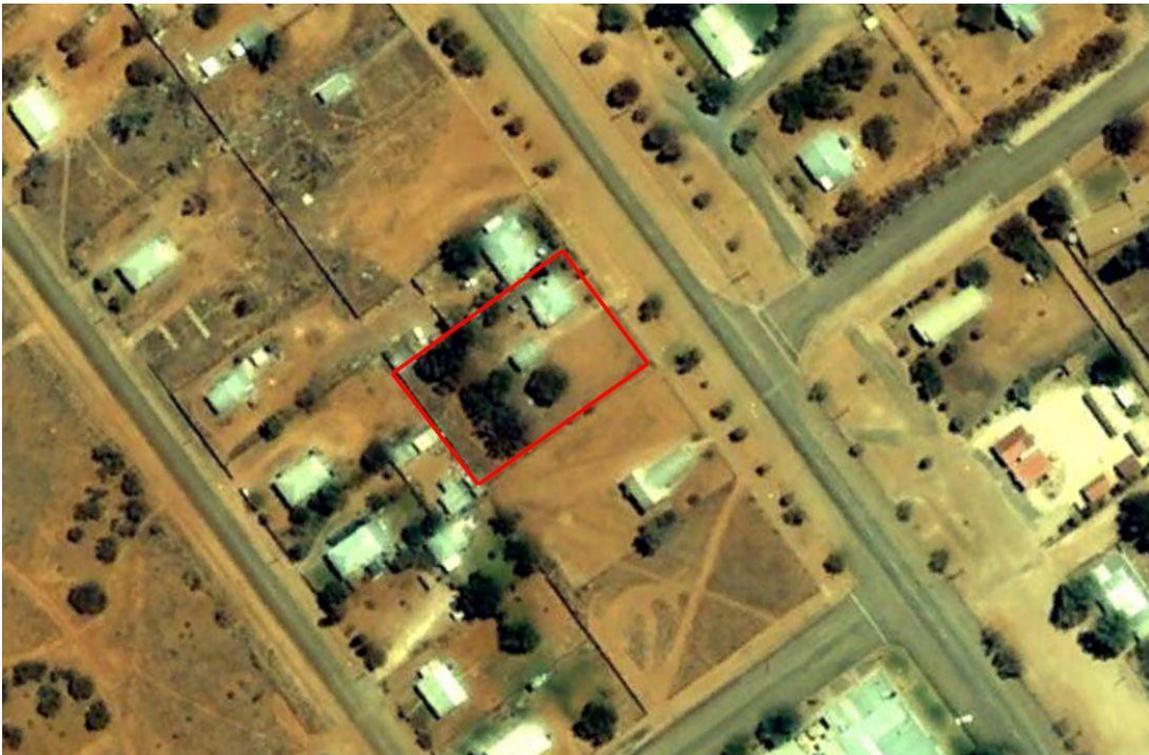
Plate 2 – Aerial Image 2002, Courtesy Google Earth.

A review of Google Earth imagery of the site indicates that the site is in similar condition as to when an image was taken in 2002. The site is therefore assumed to be natural ground with no recent tree removal or fill placed. Images exist back to 1985, yet the image is not clear enough to determine what was on the site. See 2002 aerial image below:
