Preliminary Site Contamination Assessment

Maari Ma Health Clinic
Wilcannia
NSW

(Our Reference:32342 ER01)

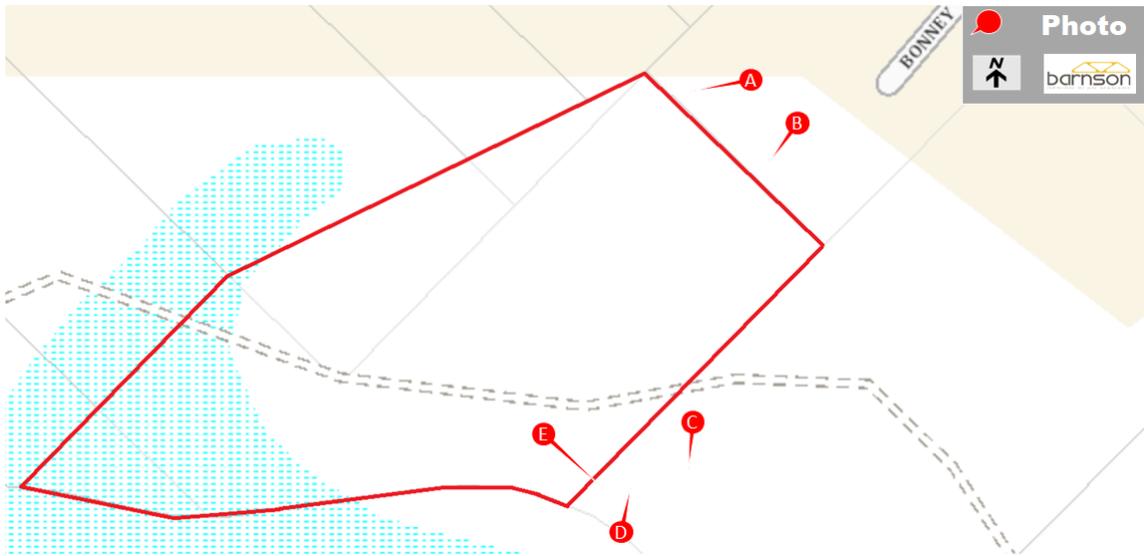
Figure 2.2: Existing Subject Site layout.

Figure 2.2 presents a plan of the Subject Site that is supplemented with photographs showing the different elements of the Site (Figure 2.3 to Figure 2.7). Figure 2.2 includes markers indicating the vantage point and direction of the photographs.

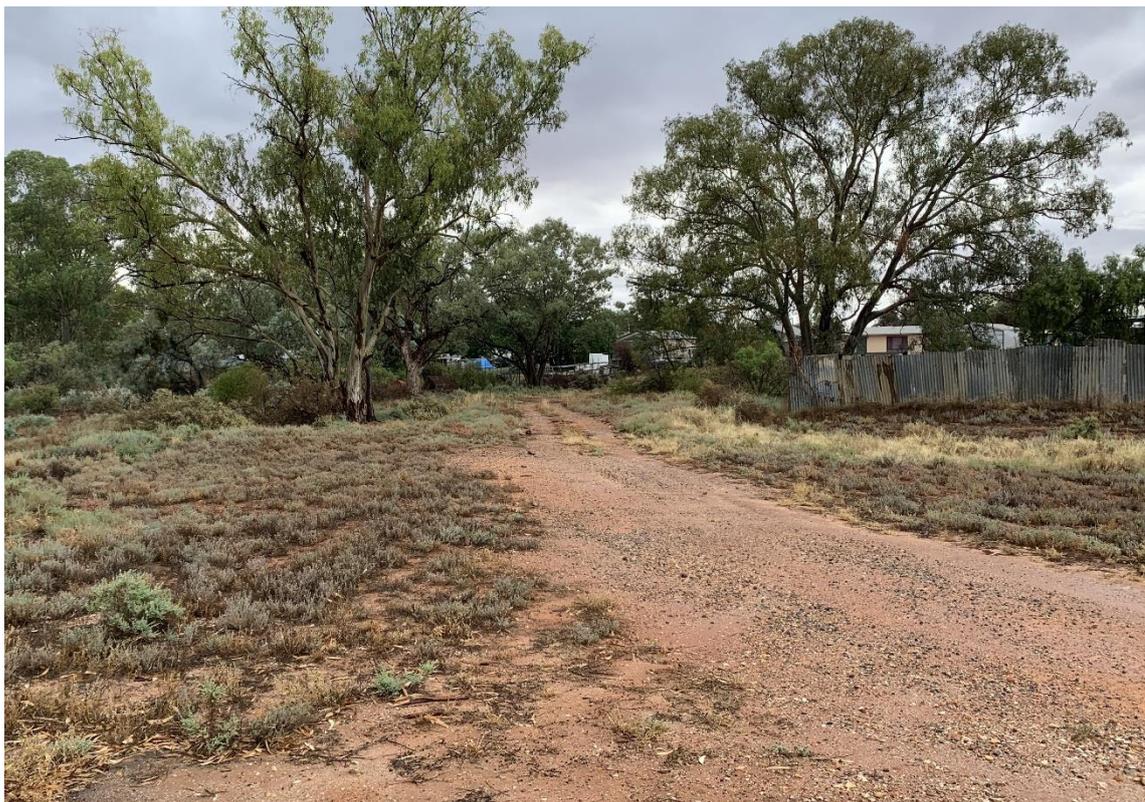
Figure 2.3: Photo A –Photo of existing driveway heading west of the Subject Site

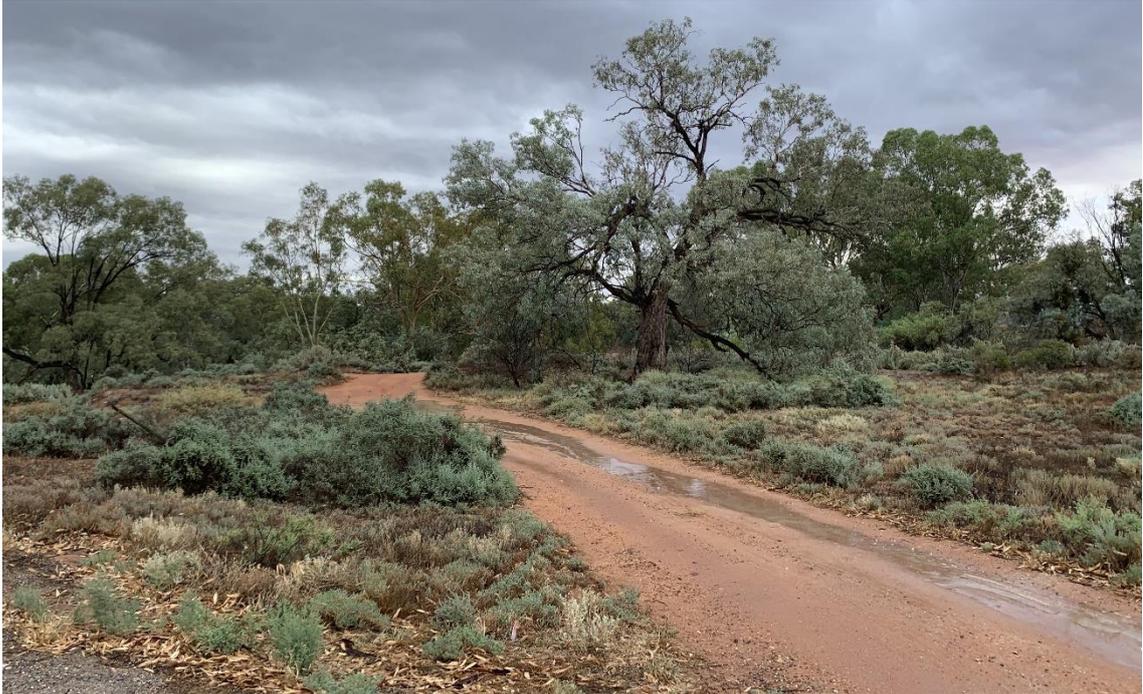
Figure 2.4: Photo B – View of the Subject Site.

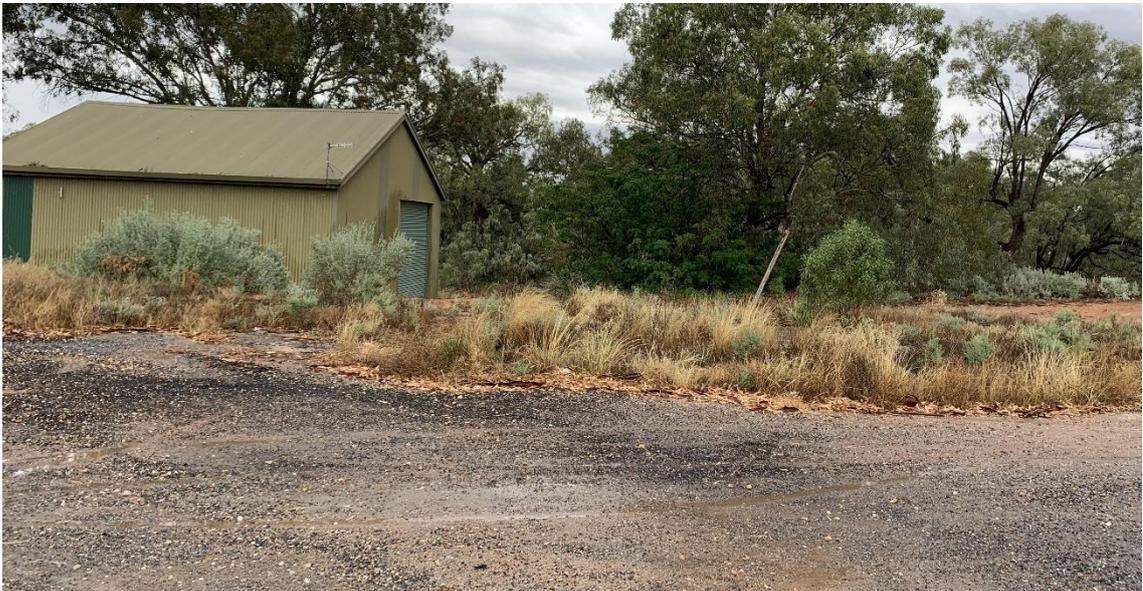
The Subject Site has previously been used for water supply with evidence of a pump shed adjacent the Subject Site and other unknown uses as remnants of an old building were also found on site. An unsealed road (Bonney Street) is the entrance to the Subject Site. The site is abundant in vegetation, as shown in Figure 2.1, and is covered in a variety of flora including trees, shrubs, and grasses.

Figure 2.5: Photo C – View of pump shed on adjacent Lot

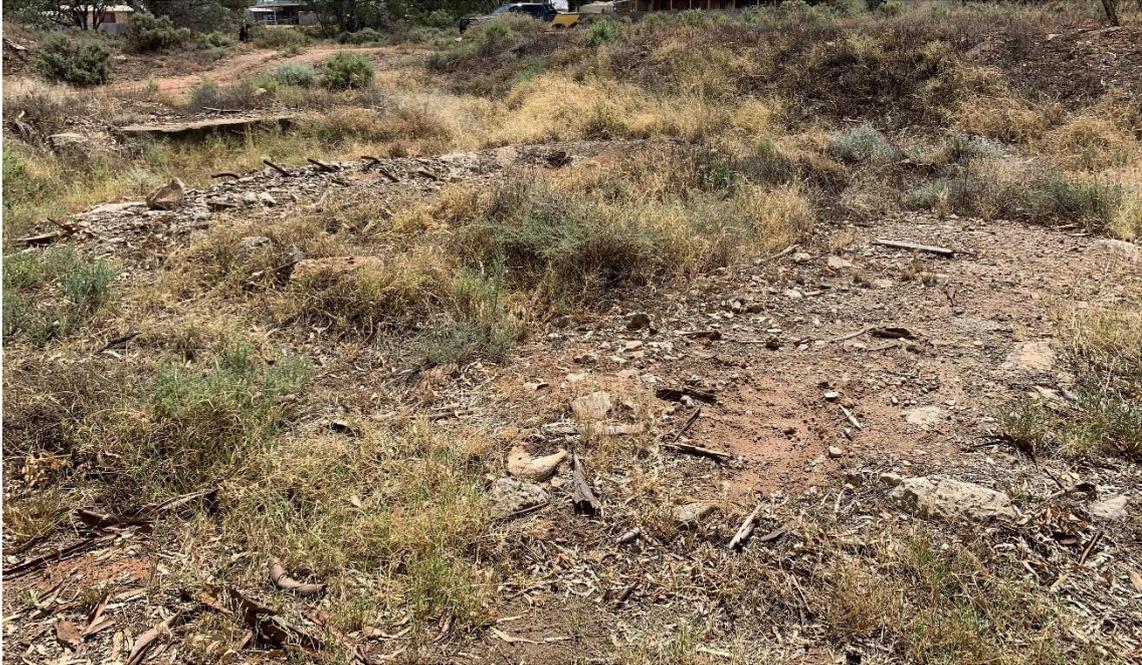
Figure 2.6: Photo D – Remnants of old building adjacent pump shed.

The Subject Site include remnants (demolition waste) of former structures. The former structures could potentially have included hazardous materials such as asbestos and lead based paint. Deterioration and demolition of the former structures can result in the localised dispersion of hazardous materials over the surface of the Subject Site.

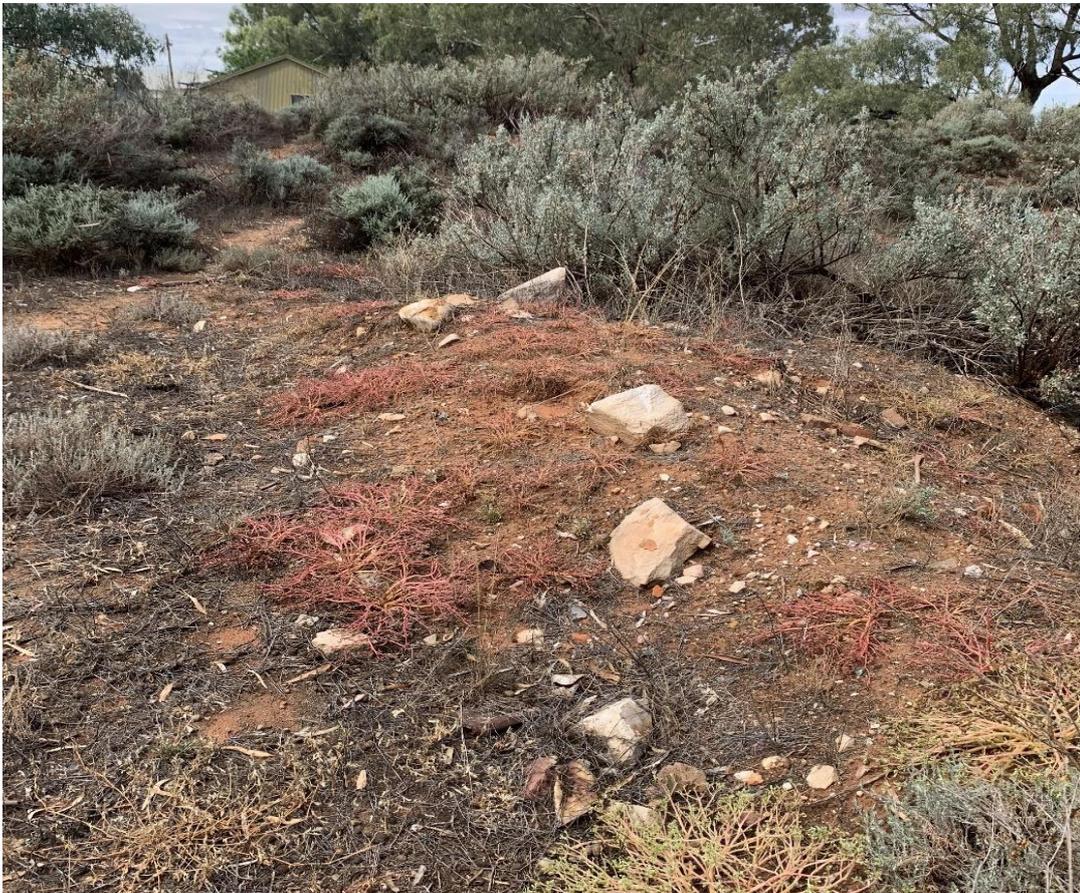
Figure 2.7: Photo E – Photo of fill and brick remnants on site

There is evidence of fill material being stockpiled at the Subject Site. Unclassified fill material could potentially originate from other contaminated sites or could contain demolition wastes contaminated with hazardous materials such as asbestos or lead based paints.

- Based on the findings of the desktop review and site investigation it can be stated with a reasonable level of confidence that the Subject Site is suitable for the proposed re-development and land use.
- It is recommended that the stockpiles of fill material as well as demolition waste present at the Subject Site be removed and appropriately disposed, prior to the commencement of any earthworks or construction.
- It is recommended that any material excavated from the drainage channel or its banks be appropriately classified in terms of the Excavated Natural Materials Order ((NSW EPA, 2014)) prior to being used on-site or removed off site.

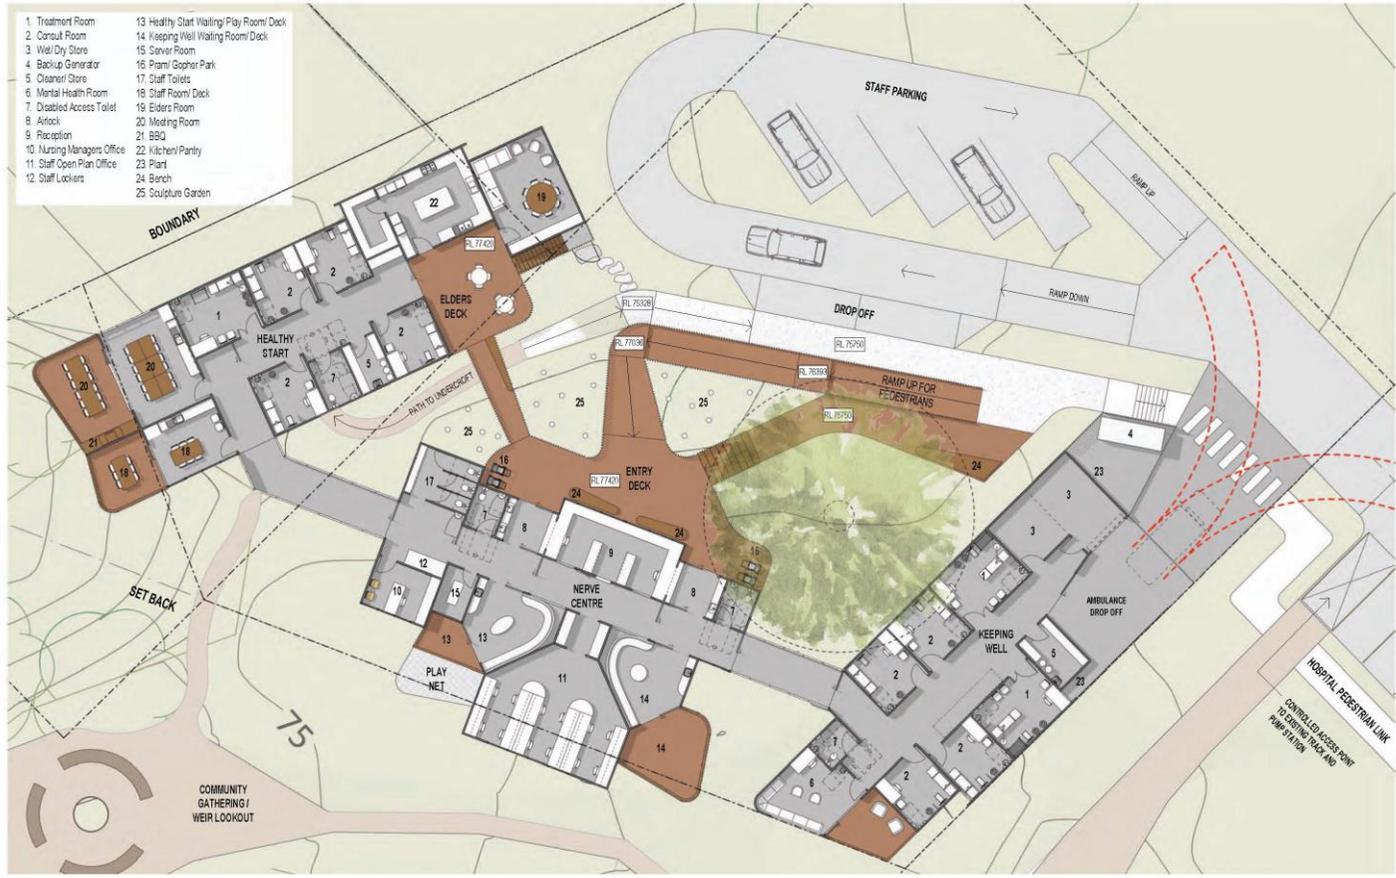
Figure 2.8: Proposed development layout

Figure 2.8 shows a detailed layout of the proposed health clinic and its associated developments. It is accepted that the proposed development will not require to significantly disturb the surface soil of the Subject Site.

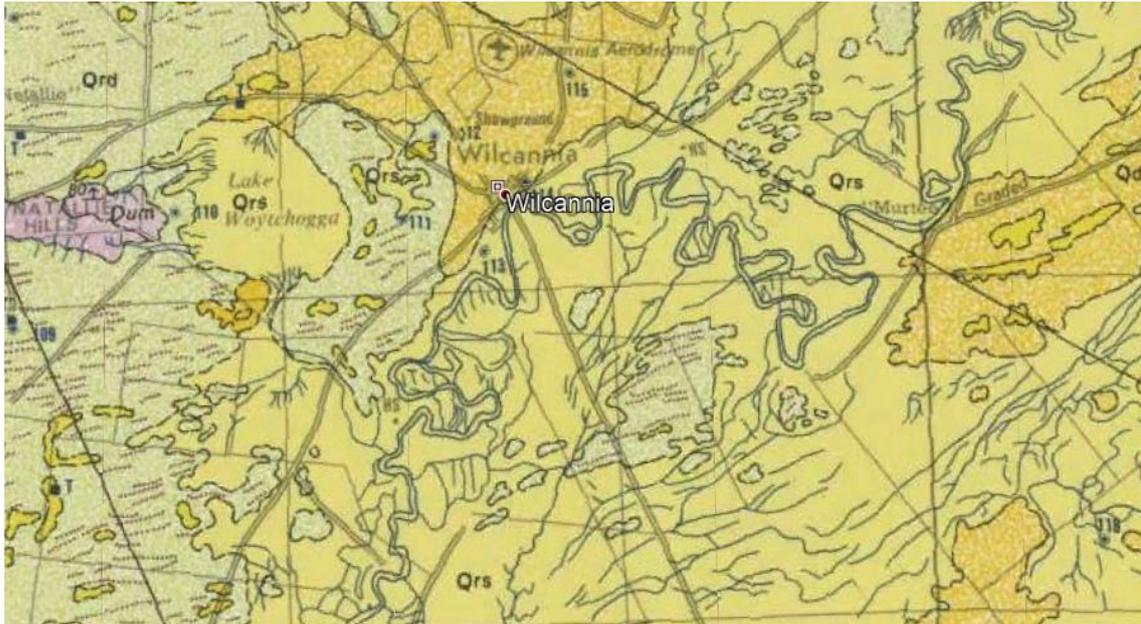
A review of the 1:250000 Geology map of Wilcannia (refer to Figure 3.1) shows that geologically, the Subject Site is underlain by Mesozoic age units of sandstone, siltstone and claystone; with flat to gently undulating plains of red and brown clayey sand, loam and lateritic soils.

Figure 3.1: Wilcannia 1:250000 geology map showing the location of the Subject Site

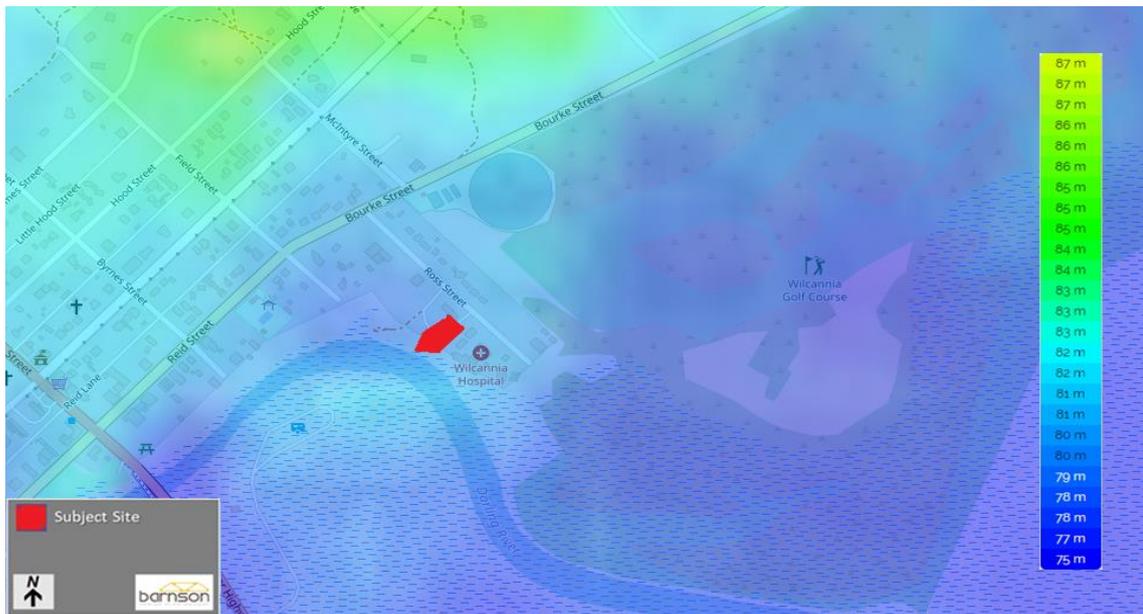
Figure 3.2 presents topographical information overlain on the map of the Subject Site. The presented data shows that the Subject Site is relatively flat throughout. there is a gradual fall from the north-eastern end of the Subject Site to the south-western.

Figure 3.2: Subject Site topography.

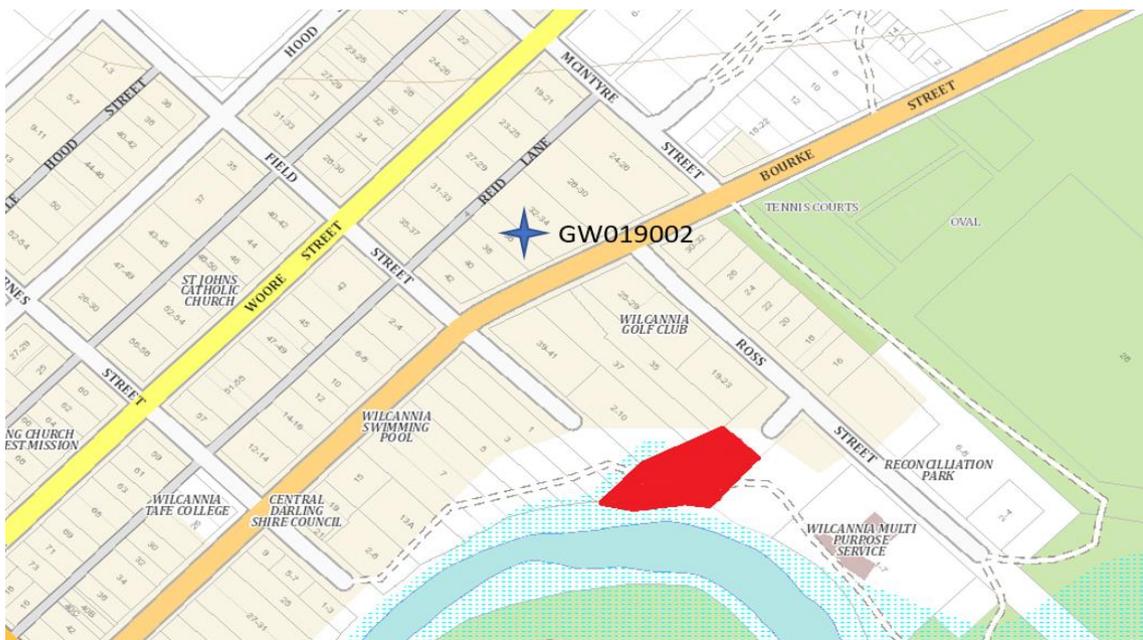
A review of existing groundwater bore records (WaterNSW, 2021) indicate no registered groundwater bores inside the boundary of the Subject Site, and only one within 500m of the Subject Site. The only groundwater bore within 500m of the Subject Site is identified in Figure 3.3, it is located to the north-west of the site.

Figure 3.3: Groundwater bores near the Subject Site.

The information recorded in the database for the closest off-site bore indicate the depth of the bore is 35.10m with a Standing Water Level (SWL) of 12.20m. The shallowest water bearing zone for GW019002 was recorded at 33.50m. According to the database, the bore is for domestic/general use purposes.

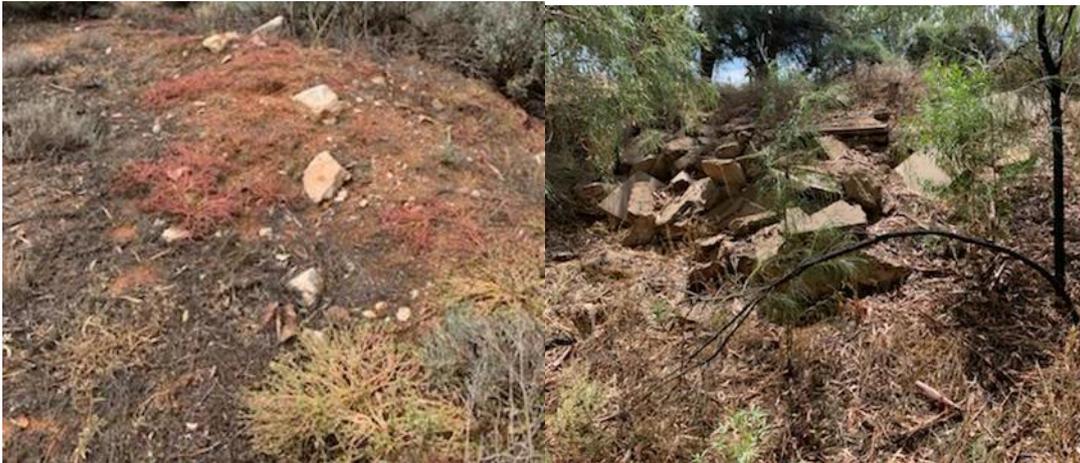
- The Subject Site is in general good order without visible signs of disturbance to the soils or vegetation at the Site.
- All visible open ground and prominent features at the Subject Site were inspected. No visible discoloration or staining of open ground or soil, and no obvious discoloration or irregularities in the occurrence of vegetation was observed during the inspection.
- Concrete and bricks remaining from the demolition of the historical structures at the site were observed at two locations (see Figure 6.1).

Figure 6.1: Historical demolition waste.

- The areas with demolition waste were carefully inspected for hazardous materials. No evidence of any fibre cement sheeting, paint or staining associated with hydrocarbons were observed.
- No evidence of any waste disposal was noted at the Subject Site and no general waste was observed in any other part of the Subject Site during the site inspection.
- A stockpile of fill material was observed near the informal vehicle pathway.
- There is a drainage channel across the western portion of the Site, draining stormwater runoff across the site to the Darling River.
