## Statement of Environmental Effects

Maari Ma Wilcannia Health Clinic  
Bonney Street  
Wilcannia NSW 2836

<b>Report Title:</b>	Statement of Environmental Effects
<b>Project Name:</b>	Maari Ma Wilcannia Health Clinic
<b>Client:</b>	Troppo Architects (for Maari Ma Health Aboriginal Corporation)
<b>Project No.</b>	32342
<b>Report Reference</b>	32342-PR01_A
<b>Date:</b>	12/10/2021
<b>Revision:</b>	Final

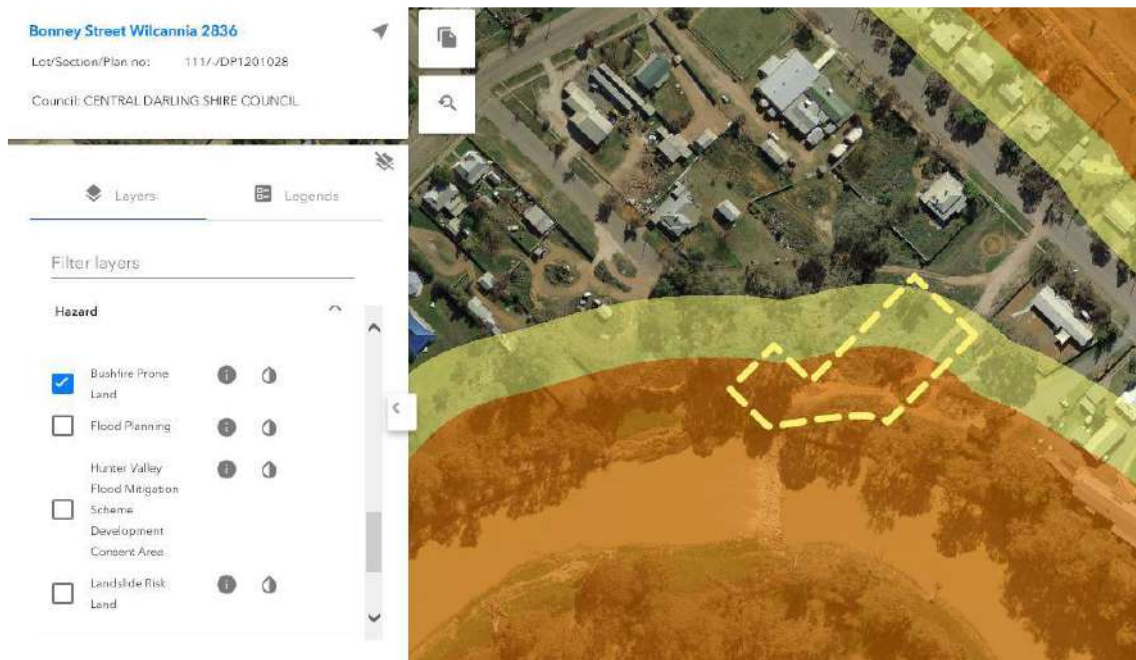
Figure 3 – Bush Fire Prone Land Map

The site is identified as containing Category 3 Vegetation and Vegetation Buffer on the Bush Fire Prone Land Map as shown in **Figure 3** below.

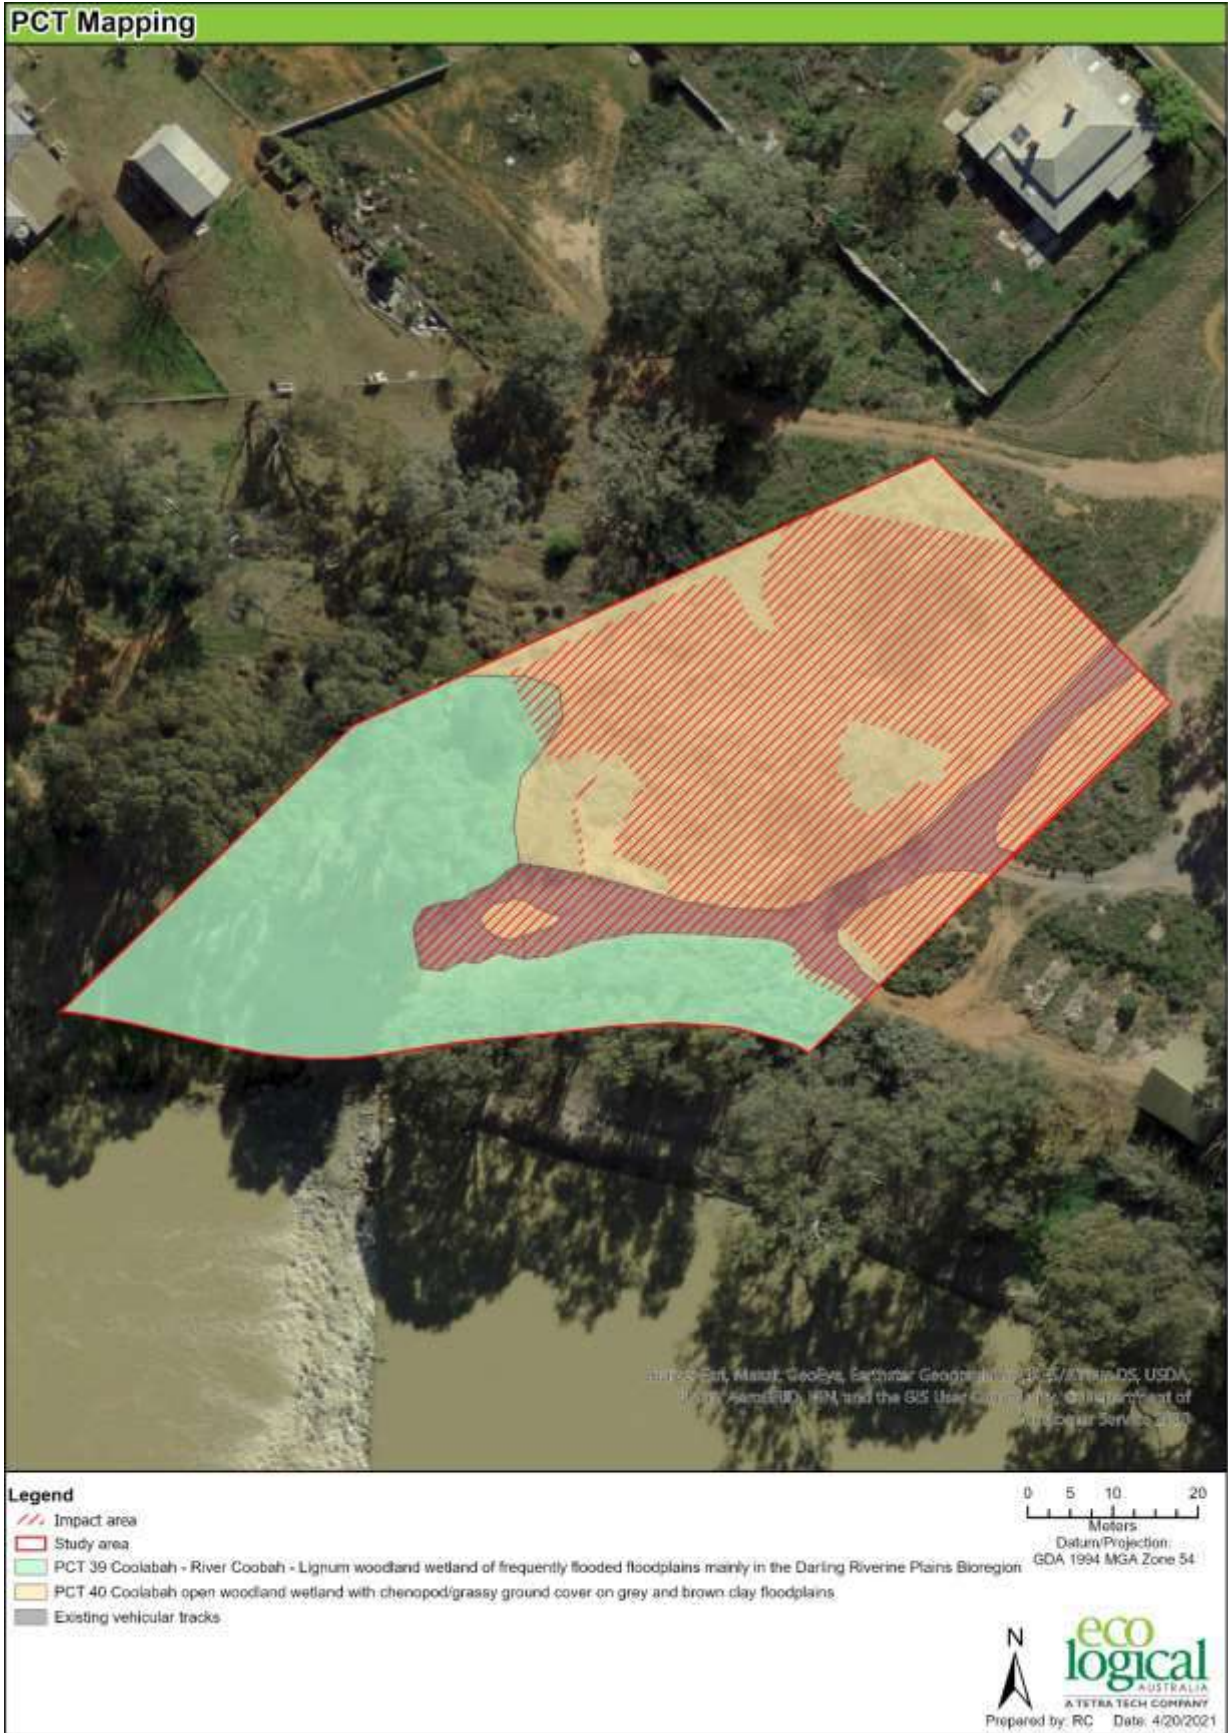
Figure 3: PCT mapping

Both PCT 39 and PCT 40 are associated, in part, with the *Coolabah-Black Box Woodland in the Darling Riverine Plains, Brigalow Belt South, Cobar Penepplain and Mulga Lands Bioregions* listed as Endangered under the BC Act and EPBC Act and the *Artesian Springs Ecological Community in the Great Artesian Basin* which is listed as Critically Endangered under the BC Act and Endangered under the EPBC Act. Assessments against the listing criteria undertaken in **Sections 3.1.1** and **3.1.2** below determined that the areas of PCT 39 and PCT 40 within the study area do not meet the listing criteria, and as such, no TECs are present within the study area.

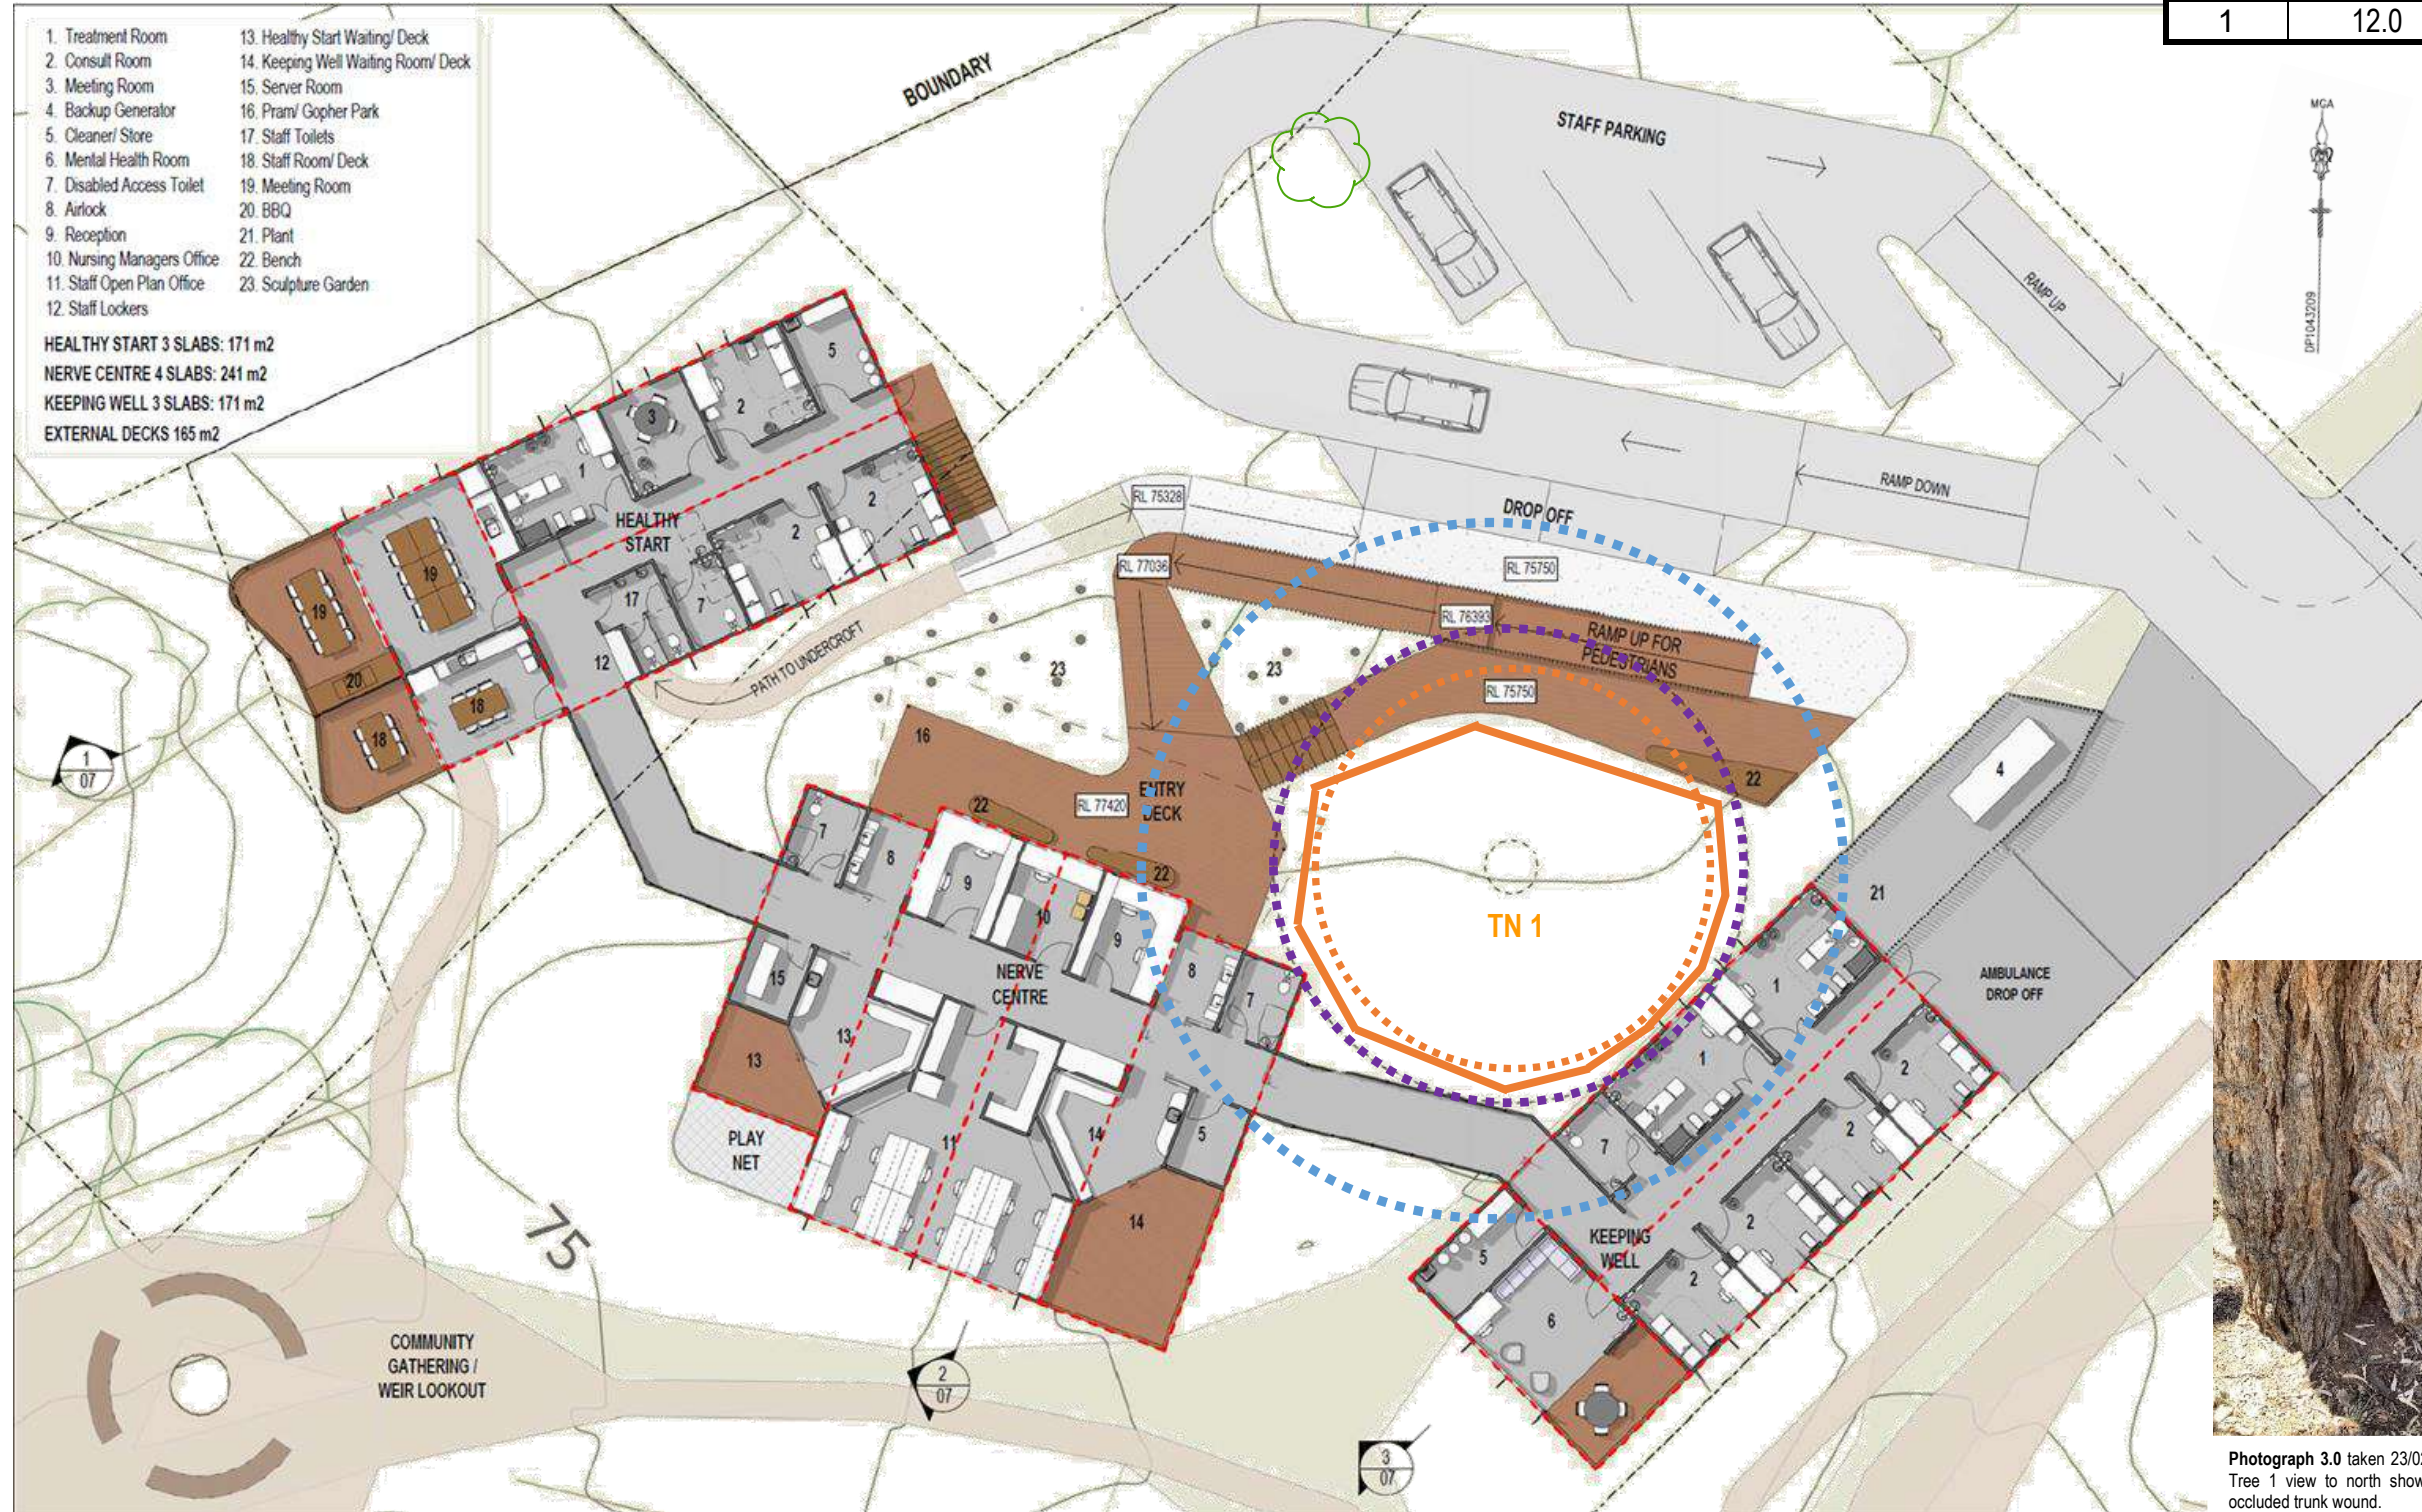
- 1. Treatment Room
  - 2. Consult Room
  - 3. Meeting Room
  - 4. Backup Generator
  - 5. Cleaner/ Store
  - 6. Mental Health Room
  - 7. Disabled Access Toilet
  - 8. Airlock
  - 9. Reception
  - 10. Nursing Managers Office
  - 11. Staff Open Plan Office
  - 12. Staff Lockers
  - 13. Healthy Start Waiting/ Deck
  - 14. Keeping Well Waiting Room/ Deck
  - 15. Server Room
  - 16. Pram/ Gopher Park
  - 17. Staff Toilets
  - 18. Staff Room/ Deck
  - 19. Meeting Room
  - 20. BBQ
  - 21. Plant
  - 22. Bench
  - 23. Sculpture Garden
- HEALTHY START 3 SLABS: 171 m<sup>2</sup>  
 NERVE CENTRE 4 SLABS: 241 m<sup>2</sup>  
 KEEPING WELL 3 SLABS: 171 m<sup>2</sup>  
 EXTERNAL DECKS 165 m<sup>2</sup>

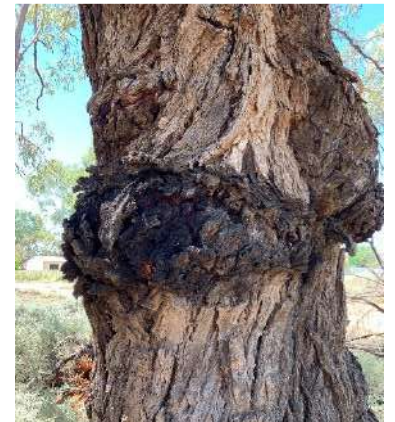
Photograph 2.0 taken 23/02/2021 by D Draper, Tree 1 view to north showing trunk burls.

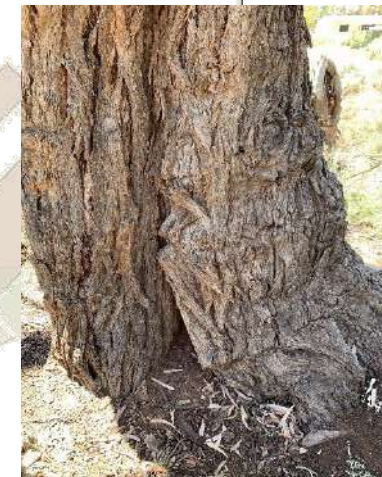
Photograph 3.0 taken 23/02/2021 by D Draper, Tree 1 view to north showing base of almost occluded trunk wound.

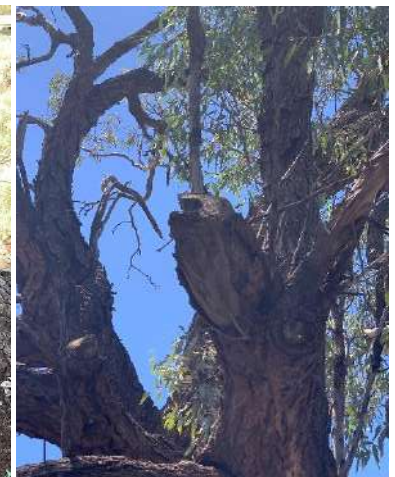
Photograph 4.0 taken 23/02/2021 by D Draper, Tree 1 view to northeast showing old pruning stubs in mid crown.

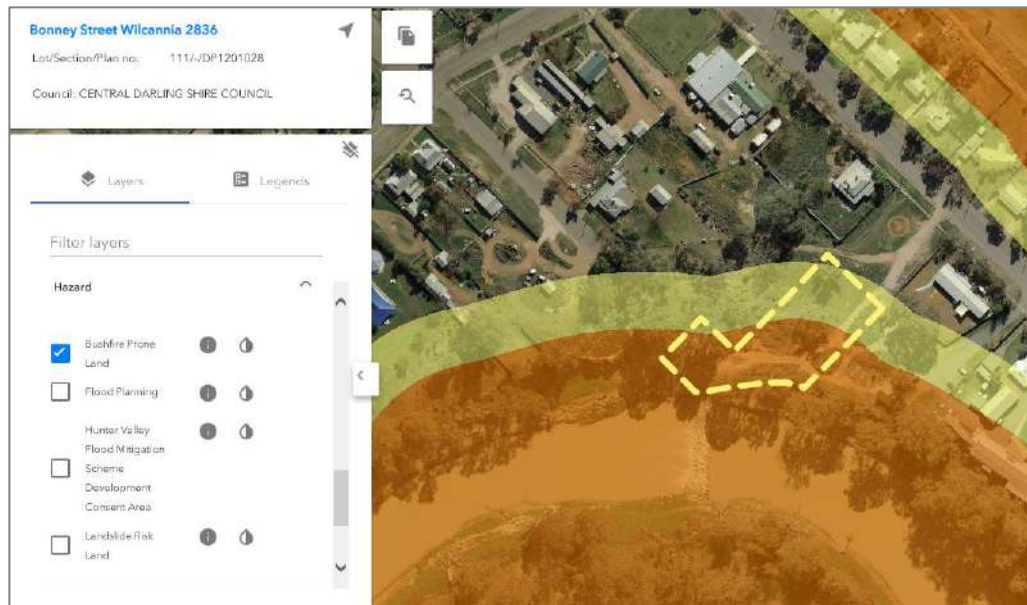
**Figure 1 – Bush Fire Prone Land Map**

The subject site is designated as bush fire prone land, pursuant to Section 10.3 of the EP&A Act. The site is identified as containing Category 3 Vegetation and Vegetation Buffer on the Bush Fire Prone Land Map as shown in **Figure 1** below.

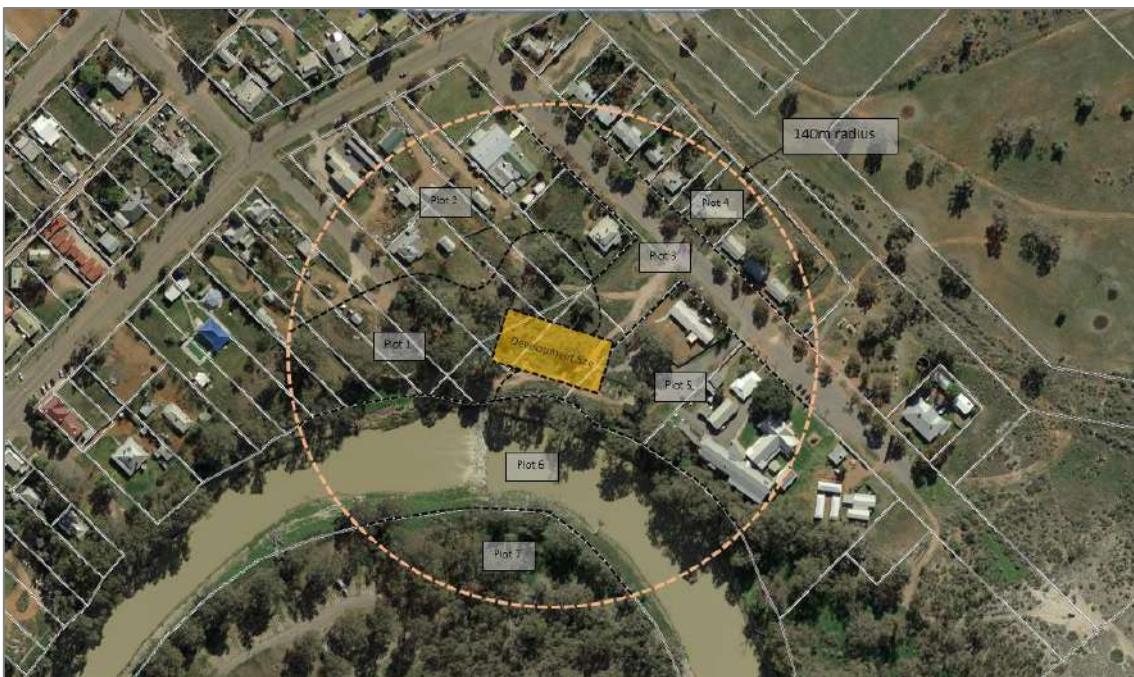
Figure 5 – Vegetation Classification

Pursuant to Appendix 1 of PBP, all vegetation within 140m of the site (assessment area) has been classified in accordance with *Ocean Shores to Desert Dunes* (Keith, 2004) and Figure 2.3 of AS3959. Photographs of the vegetation from the site inspection carried out on 12 March 2021 are provided in the following plates for each assessment plot.

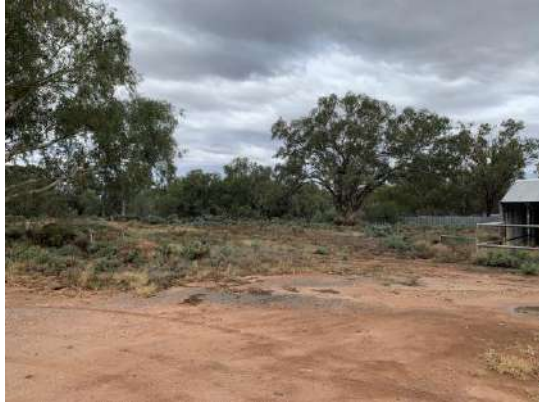
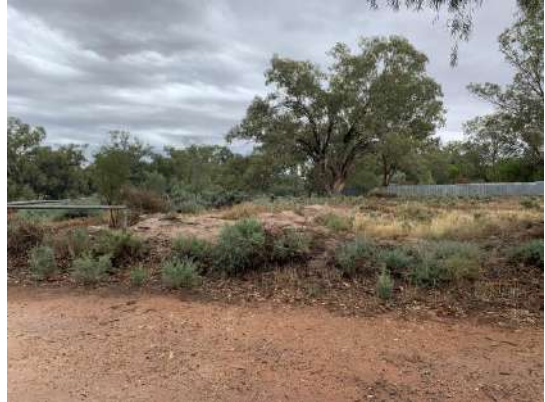
<p align="center"><b>Plate 1 – Plot 1</b></p>	<p align="center"><b>Plate 2 – Plot 1</b></p>

Plot 1	
Existing Classification:	Managed vegetation
Post Development Classification:	Managed vegetation
Description:	Managed vegetation within the existing urban area of Wilcannia. Some Eucalypts.

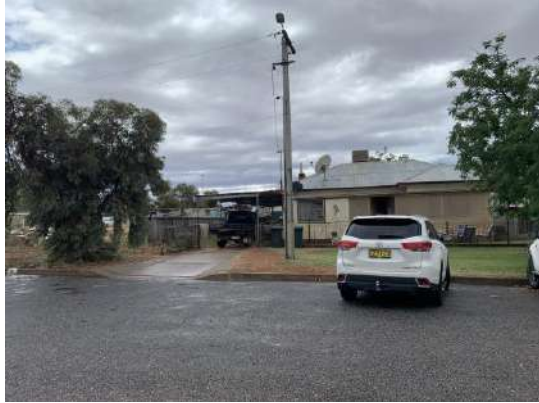
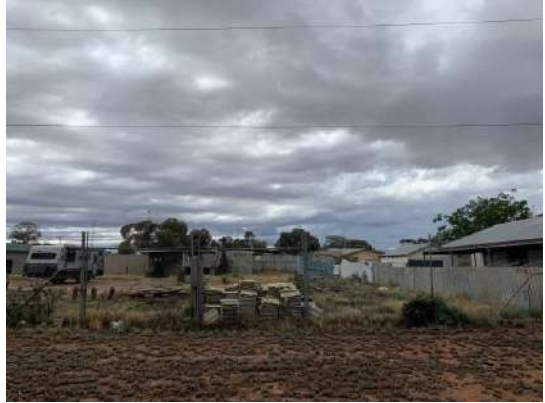
<p align="center"><b>Plate 3 – Plot 2</b></p>	<p align="center"><b>Plate 4 – Plot 2</b></p>

<p><b>Plot 2</b></p>	
<p><b>Existing Classification:</b></p>	<p>Managed vegetation</p>
<p><b>Post Development Classification:</b></p>	<p>Managed vegetation</p>
<p><b>Description:</b></p>	<p>Managed vegetation within the existing urban area of Wilcannia.</p>

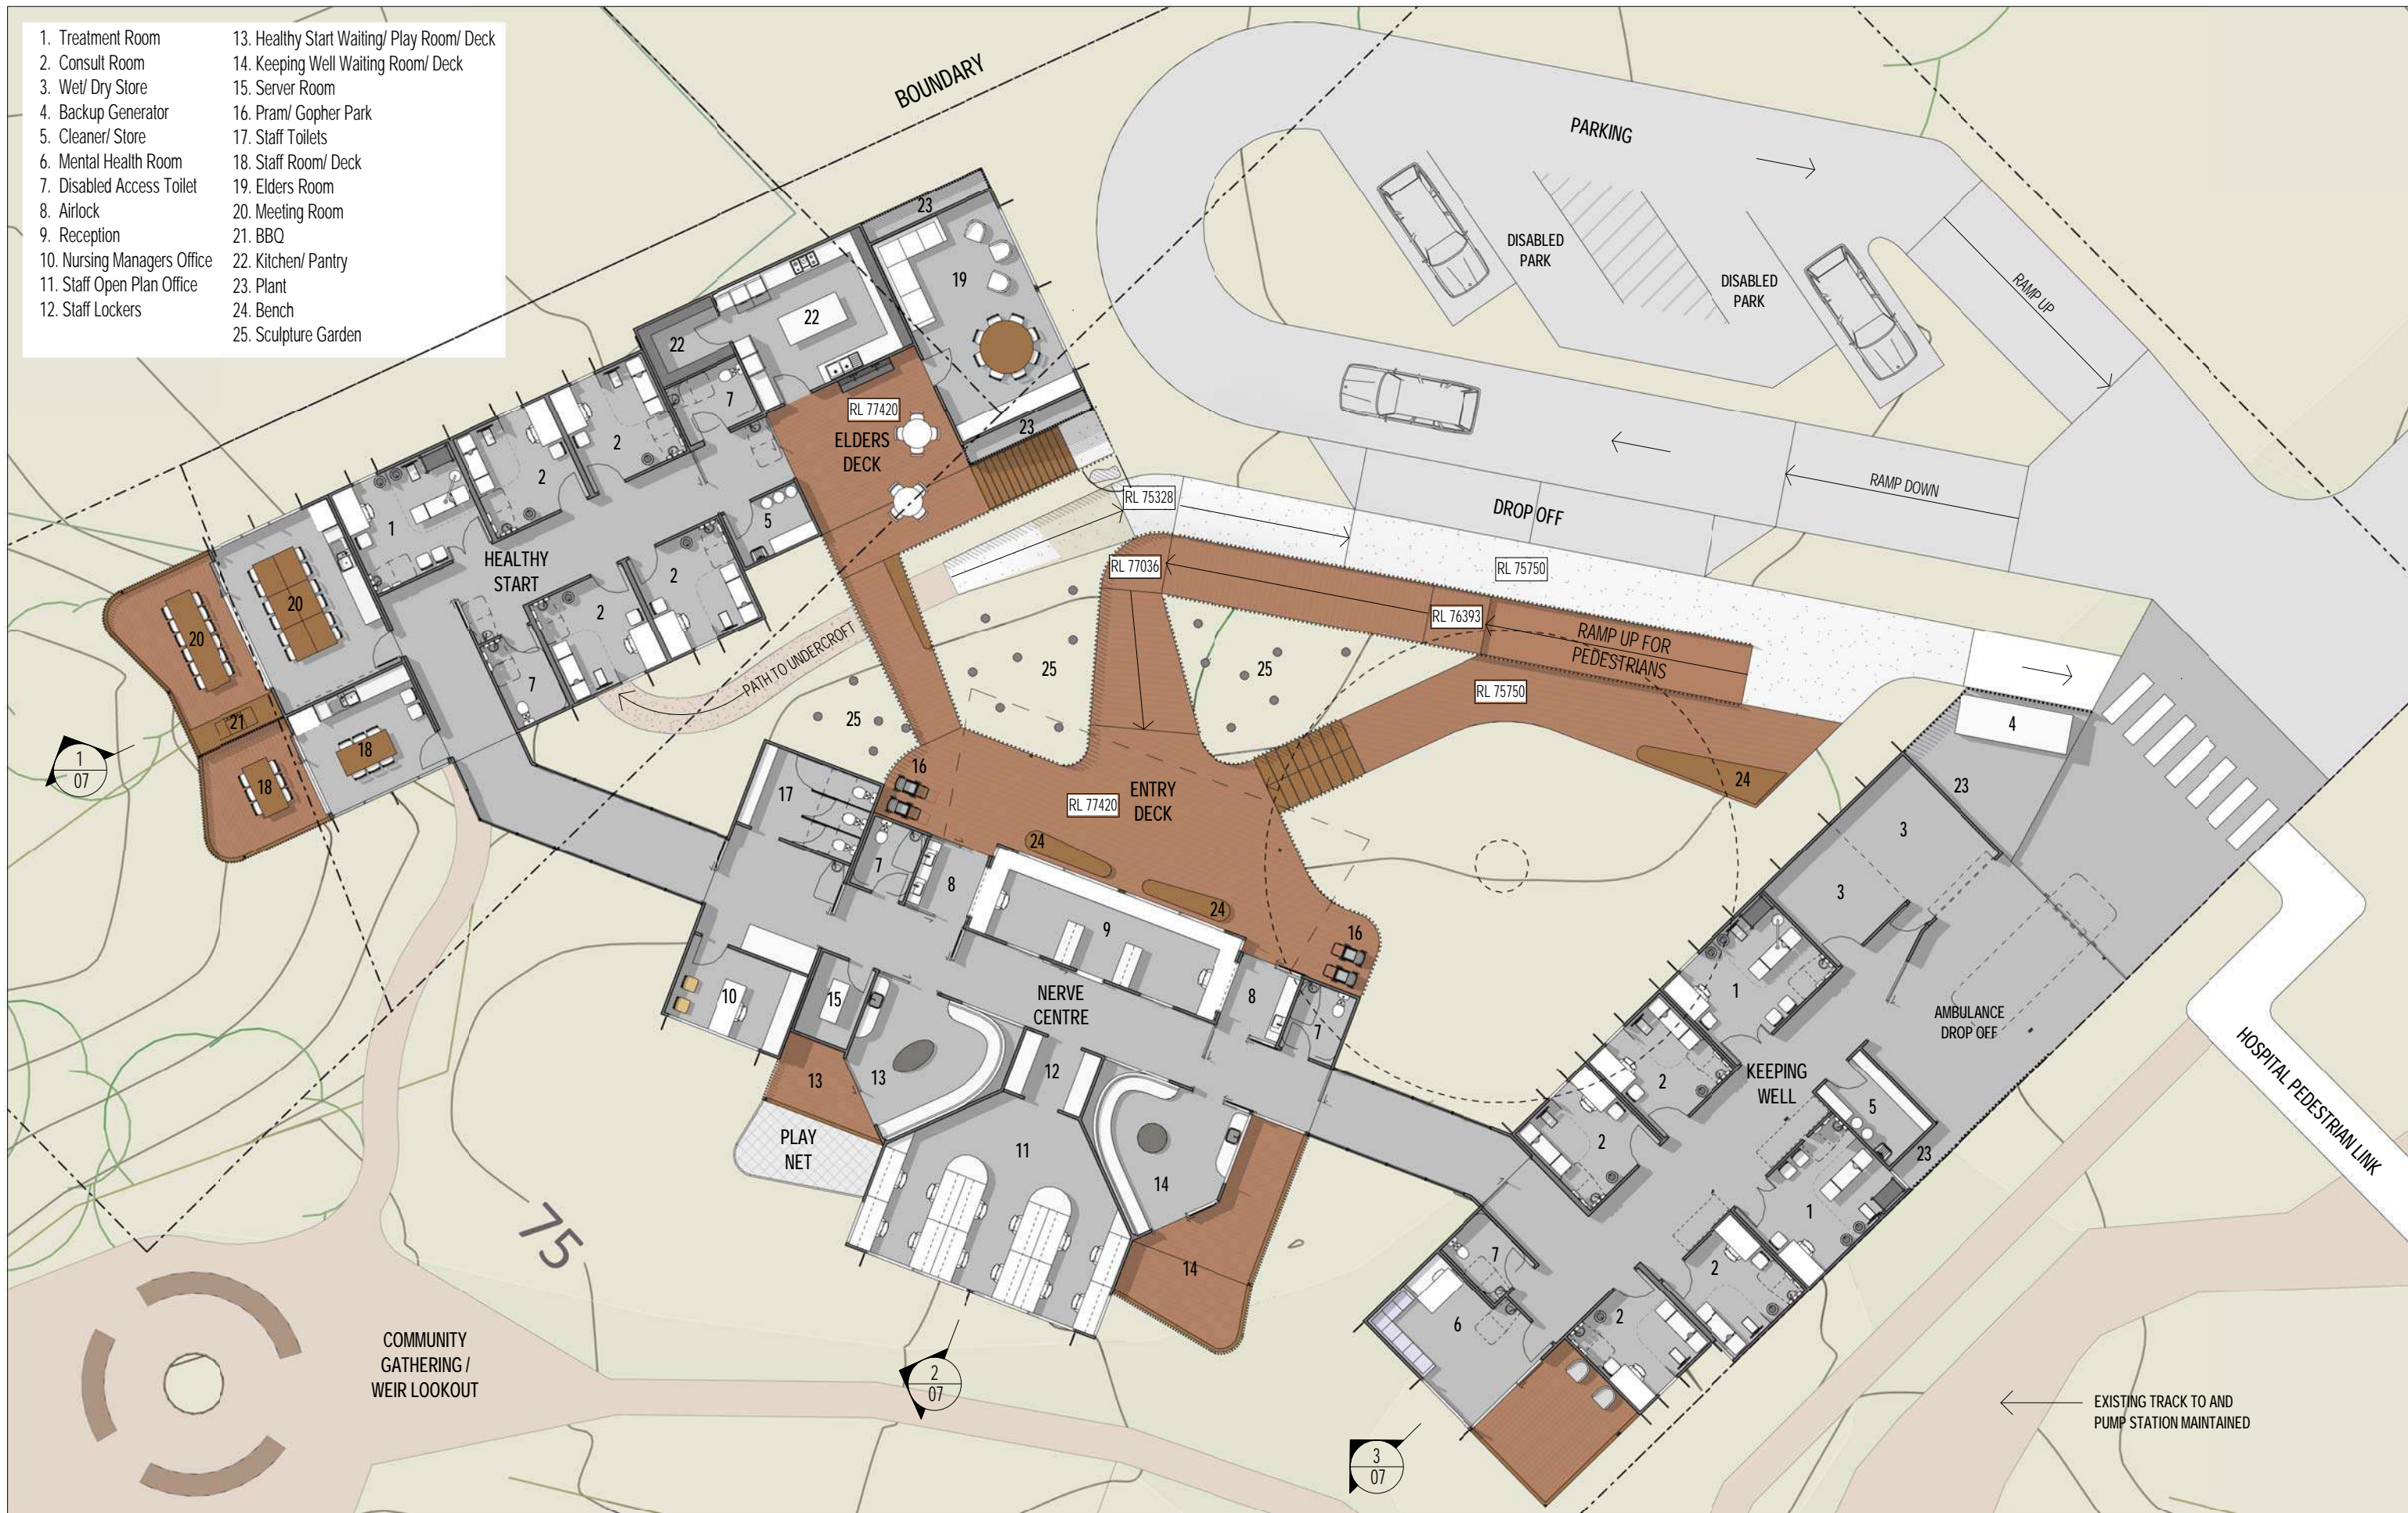
Job No:	480	Issue:	
Scale:	1 : 500 @ A3	Dwg No:	01
Issue Date:		Drawn:	Author
		Checked:	Checker

- 1. Treatment Room
- 2. Consult Room
- 3. Wet/ Dry Store
- 4. Backup Generator
- 5. Cleaner/ Store
- 6. Mental Health Room
- 7. Disabled Access Toilet
- 8. Airlock
- 9. Reception
- 10. Nursing Managers Office
- 11. Staff Open Plan Office
- 12. Staff Lockers
- 13. Healthy Start Waiting/ Play Room/ Deck
- 14. Keeping Well Waiting Room/ Deck
- 15. Server Room
- 16. Pram/ Gopher Park
- 17. Staff Toilets
- 18. Staff Room/ Deck
- 19. Elders Room
- 20. Meeting Room
- 21. BBQ
- 22. Kitchen/ Pantry
- 23. Plant
- 24. Bench
- 25. Sculpture Garden

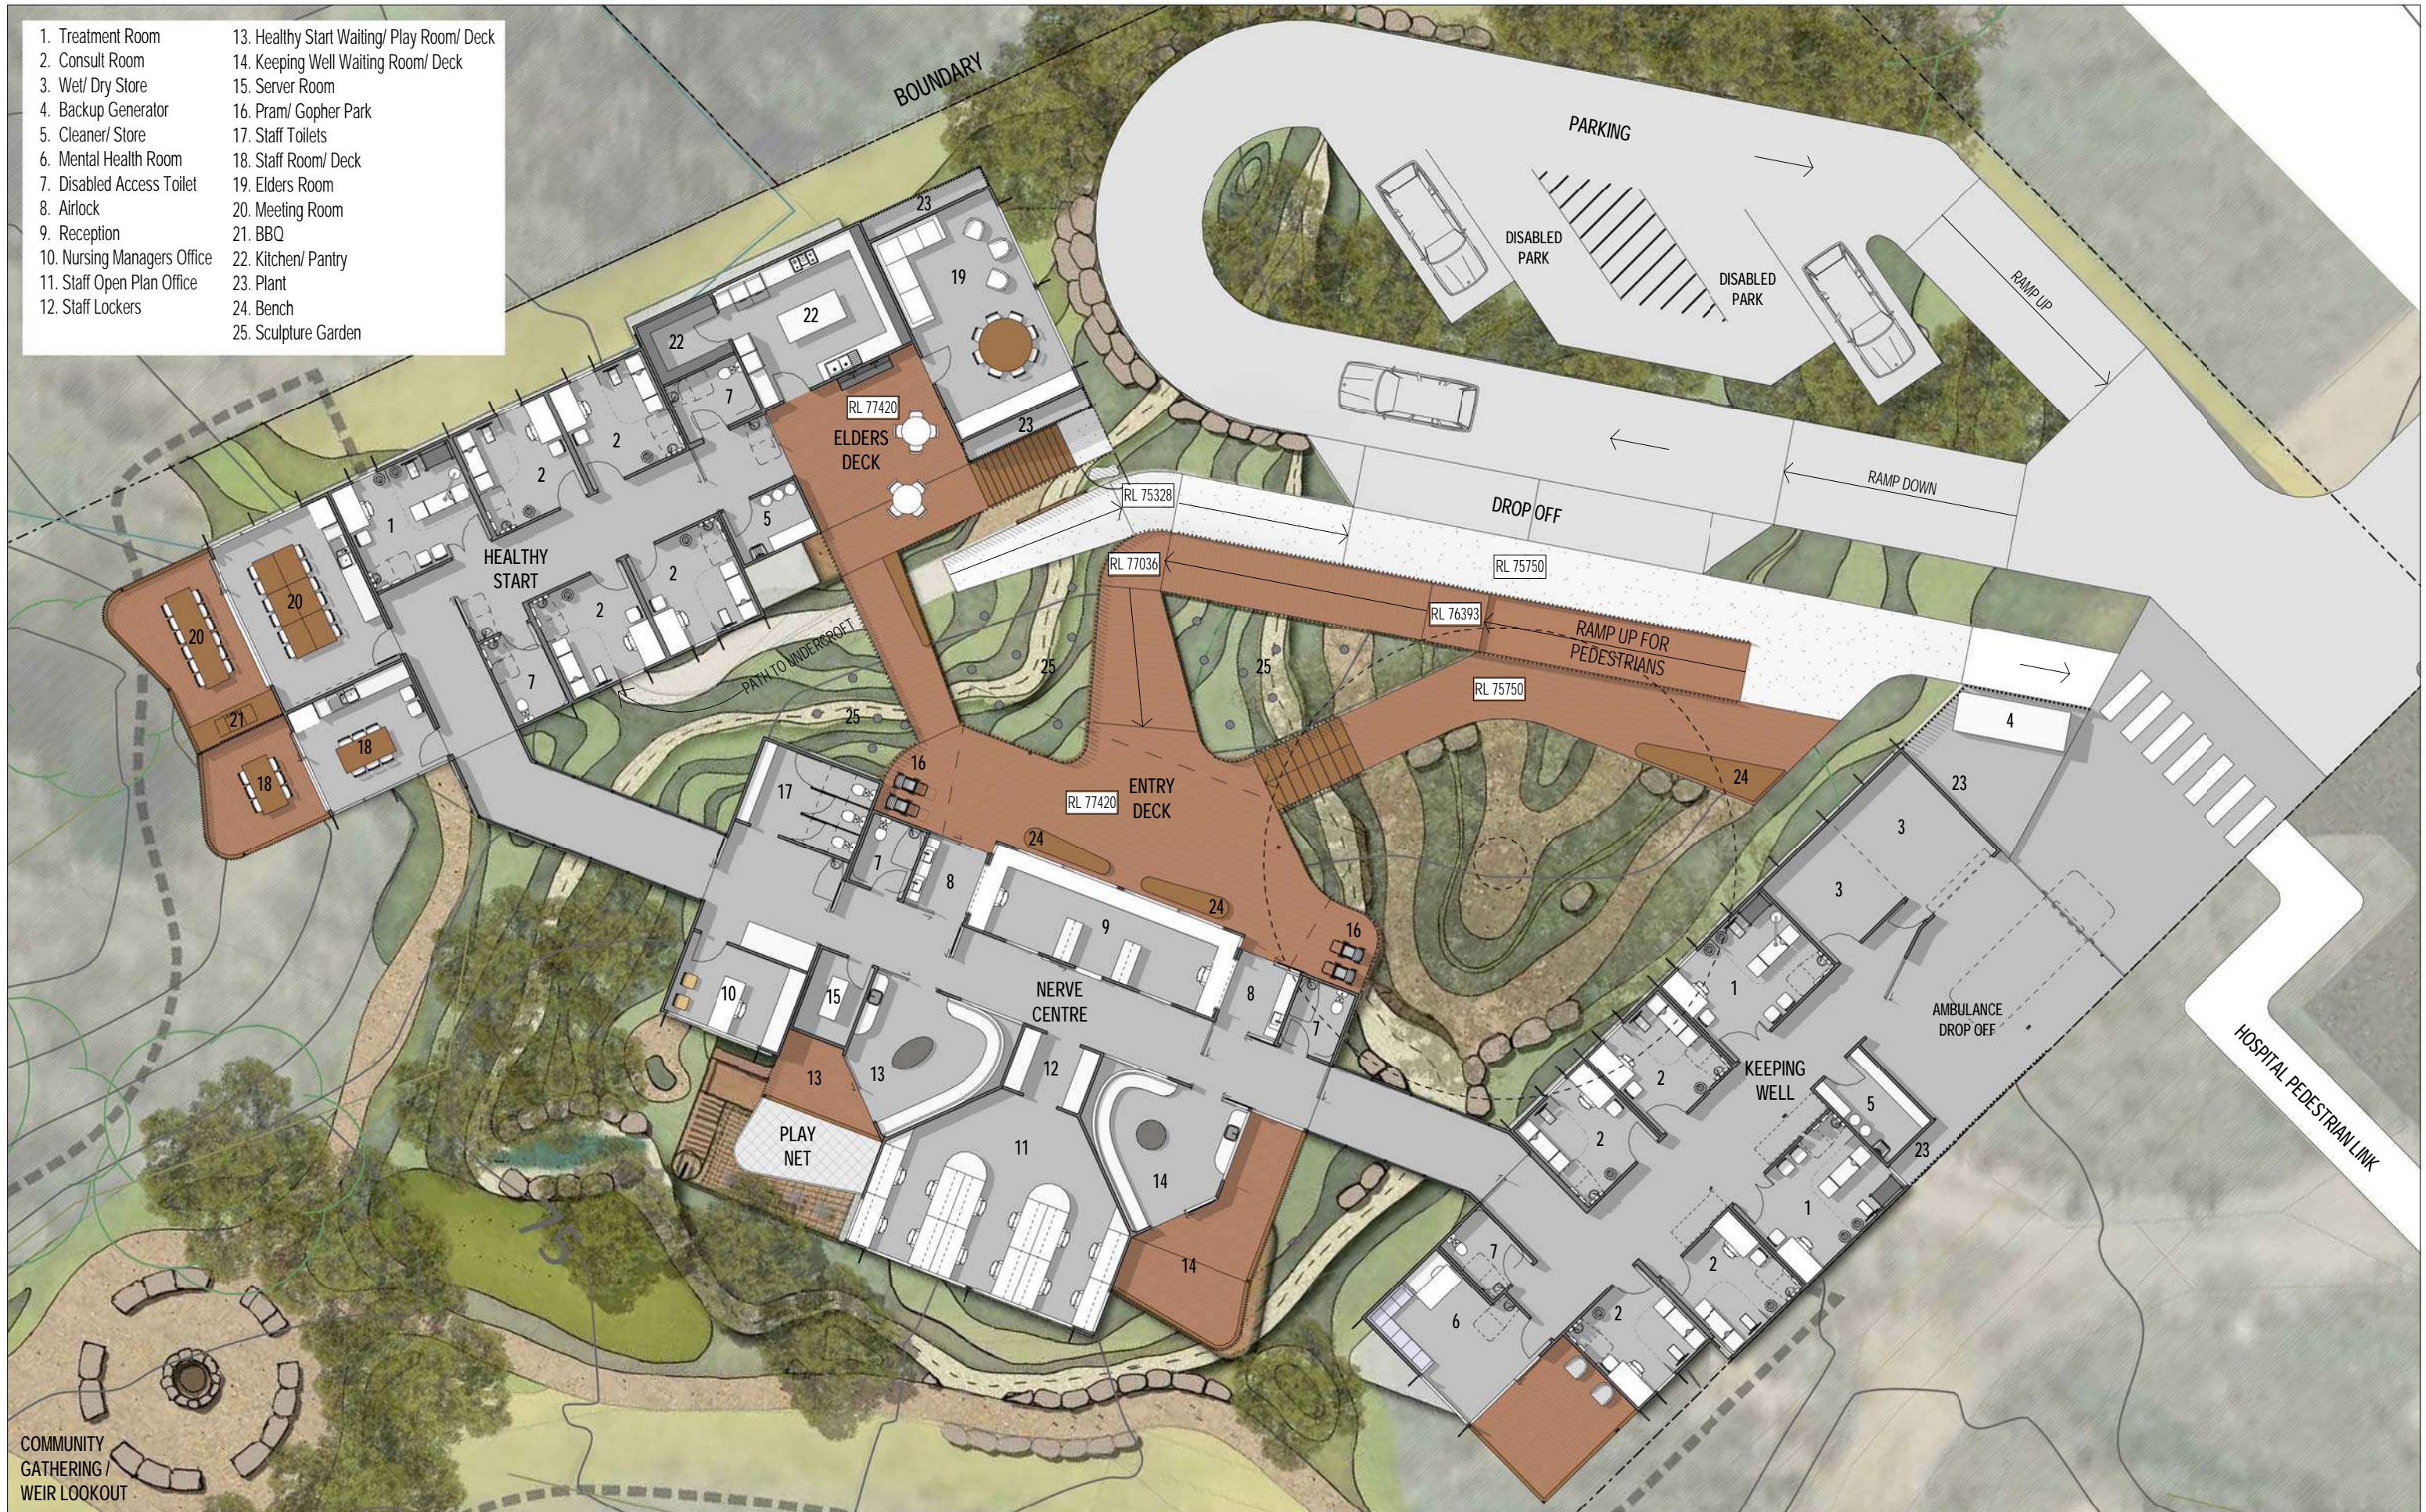
Job No:	480	Issue:	
Scale:	1 : 200	@ A3	
Issue Date:		Dwg No:	07
Drawn:	ML	Checked:	AOL

- 1. Treatment Room
- 2. Consult Room
- 3. Wet/ Dry Store
- 4. Backup Generator
- 5. Cleaner/ Store
- 6. Mental Health Room
- 7. Disabled Access Toilet
- 8. Airlock
- 9. Reception
- 10. Nursing Managers Office
- 11. Staff Open Plan Office
- 12. Staff Lockers
- 13. Healthy Start Waiting/ Play Room/ Deck
- 14. Keeping Well Waiting Room/ Deck
- 15. Server Room
- 16. Pram/ Gopher Park
- 17. Staff Toilets
- 18. Staff Room/ Deck
- 19. Elders Room
- 20. Meeting Room
- 21. BBQ
- 22. Kitchen/ Pantry
- 23. Plant
- 24. Bench
- 25. Sculpture Garden

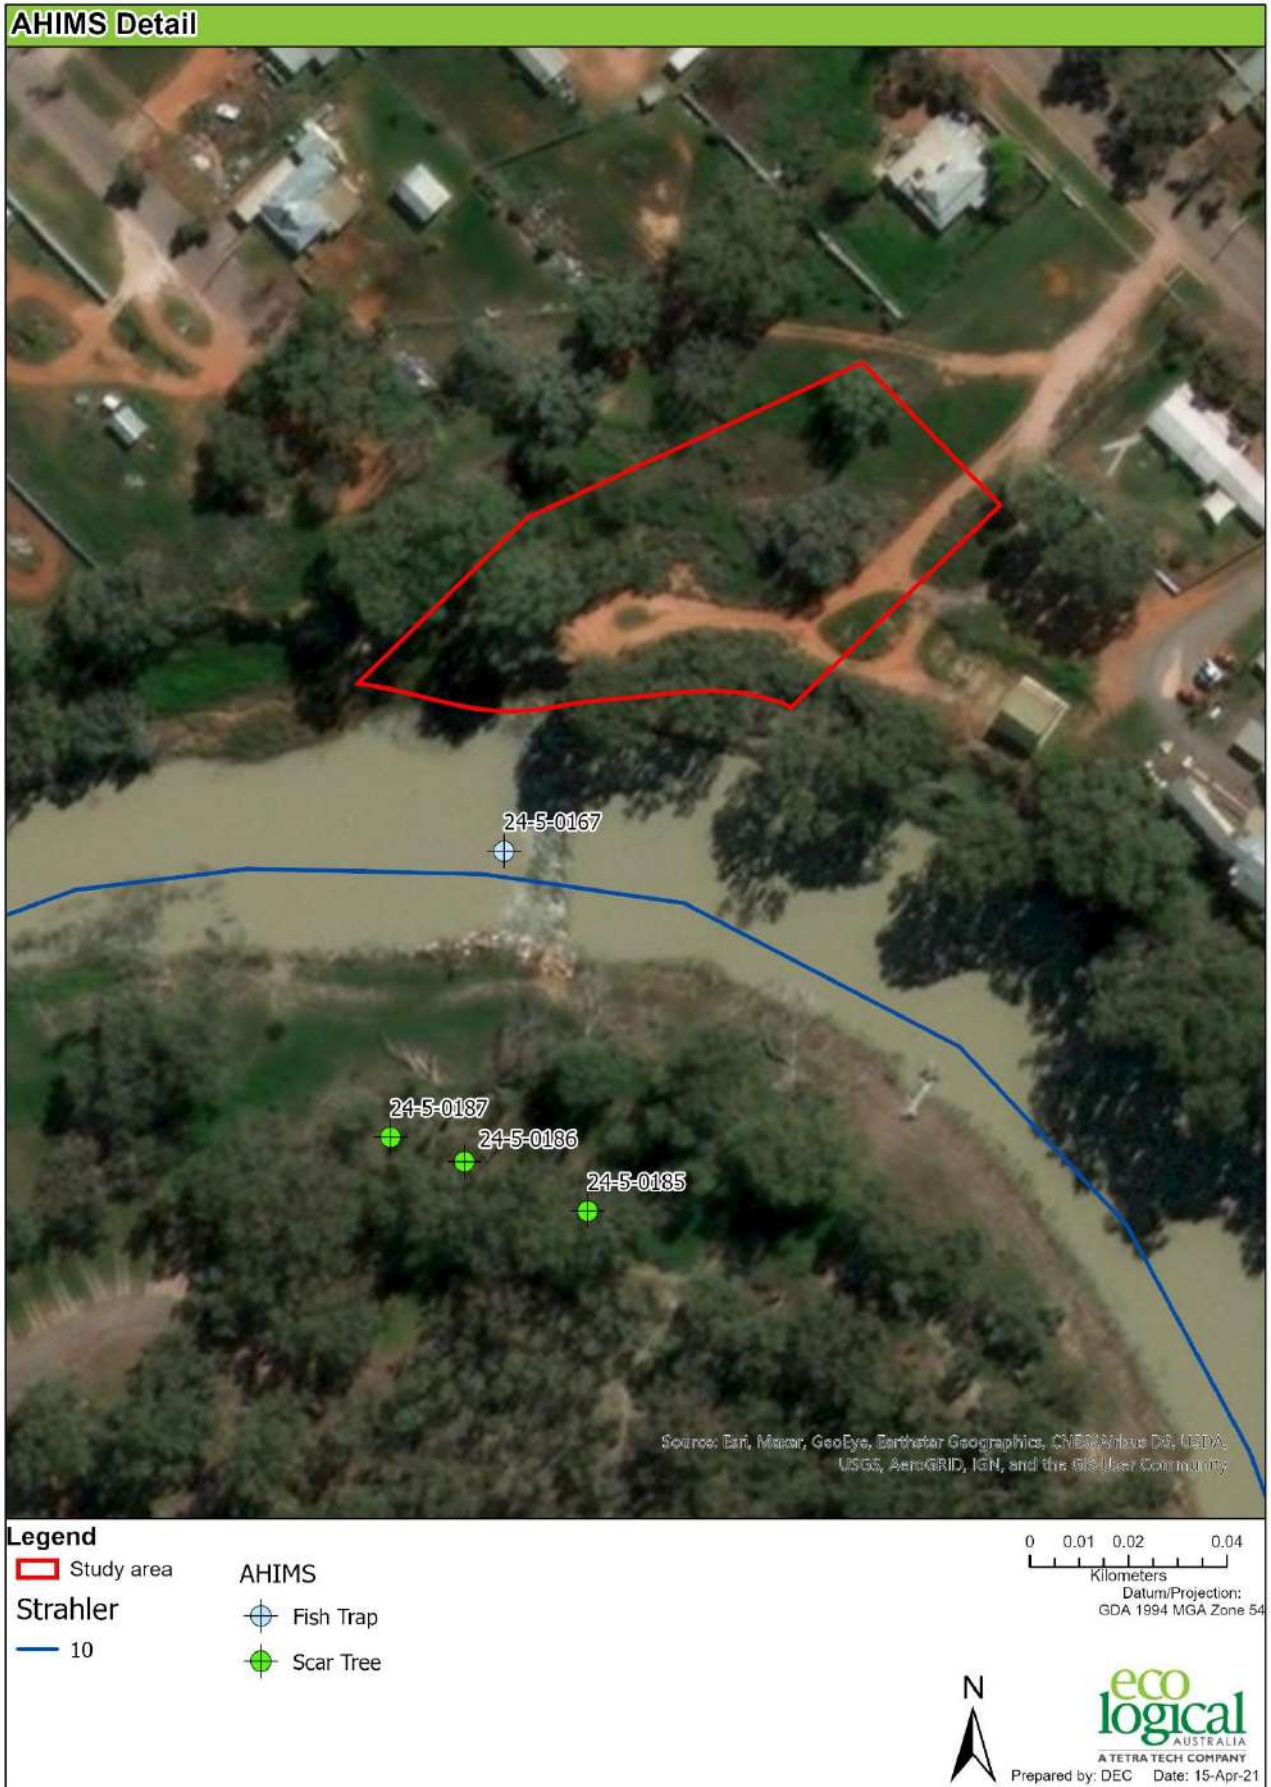
Figure 3: AHIMS registered sites in/within the vicinity of the study area

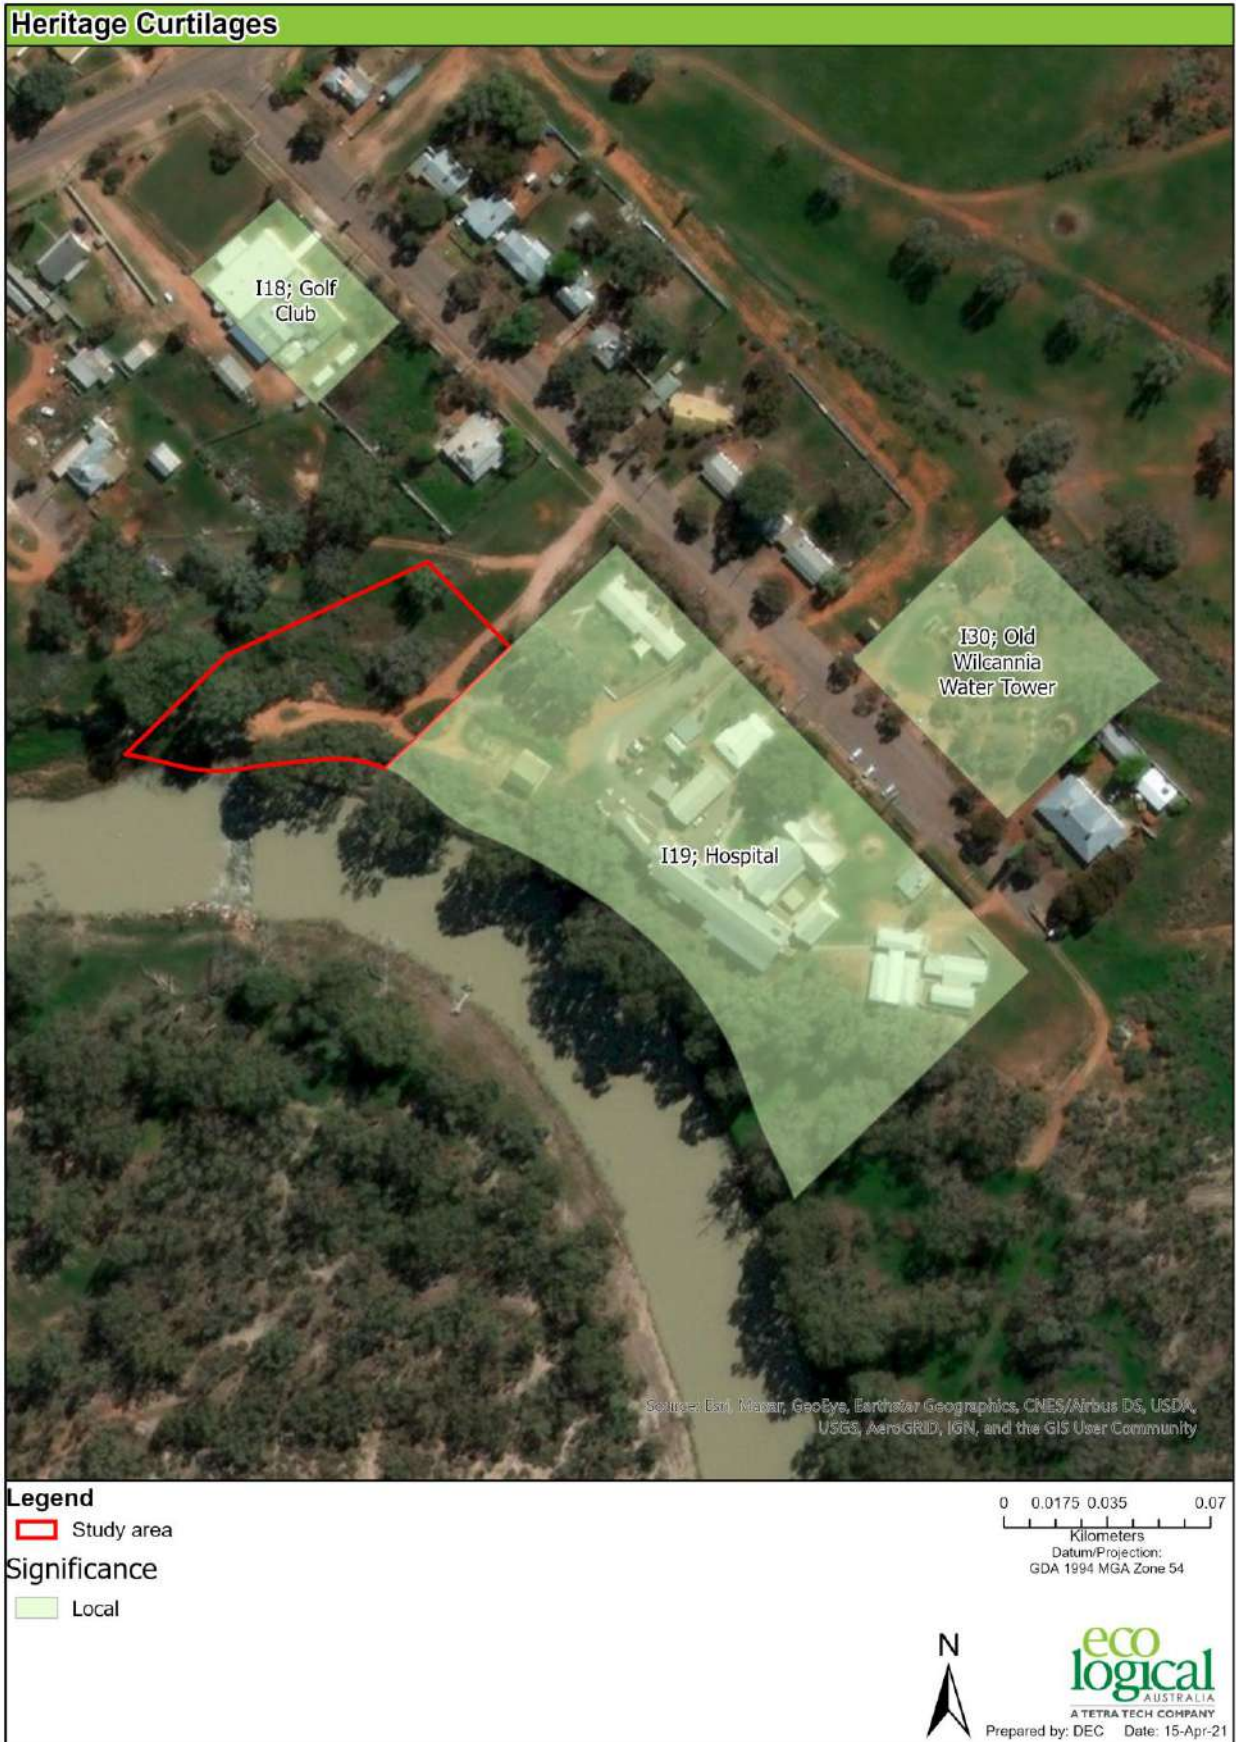
Figure 5: Heritage items within the vicinity of the study area
