## Statement of Environmental Effects

Maari Ma Wilcannia Health Clinic  
Bonney Street  
Wilcannia NSW 2836

<b>Report Title:</b>	Statement of Environmental Effects
<b>Project Name:</b>	Maari Ma Wilcannia Health Clinic
<b>Client:</b>	Troppo Architects (for Maari Ma Health Aboriginal Corporation)
<b>Project No.</b>	32342
<b>Report Reference</b>	32342-PR01_A
<b>Date:</b>	12/10/2021
<b>Revision:</b>	Final

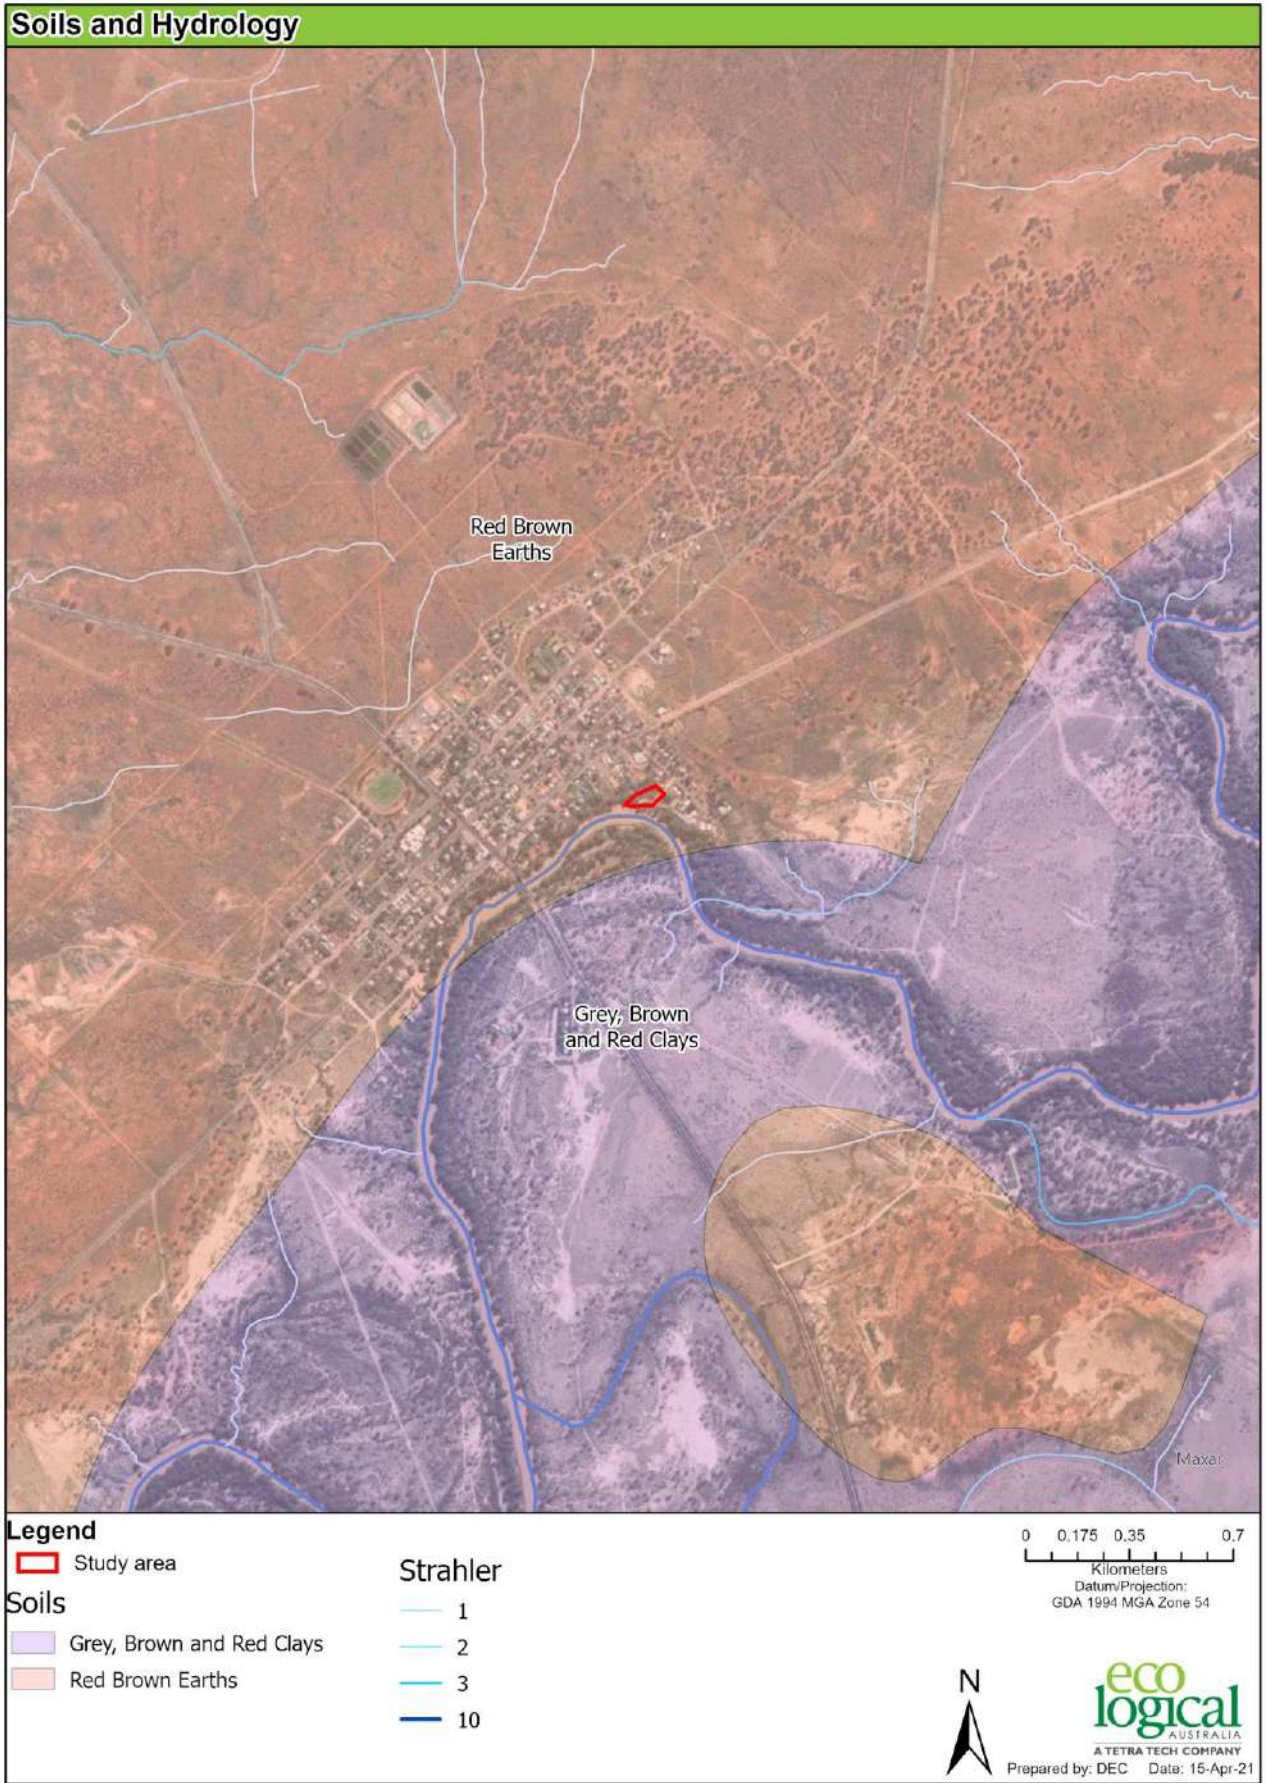
Figure 6: Soils and hydrology of the study area

The study area is located on the northern bank of the Darling River (*Barka*) (Figure 6). A permanent source of fresh water and a major landscape feature in the region. It would have been a focal point of past Aboriginal occupation.

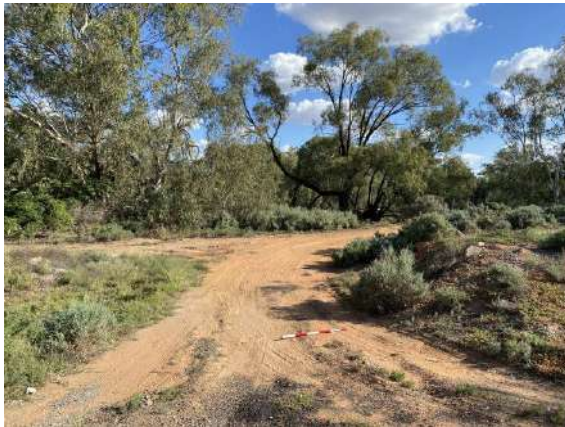
Figure 7: disturbed vehicle track

Initial visual inspection identified a significantly disturbed landscape. Disturbances to the study area were a result of the construction, maintenance, and ongoing use of unsealed dirt vehicle tracks, the cutting/scraping and mounding of soils, and the widespread soil erosion caused by those activities.

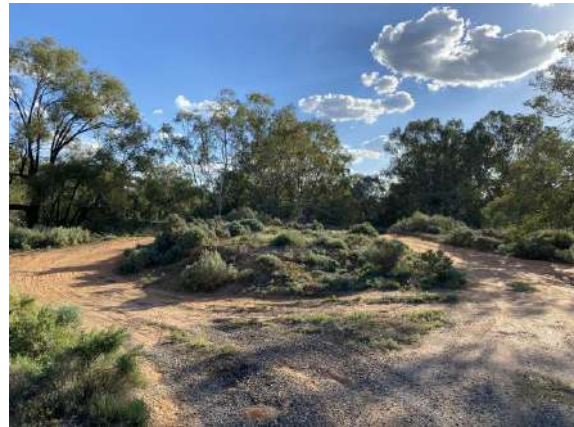
Figure 8: Disturbed vehicle track

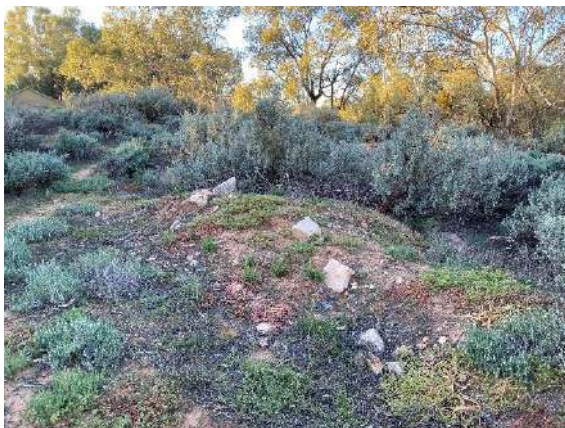
Figure 9: soil dumping/mounding on site

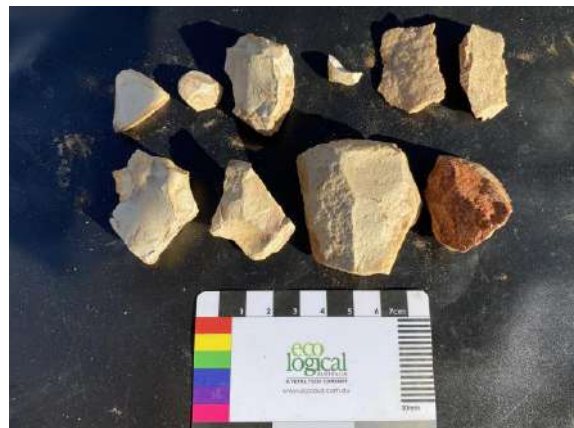
Figure 10: Representative selection of Aboriginal artefacts observed within study area (AHIMS site 24-5-0221)

Despite these disturbances previously unidentified Aboriginal objects were observed across the study area, in addition an Aboriginal scarred tree was found along the shoreline of the Darling River but it has been determined that it is outside the study area and will not be impacted by the proposed works. The artefacts were observed eroding out of the sides and surface of the vehicle tracks, and within the disturbed land adjacent to the track. As a result, these two areas recorded and registered on the AHIMS database as AHIMS #'s 24-5-0220 and 24-5-0221.

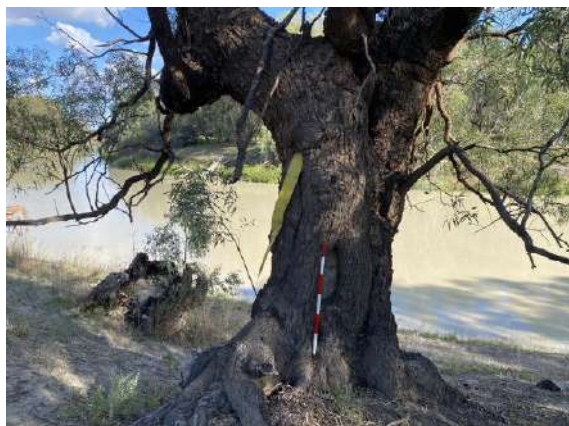
Figure 11: AHIMS site 24-5-0220

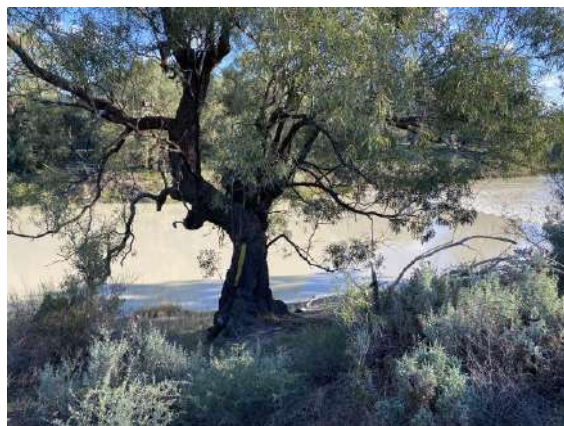
Figure 12: Location of site 24-5-0220 along Darling River

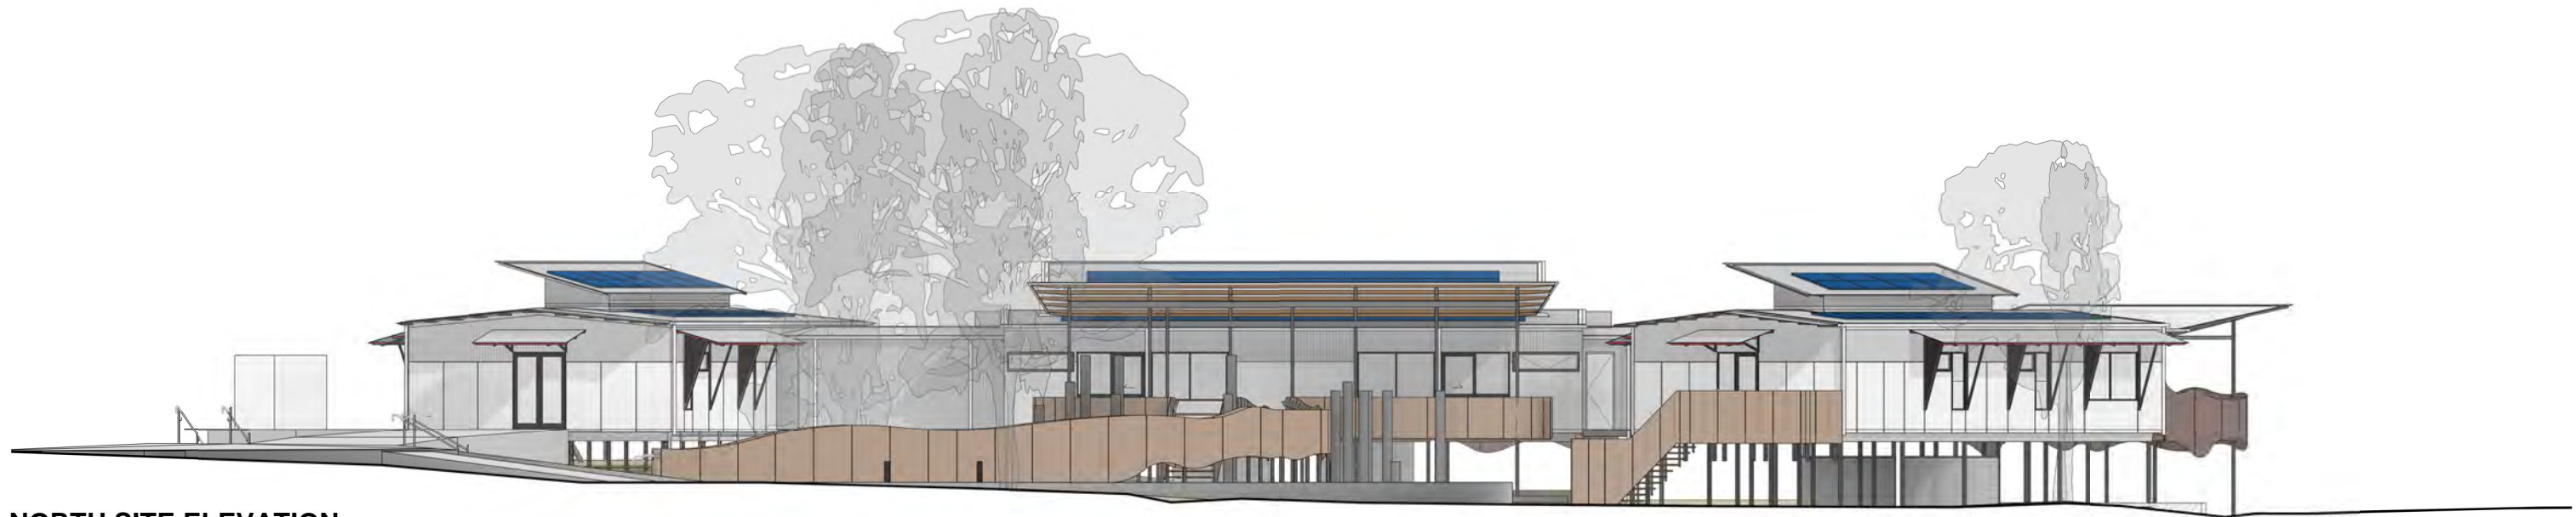
**NORTH SITE ELEVATION**

DECKING:  
FRP MESH

ROOF EQUIPMENT:  
SOLAR PANELS

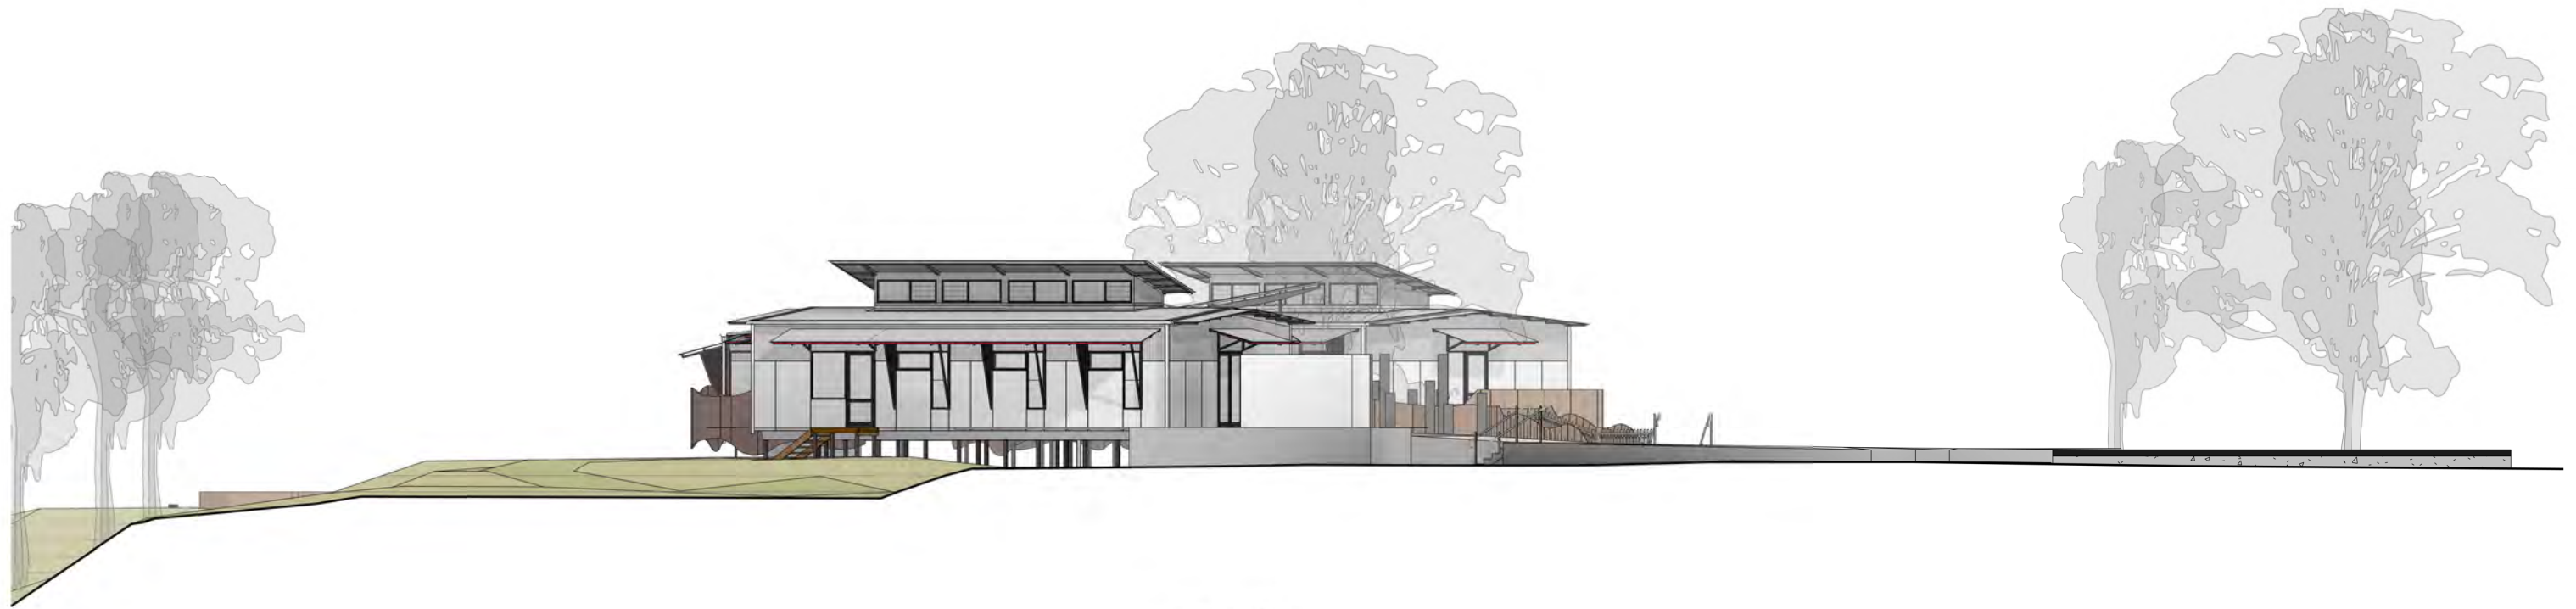
**EASTSITE ELEVATION**

ROOF/ WALL SHEETING:  
'DUNE' CUSTOM ORB  
TRIMS IN 'DUNE'

DECKING:  
FRP MESH

ROOF EQUIPMENT:  
SOLAR PANELS

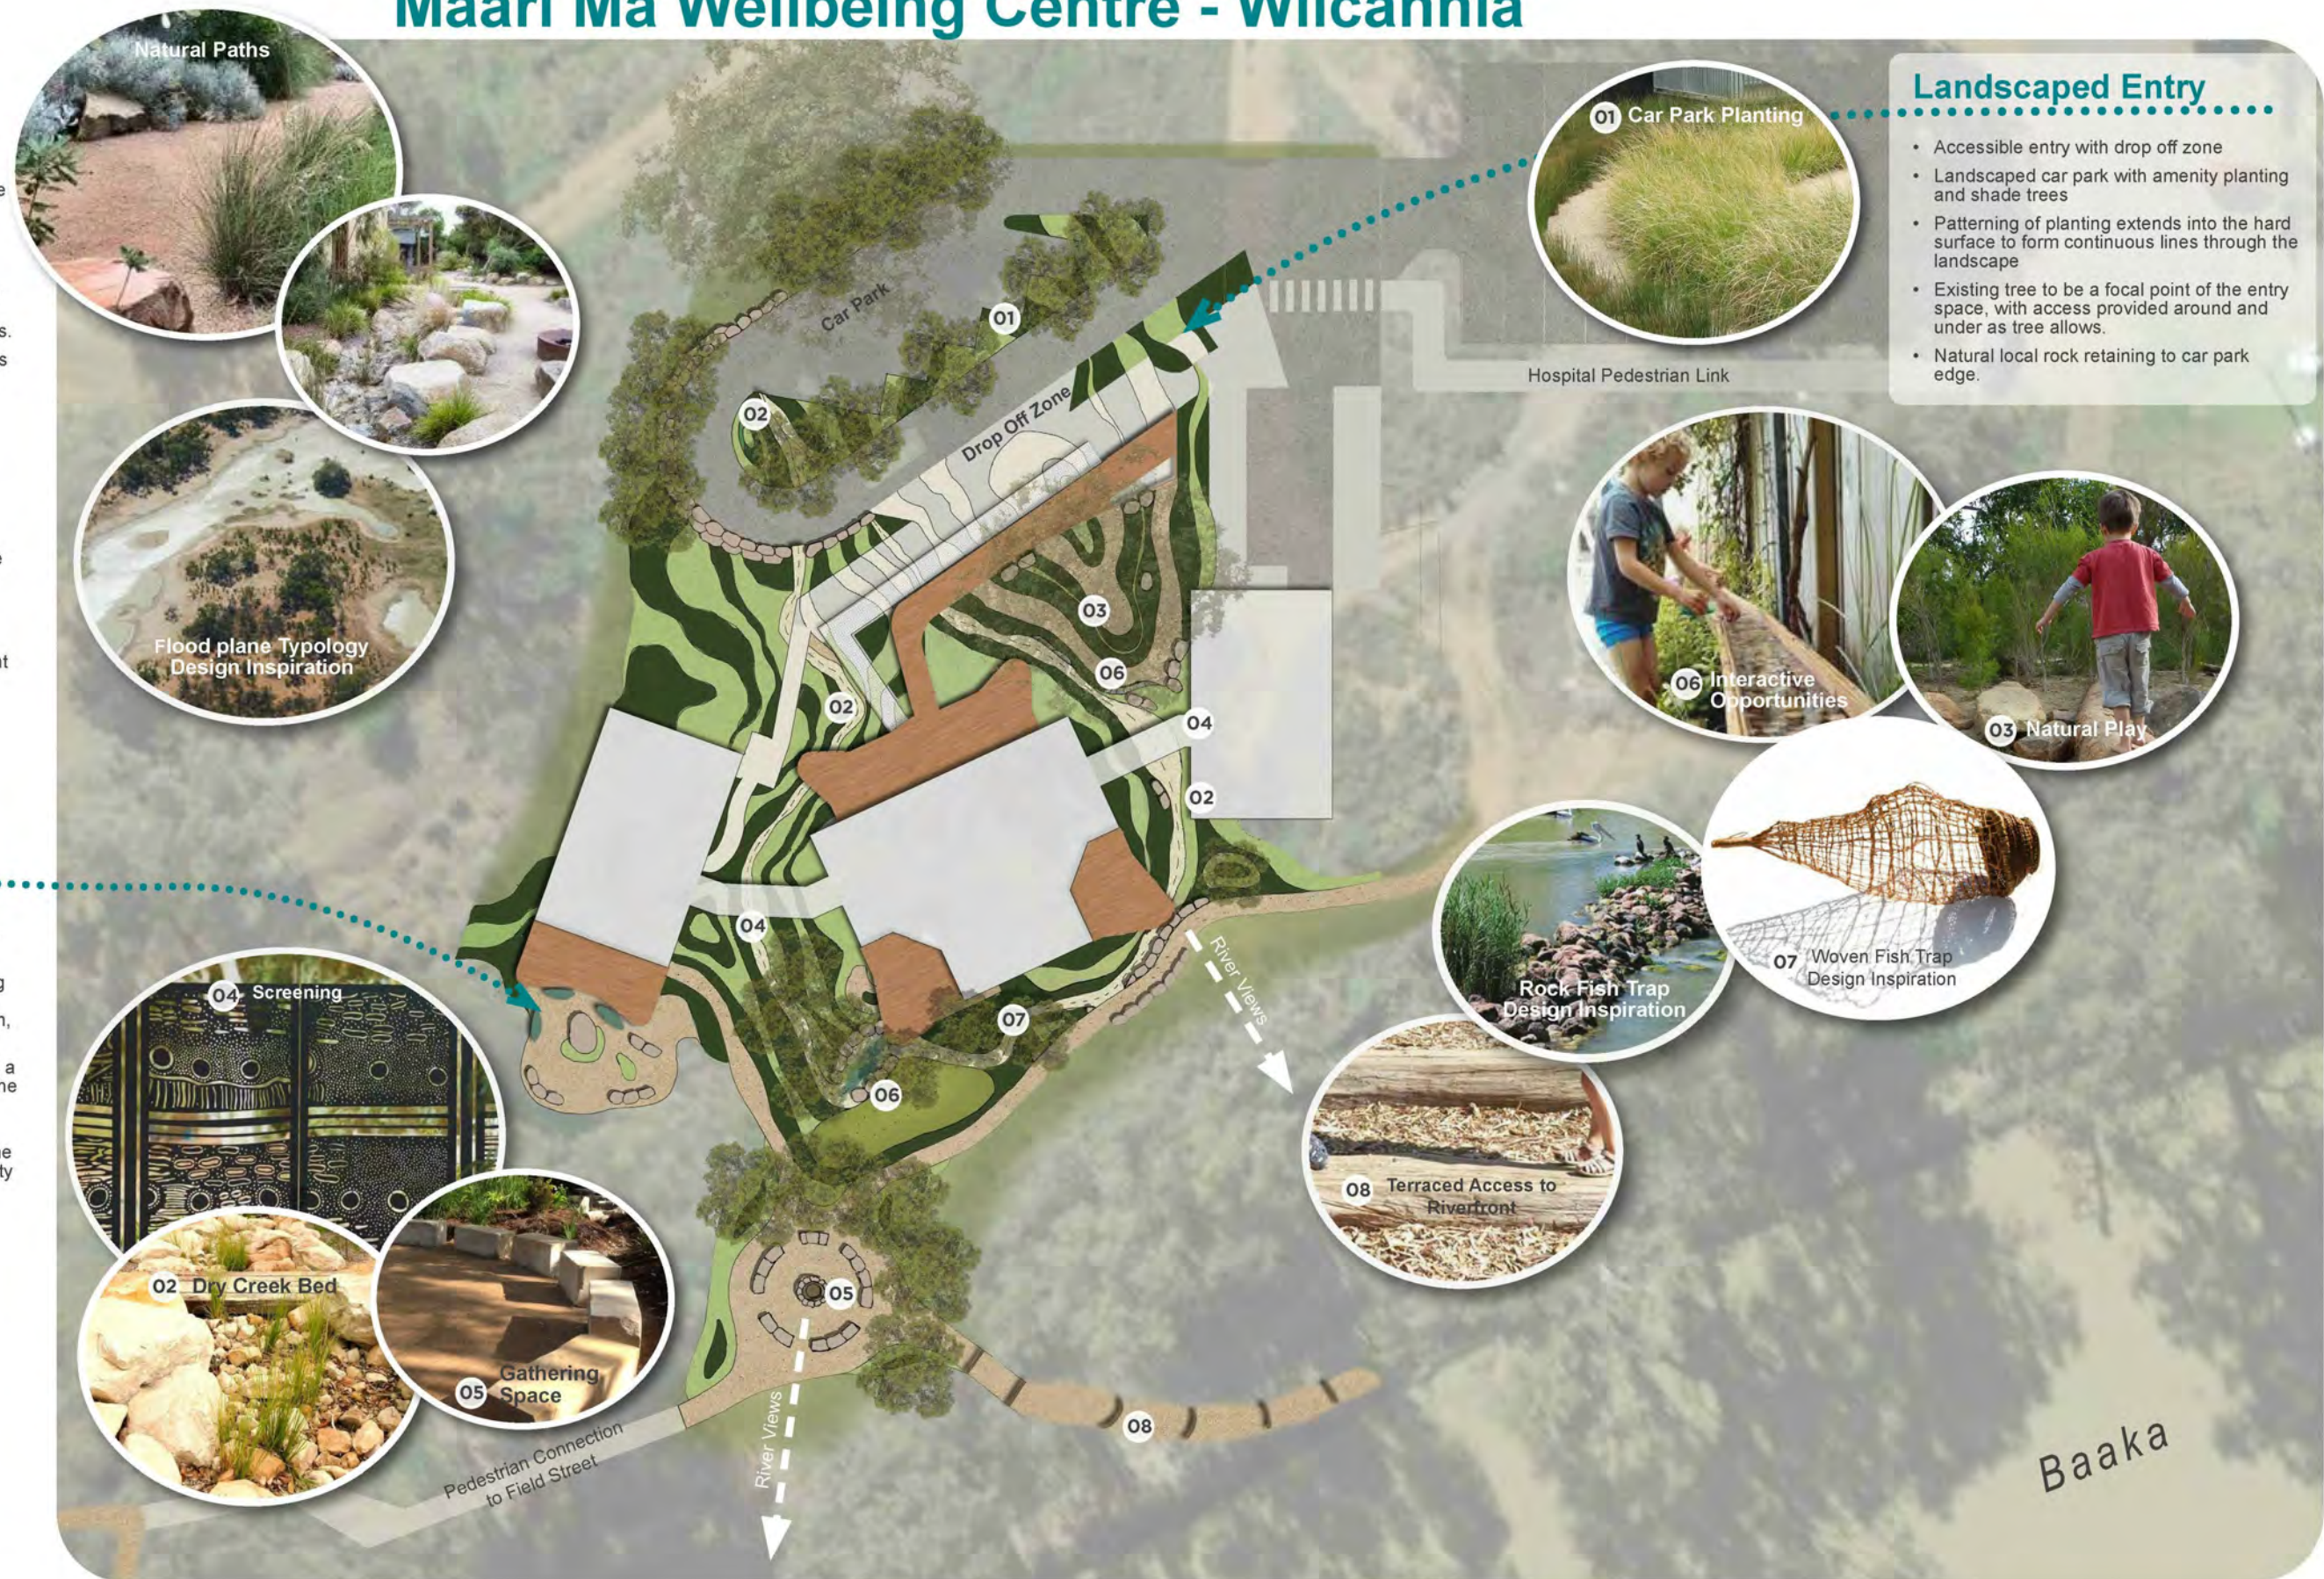
## Landscaped Entry

- Accessible entry with drop off zone
- Landscaped car park with amenity planting and shade trees
- Patterning of planting extends into the hard surface to form continuous lines through the landscape
- Existing tree to be a focal point of the entry space, with access provided around and under as tree allows.
- Natural local rock retaining to car park edge.

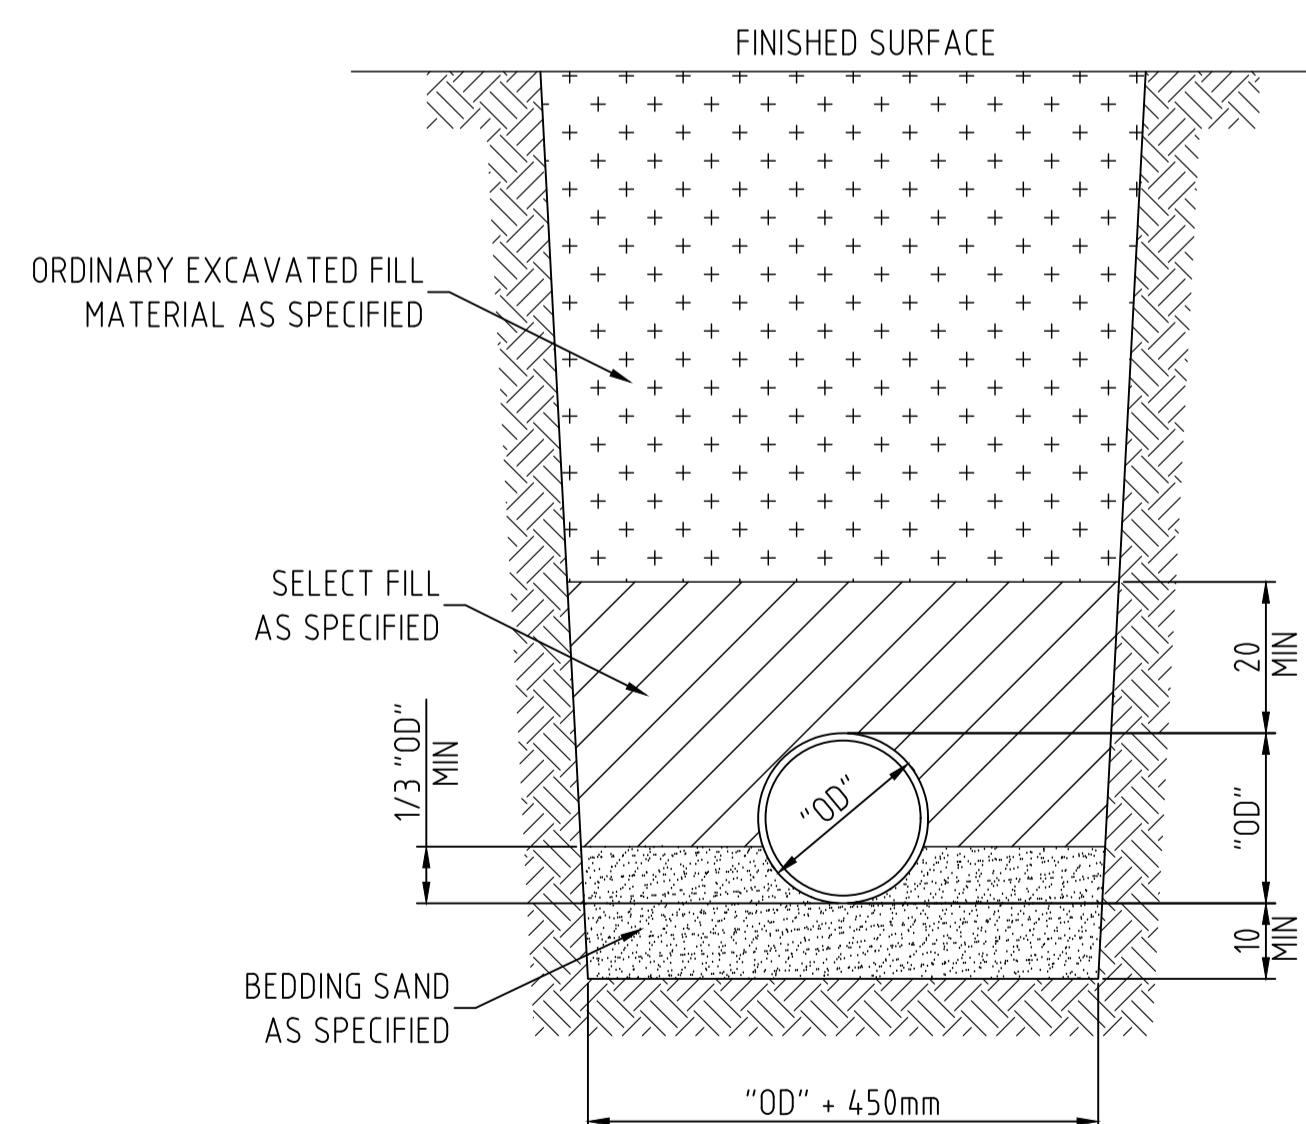
**PIPE TRENCH - EARTH FOUNDATION**  
SCALE = 1:10

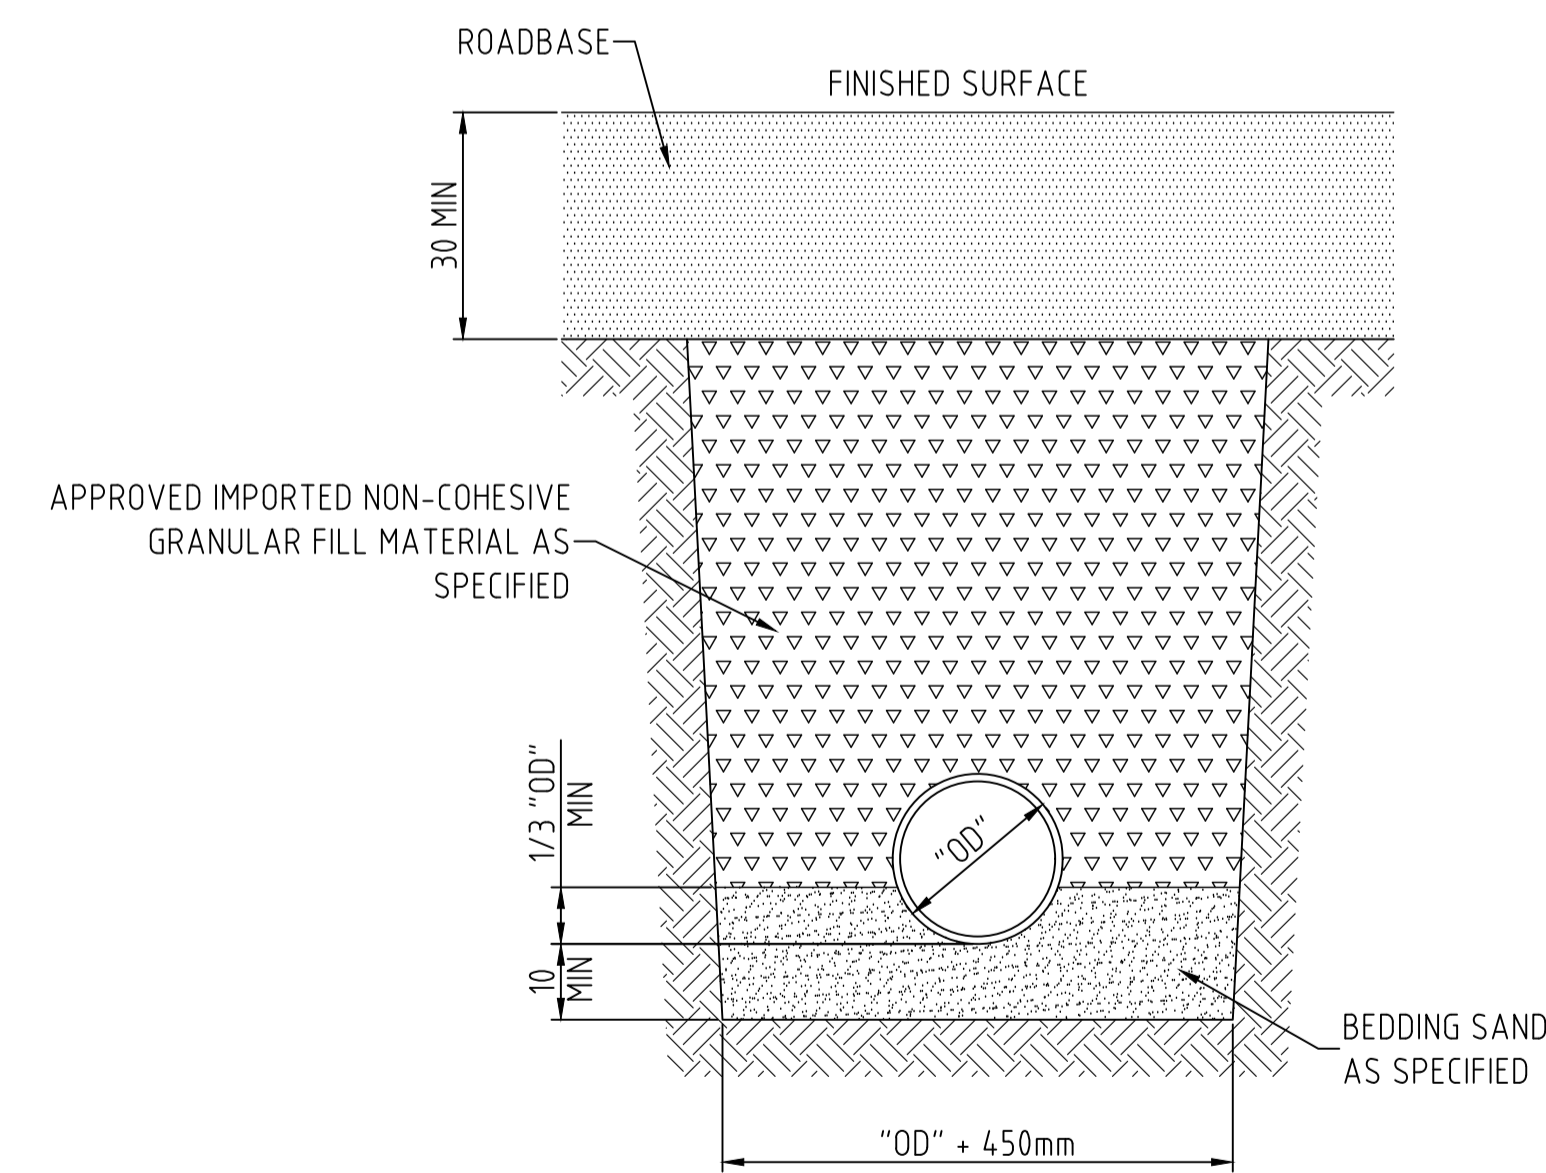
**PIPE TRENCH - ROADWAY**  
SCALE = 1:10

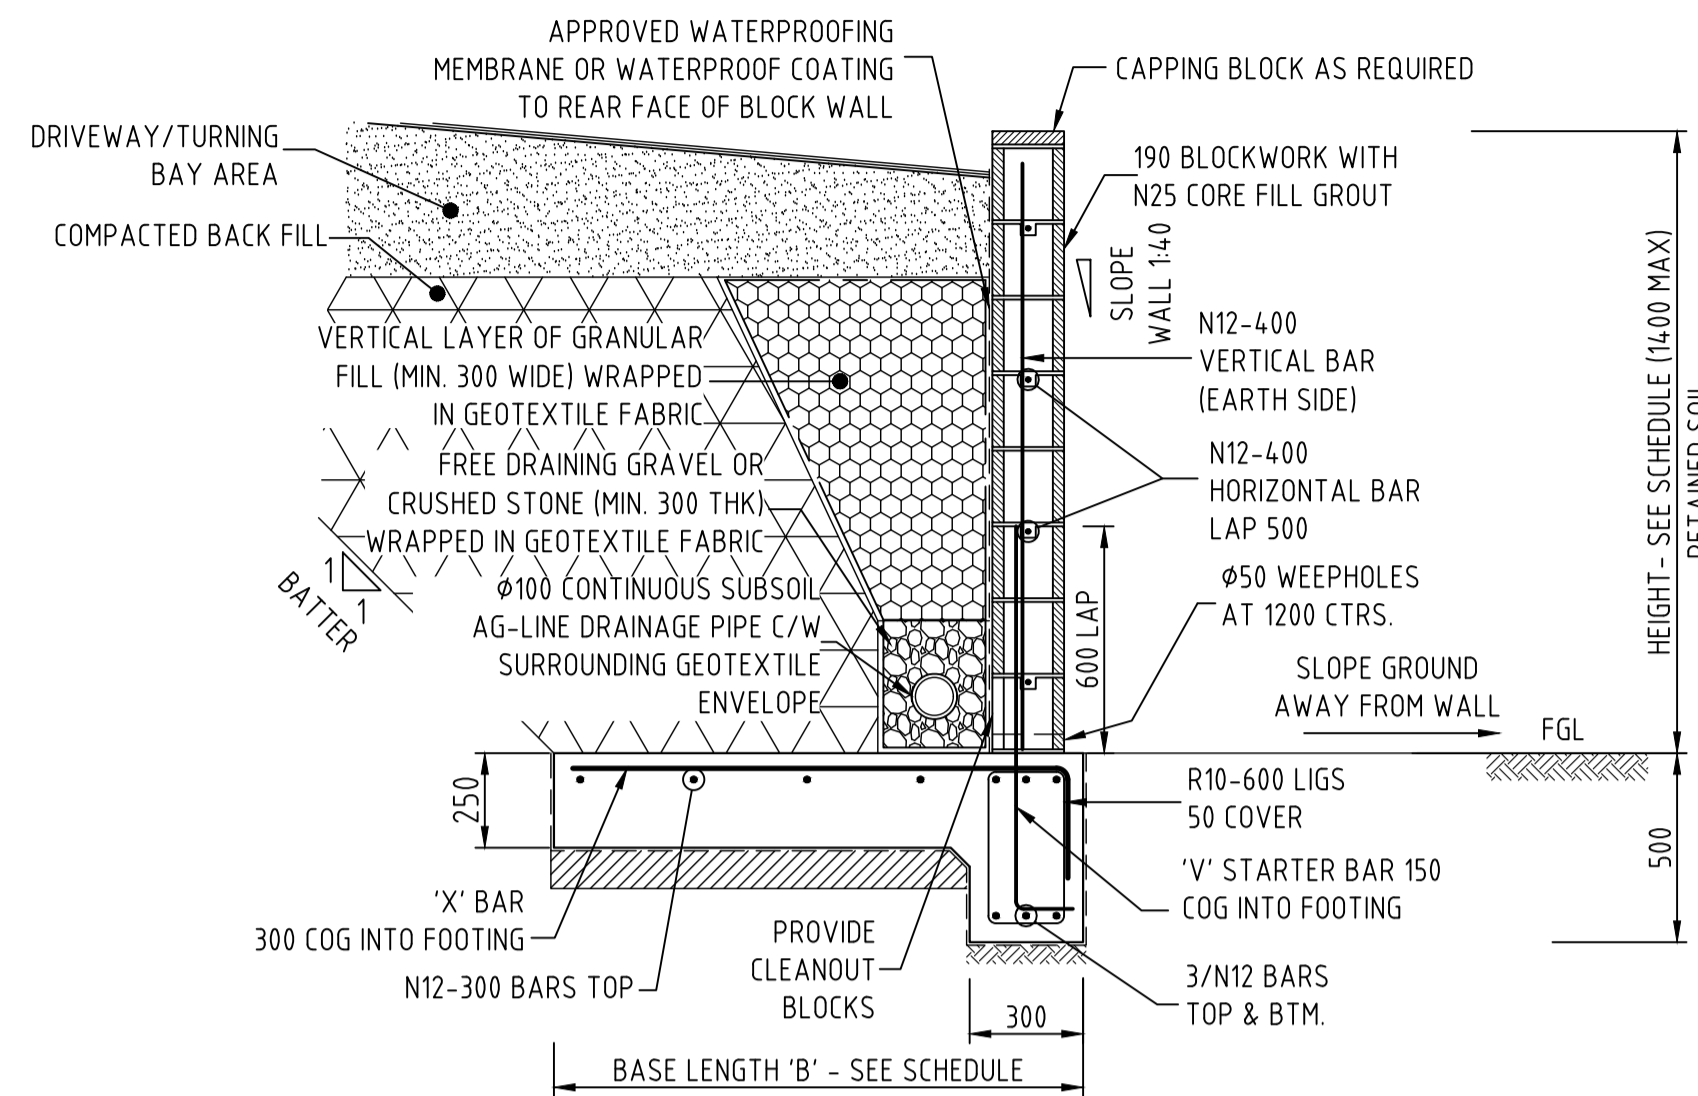
15. MASONRY IS NOT TO BE ERECTED OFF SUSPENDED WORK UNTIL ALL FORMWORK & FALSEWORK SYSTEMS PROVIDING SUPPORT HAVE BEEN REMOVED.
19. A 300mm WIDE STRIP OF COARSE GRAINED MATERIAL IS TO BE PLACED BEHIND ALL RETAINING WALLS.

**RETAINING WALL (MAX. 1400 HIGH)**

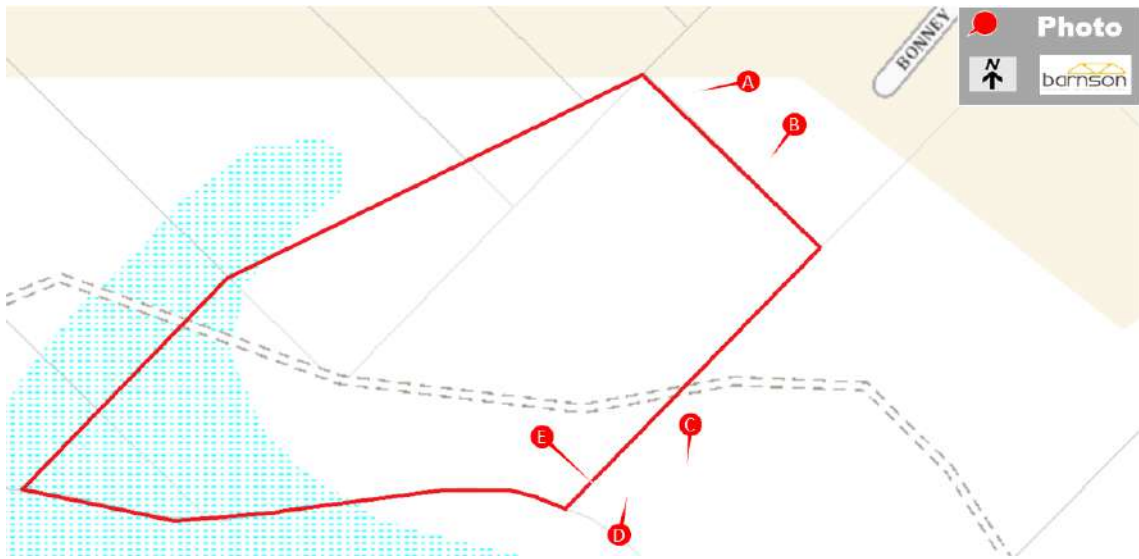
Figure 2.2: Existing Subject Site layout.

Figure 2.2 presents a plan of the Subject Site that is supplemented with photographs showing the different elements of the Site (Figure 2.3 to Figure 2.7). Figure 2.2 includes markers indicating the vantage point and direction of the photographs.

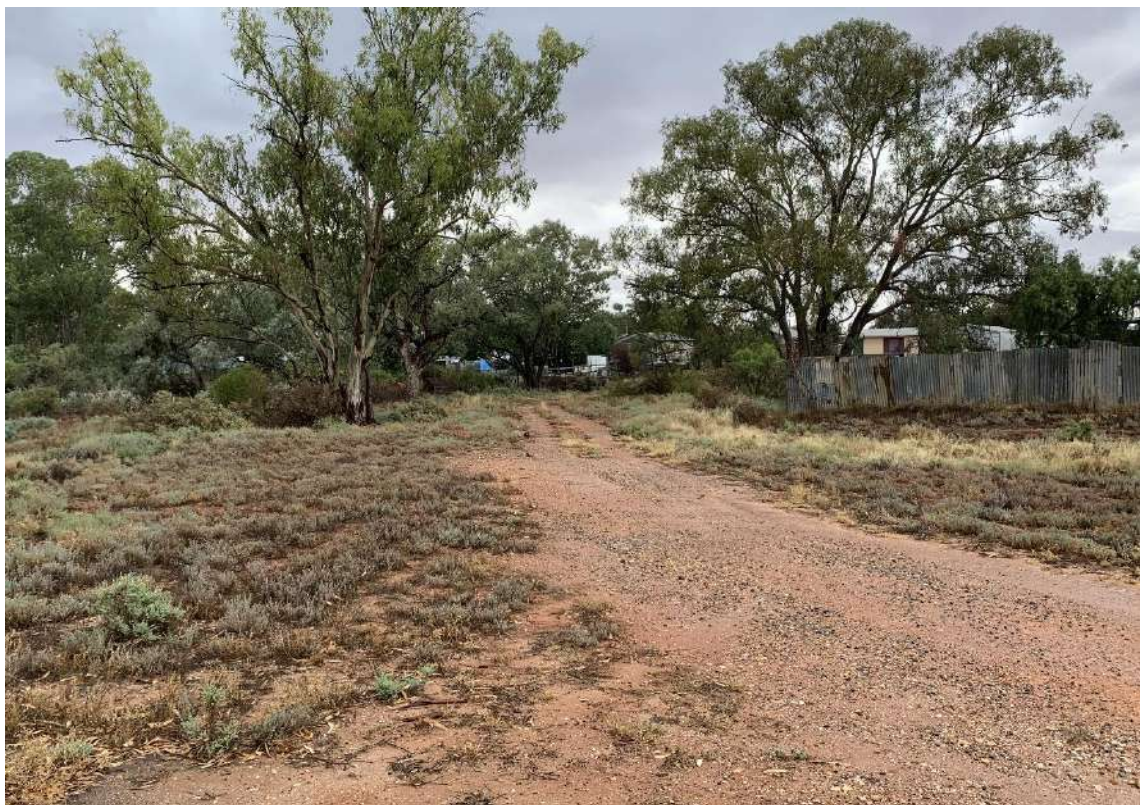
Figure 2.3: Photo A –Photo of existing driveway heading west of the Subject Site

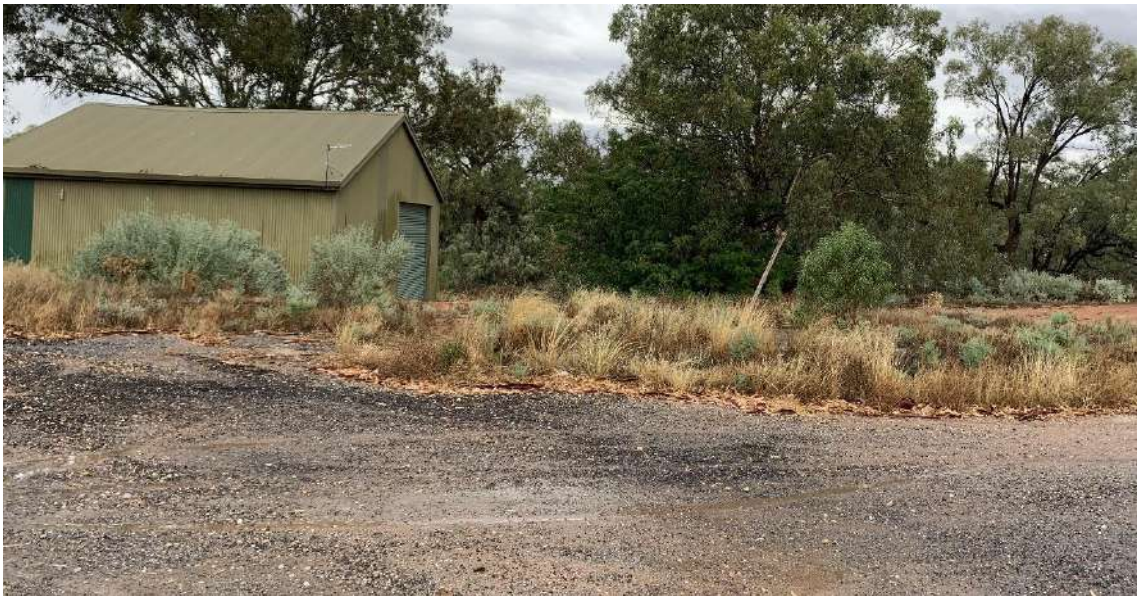
Figure 2.5: Photo C – View of pump shed on adjacent Lot

The Subject Site has previously been used for water supply with evidence of a pump shed adjacent the Subject Site and other unknown uses as remnants of an old building were also found on site. An unsealed road (Bonney Street) is the entrance to the Subject Site. The site is abundant in vegetation, as shown in Figure 2.1, and is covered in a variety of flora including trees, shrubs, and grasses.

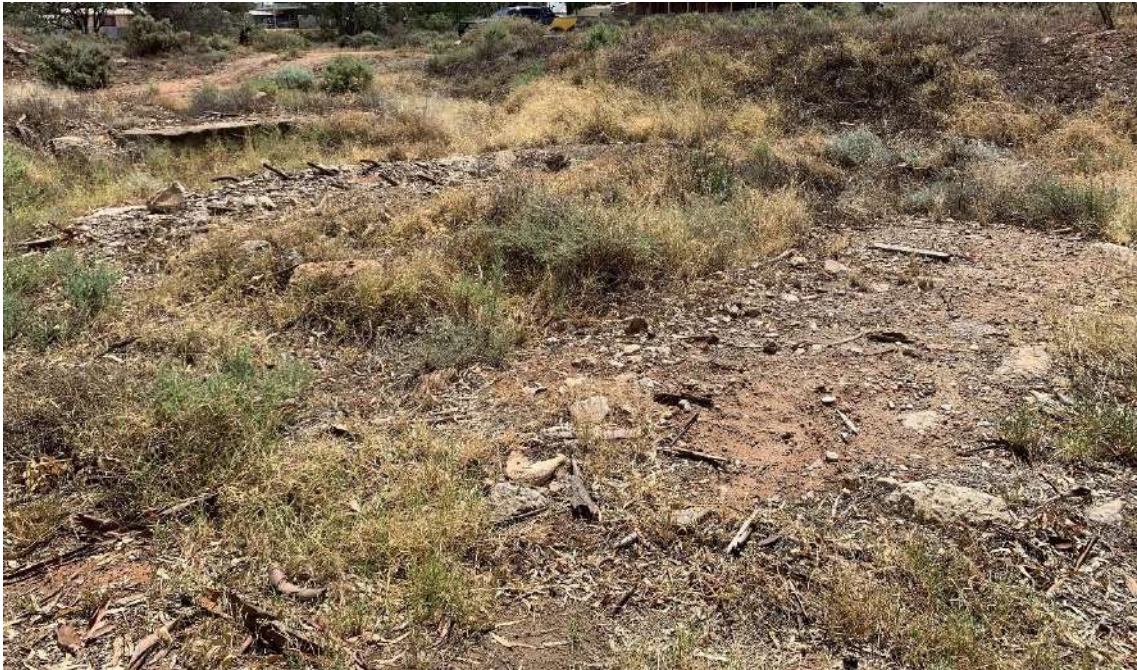
Figure 2.6: Photo D – Remnants of old building adjacent pump shed.

The Subject Site include remnants (demolition waste) of former structures. The former structures could potentially have included hazardous materials such as asbestos and lead based paint. Deterioration and demolition of the former structures can result in the localised dispersion of hazardous materials over the surface of the Subject Site.

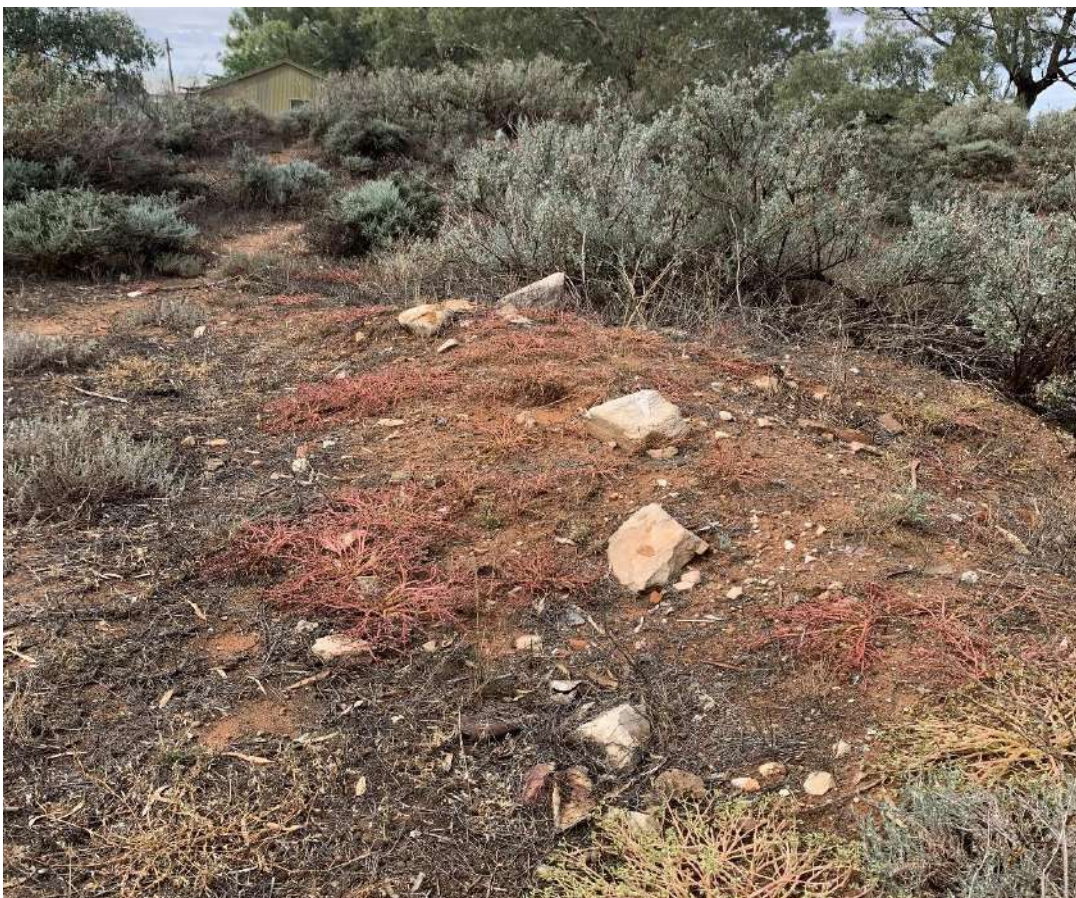
Figure 2.7: Photo E – Photo of fill and brick remnants on site

There is evidence of fill material being stockpiled at the Subject Site. Unclassified fill material could potentially originate from other contaminated sites or could contain demolition wastes contaminated with hazardous materials such as asbestos or lead based paints.

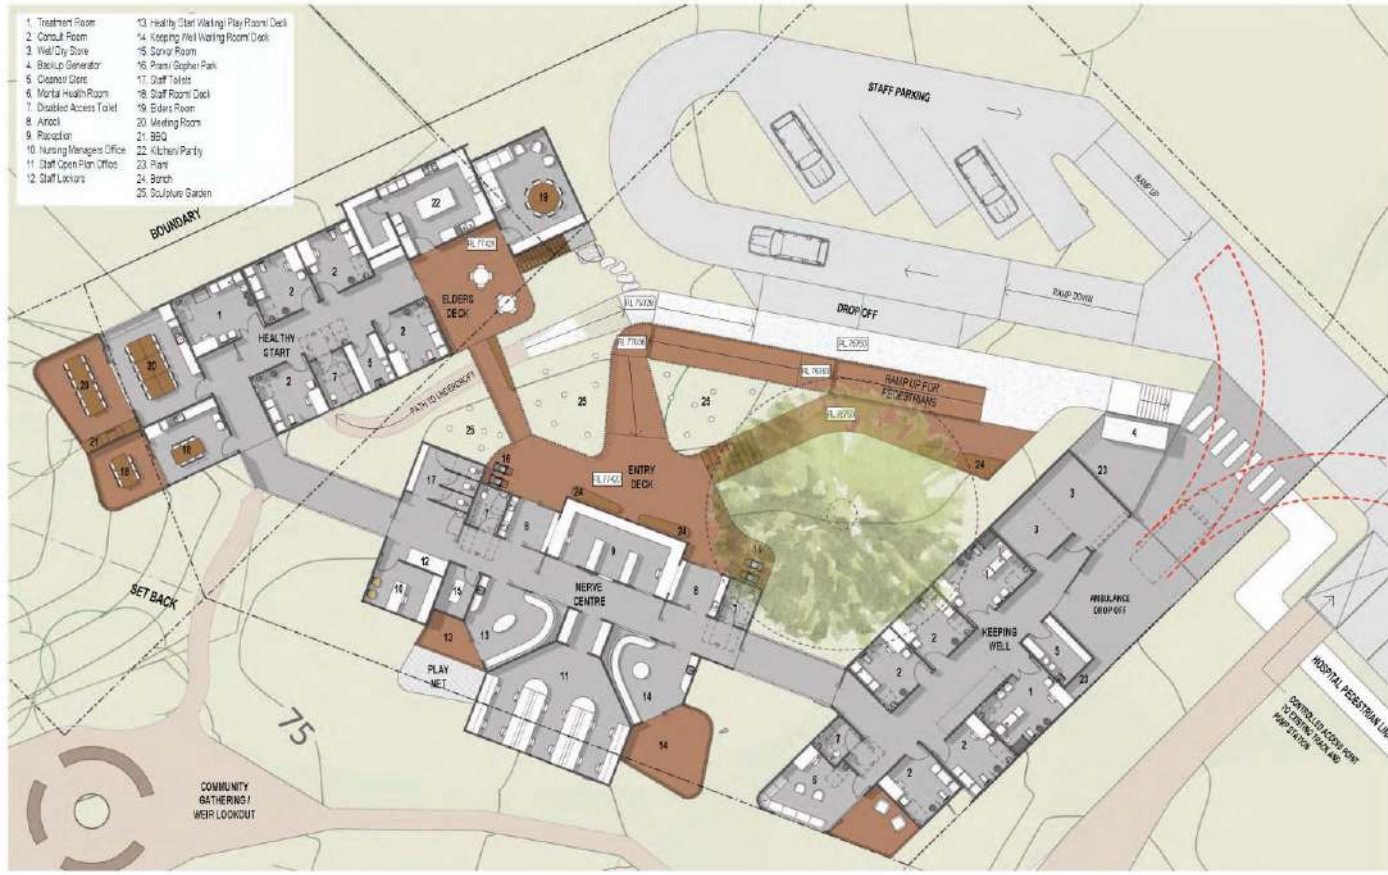
Figure 2.8: Proposed development layout

Figure 2.8 shows a detailed layout of the proposed health clinic and its associated developments. It is accepted that the proposed development will not require to significantly disturb the surface soil of the Subject Site.

MAARI MA WELLBEING CENTRE - WILCANNIA  
 SITE PLAN - KITCHEN IN HEALTHY START  
 23.07.2020

Tropo Architects approached Barnson to provide support in the preparation of a Development Application (DA) for the proposed Maari Ma Health Clinic within the township of Wilcannia on Lot 2, 3 and 4 DP 1201089 and Lot 111 DP 1201028. The development will include associated car parking, ambulance and drop off areas, “Keeping Well” section, nerve centre, “Healthy Start” Section, entry deck and elders’ deck, community and gathering areas and related landscaping throughout. The proposed development can be deemed a health services facility.

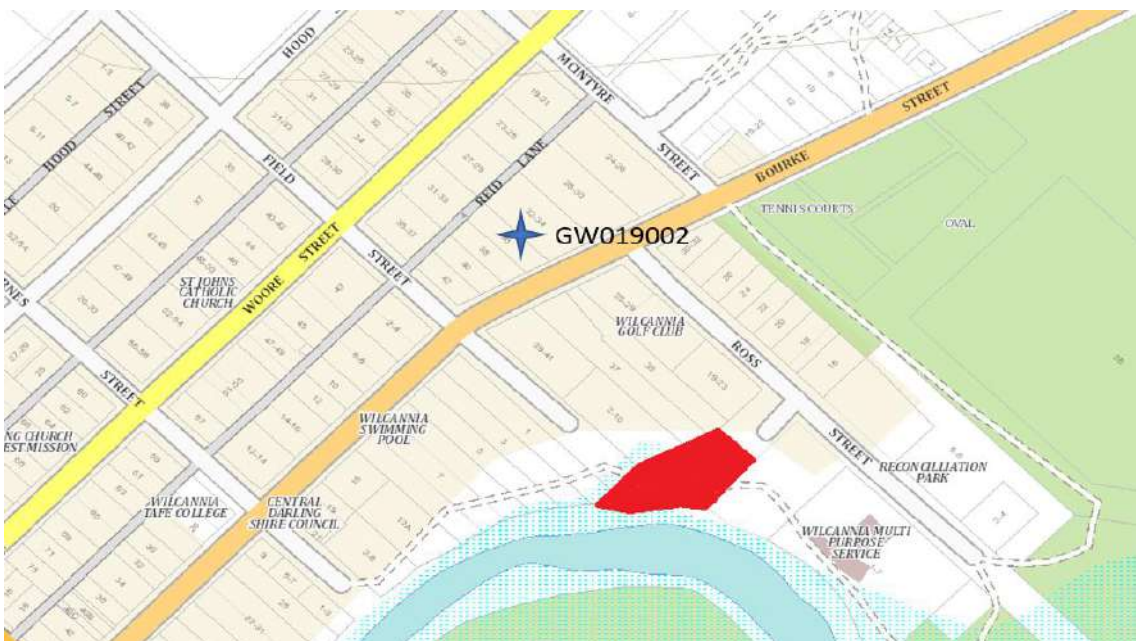
Figure 3.3: Groundwater bores near the Subject Site.

A review of existing groundwater bore records (WaterNSW, 2021) indicate no registered groundwater bores inside the boundary of the Subject Site, and only one within 500m of the Subject Site. The only groundwater bore within 500m of the Subject Site is identified in Figure 3.3, it is located to the north-west of the site.

The information recorded in the database for the closest off-site bore indicate the depth of the bore is 35.10m with a Standing Water Level (SWL) of 12.20m. The shallowest water bearing zone for GW019002 was recorded at 33.50m. According to the database, the bore is for domestic/general use purposes.
