## Statement of Environmental Effects

Maari Ma Wilcannia Health Clinic  
Bonney Street  
Wilcannia NSW 2836

<b>Report Title:</b>	Statement of Environmental Effects
<b>Project Name:</b>	Maari Ma Wilcannia Health Clinic
<b>Client:</b>	Troppo Architects (for Maari Ma Health Aboriginal Corporation)
<b>Project No.</b>	32342
<b>Report Reference</b>	32342-PR01_A
<b>Date:</b>	12/10/2021
<b>Revision:</b>	Final

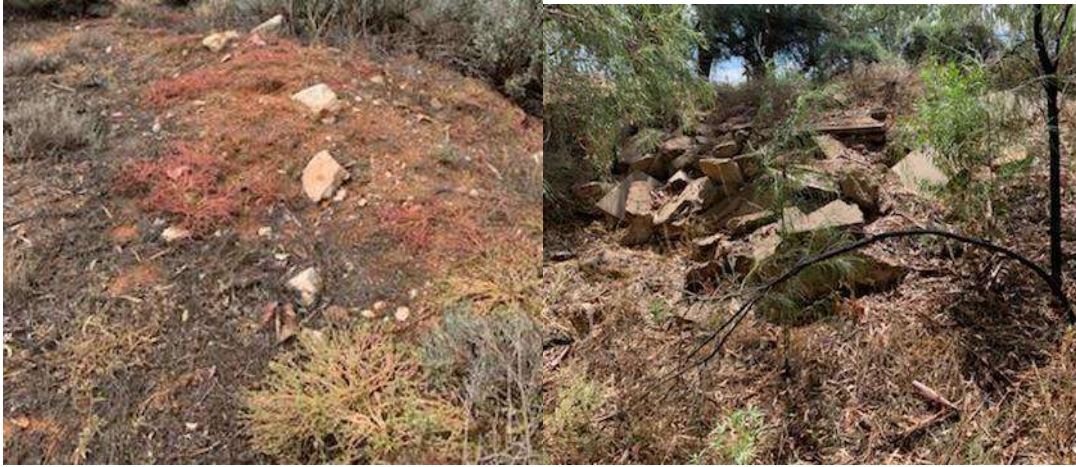
**Figure 6.1: Historical demolition waste.**

- The Subject Site is in general good order without visible signs of disturbance to the soils or vegetation at the Site.
- All visible open ground and prominent features at the Subject Site were inspected. No visible discoloration or staining of open ground or soil, and no obvious discoloration or irregularities in the occurrence of vegetation was observed during the inspection.
- Concrete and bricks remaining from the demolition of the historical structures at the site were observed at two locations (see Figure 6.1).

- The areas with demolition waste were carefully inspected for hazardous materials. No evidence of any fibre cement sheeting, paint or staining associated with hydrocarbons were observed.
- No evidence of any waste disposal was noted at the Subject Site and no general waste was observed in any other part of the Subject Site during the site inspection.
- A stockpile of fill material was observed near the informal vehicle pathway.
- There is a drainage channel across the western portion of the Site, draining stormwater runoff across the site to the Darling River.

The Subject Site include remnants (demolition waste) of former structures. The former structures could potentially have included hazardous materials such as asbestos and lead based paint. Deterioration and demolition of the former structures can result in the localised dispersion of hazardous materials over the surface of the Subject Site.
