White Cliffs Water Supply Scheme Water Treatment Plant, Rising Mains and Weir

Geotechnical Investigation

Report Number: 17-GT29A

Central Darling Shire Council

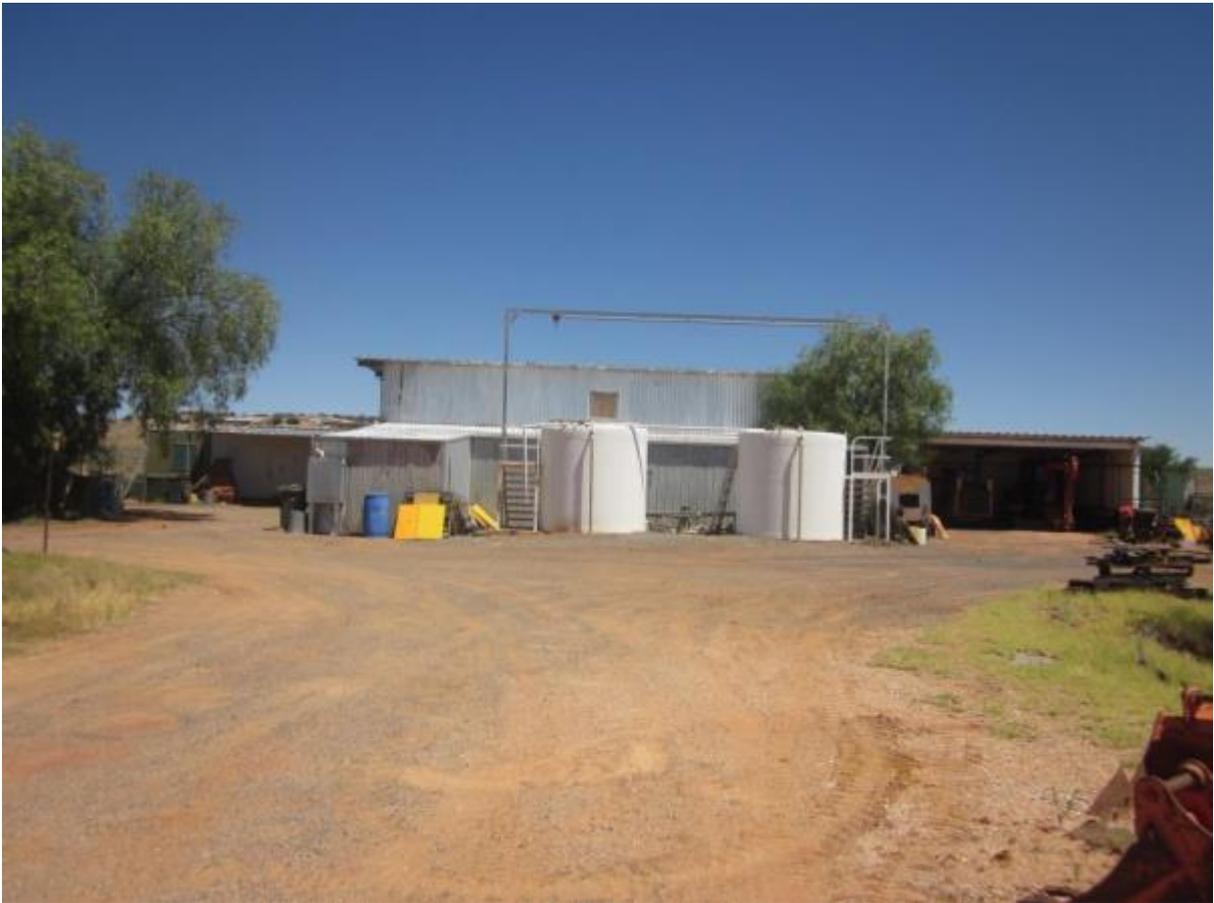
PLATE 1: View looking south showing the existing water treatment plant buildings and tanks.

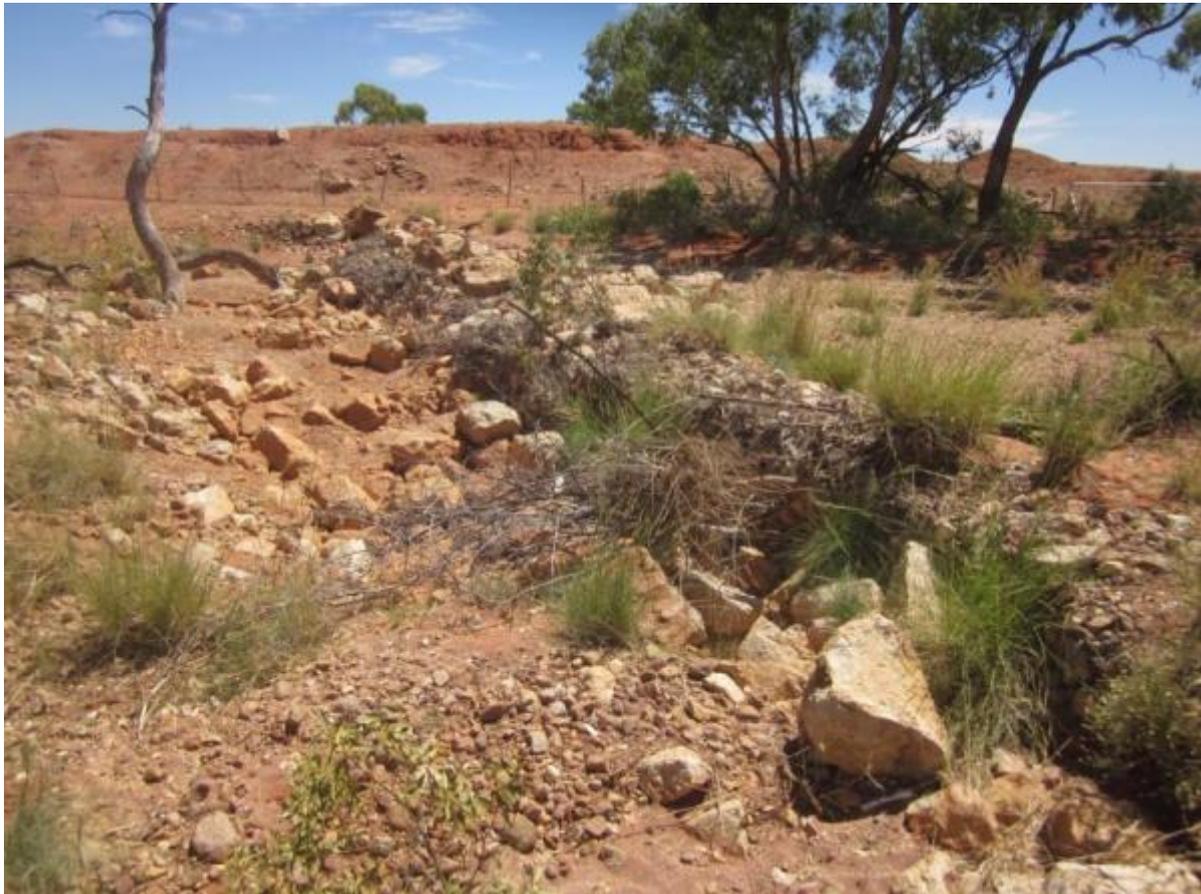
PLATE 9: View looking west showing the existing weir, which is a rock-filled gabion structure. The gabion mesh is mostly damaged. The Dam No.3 (Wakefield) embankment is visible in the background of the photo.

The proposed weir is to be located approximately 4.5km north-northeast of White Cliffs. It will be located to the north-east of Dam No.3 (Wakefield), in close proximity to where the existing weir is located (see **Figure 15**). The existing weir is a currently a rock-filled gabion structure (see **Plate 9**). The gabion mesh is mostly damaged and the rocks are exposed, particularly on the northern side. The nearby dam is shown in **Plate 10**. **Plate 11** shows the location of borehole WR1, while **Plate 12** shows the general view from WR1, looking south-east towards the direction of the existing weir. Vehicle access closer to the existing weir was not possible at the time of fieldwork due to very soft ground conditions (see **Plate 13**).

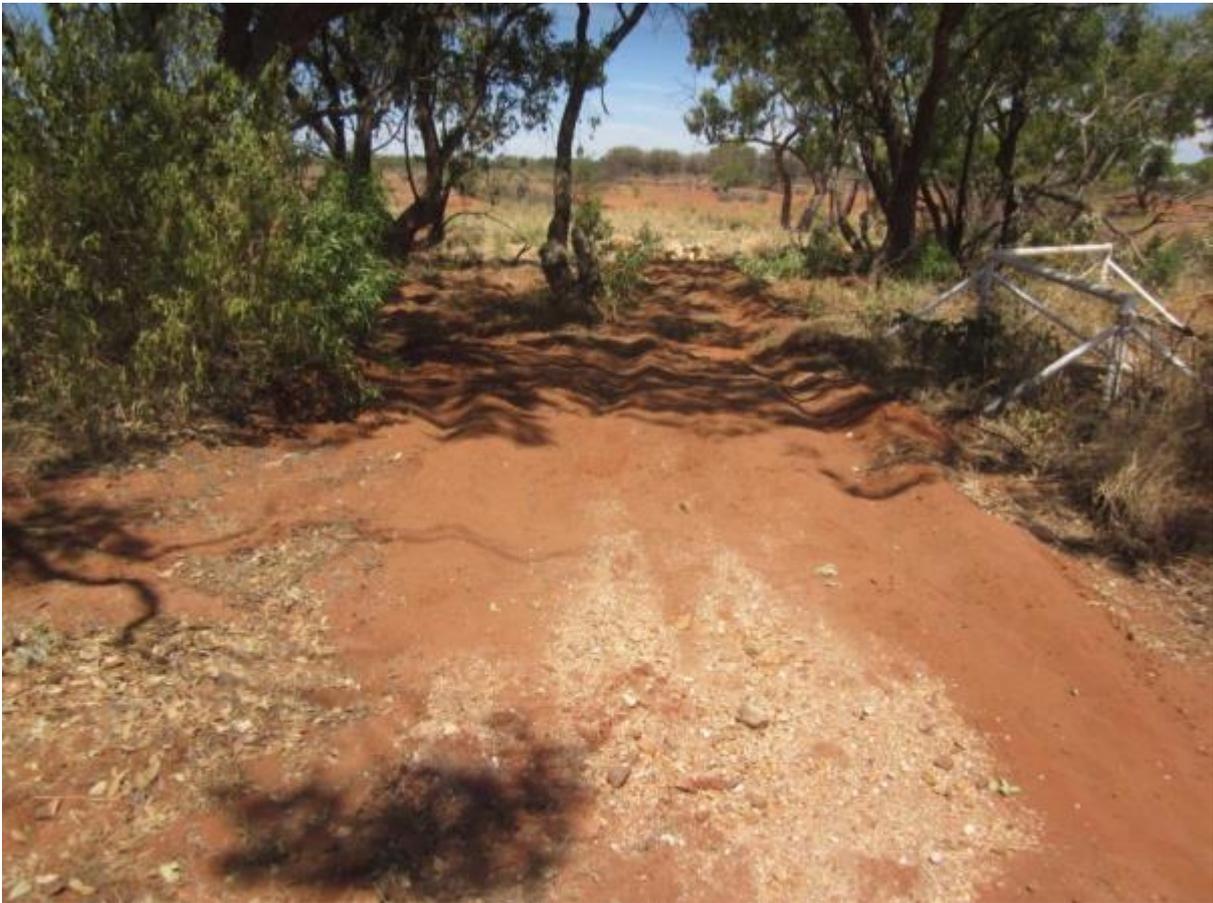
PLATE 13: View looking south-east across the bank shown in Plate 12. The ground is very soft and was inaccessible at the time of fieldwork. The existing weir is located beyond the trees.

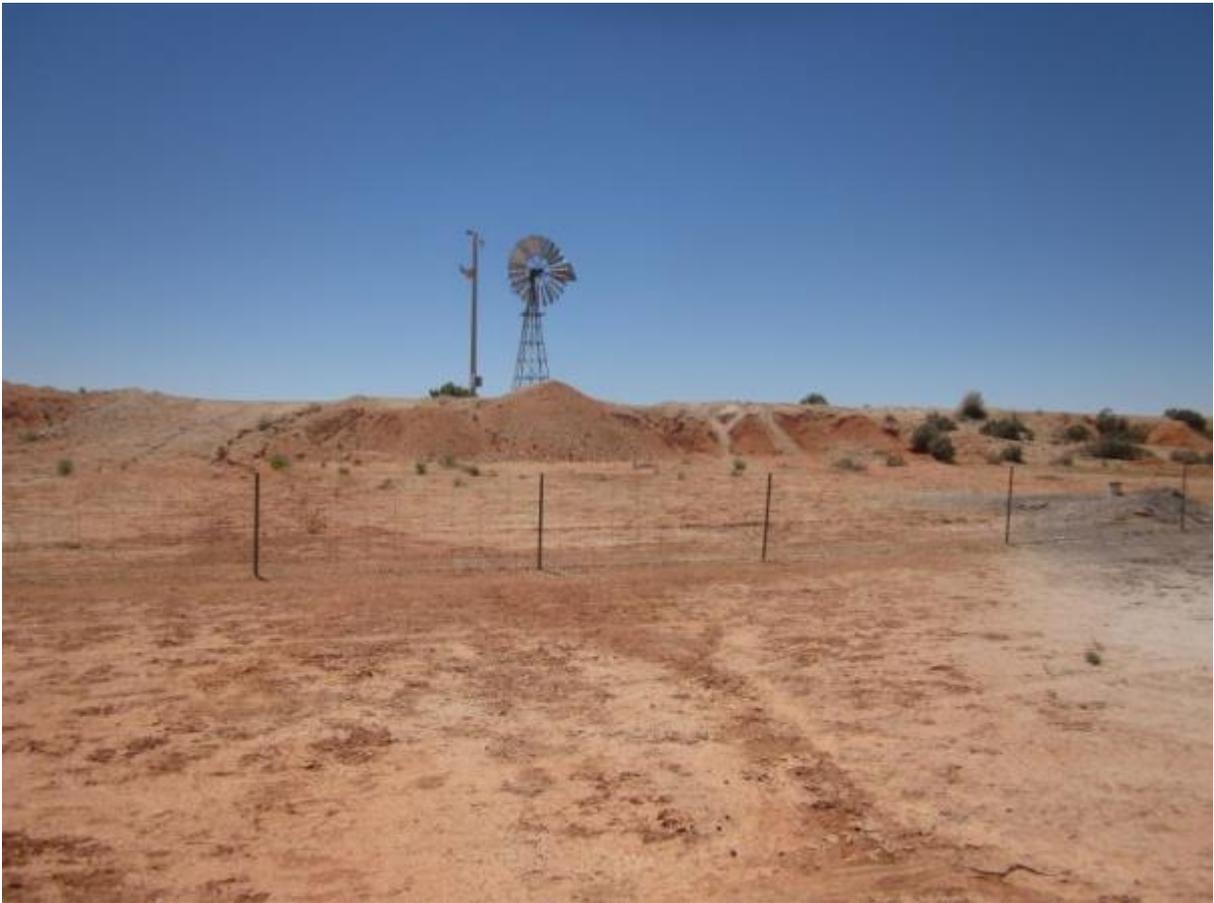
PLATE 21: View looking north-east towards Dam No. 3. Some rutting and gullies are visible where water has overflowed the dam embankment.

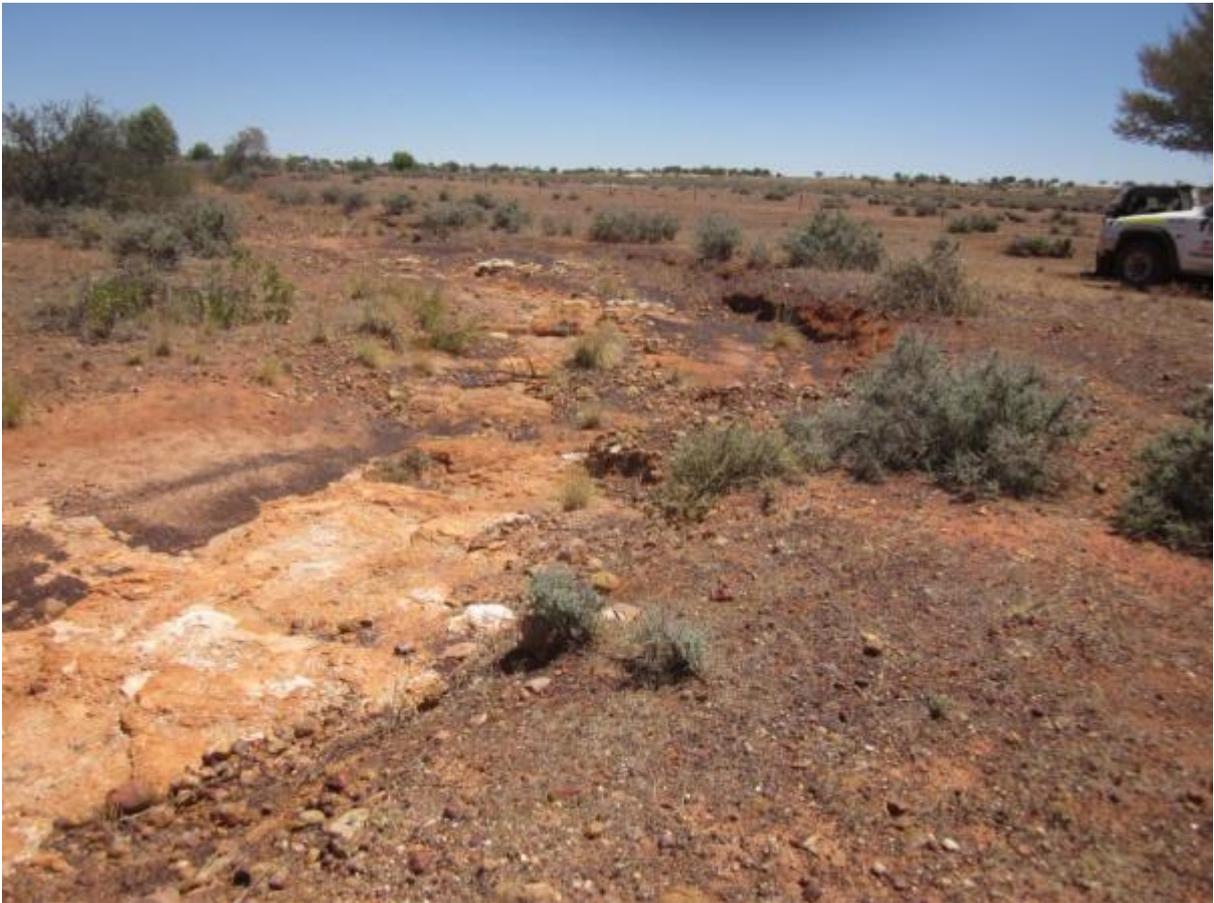
PLATE 25: View looking west showing the watercourse near RM15. Weathered siltstone is exposed in the base of the watercourse.

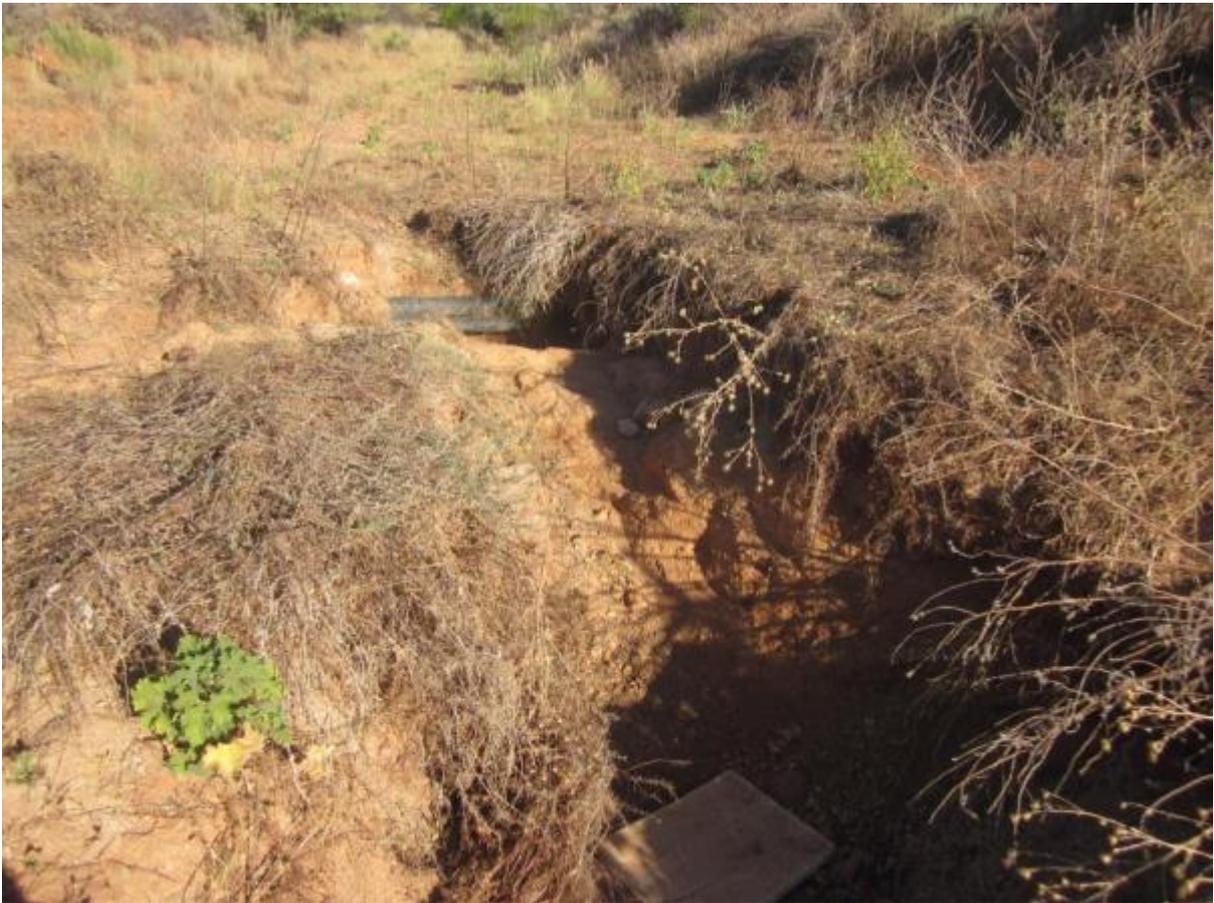
PLATE 33: Pipelines exposed in the base of the watercourse to the west of borehole RM6.

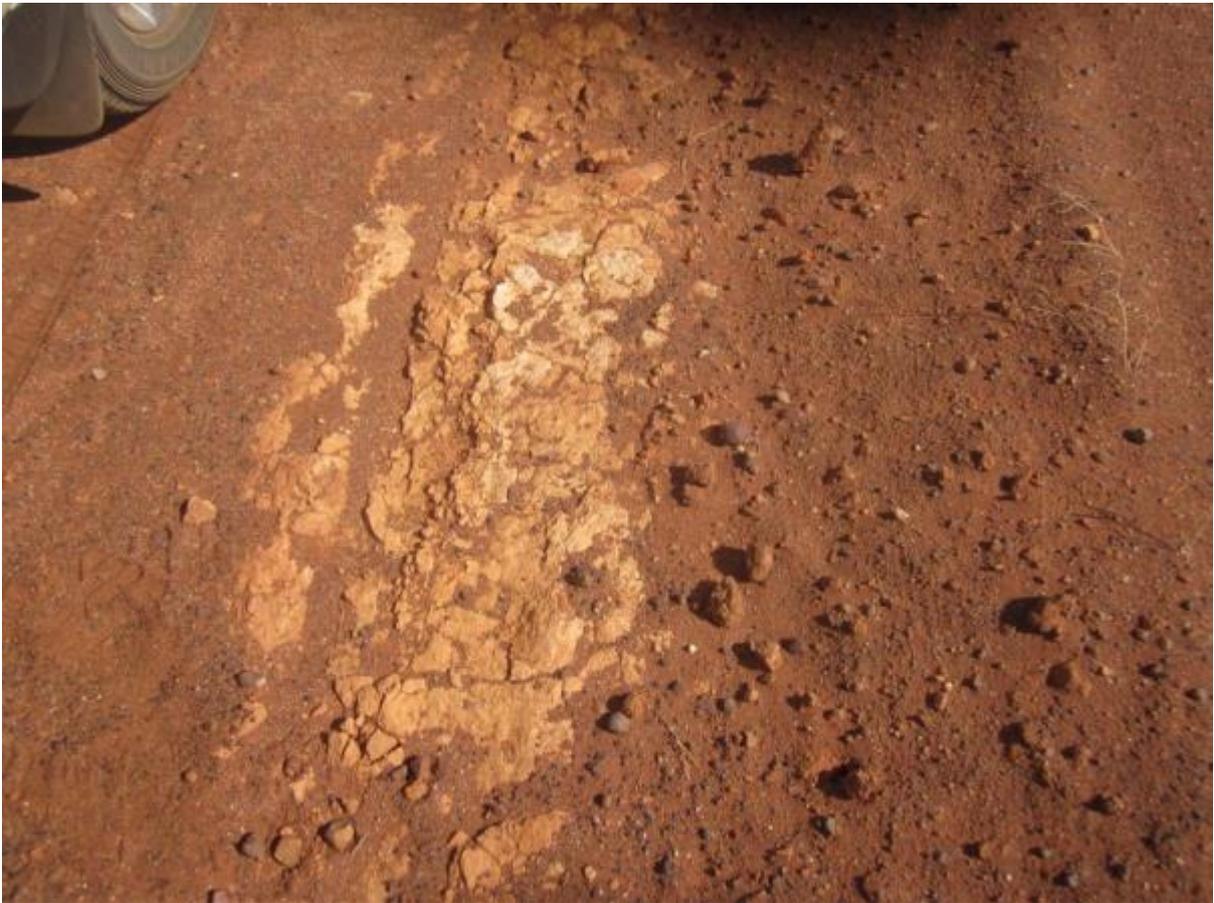
PLATE 39: Rock outcrop in the vicinity of RM21.

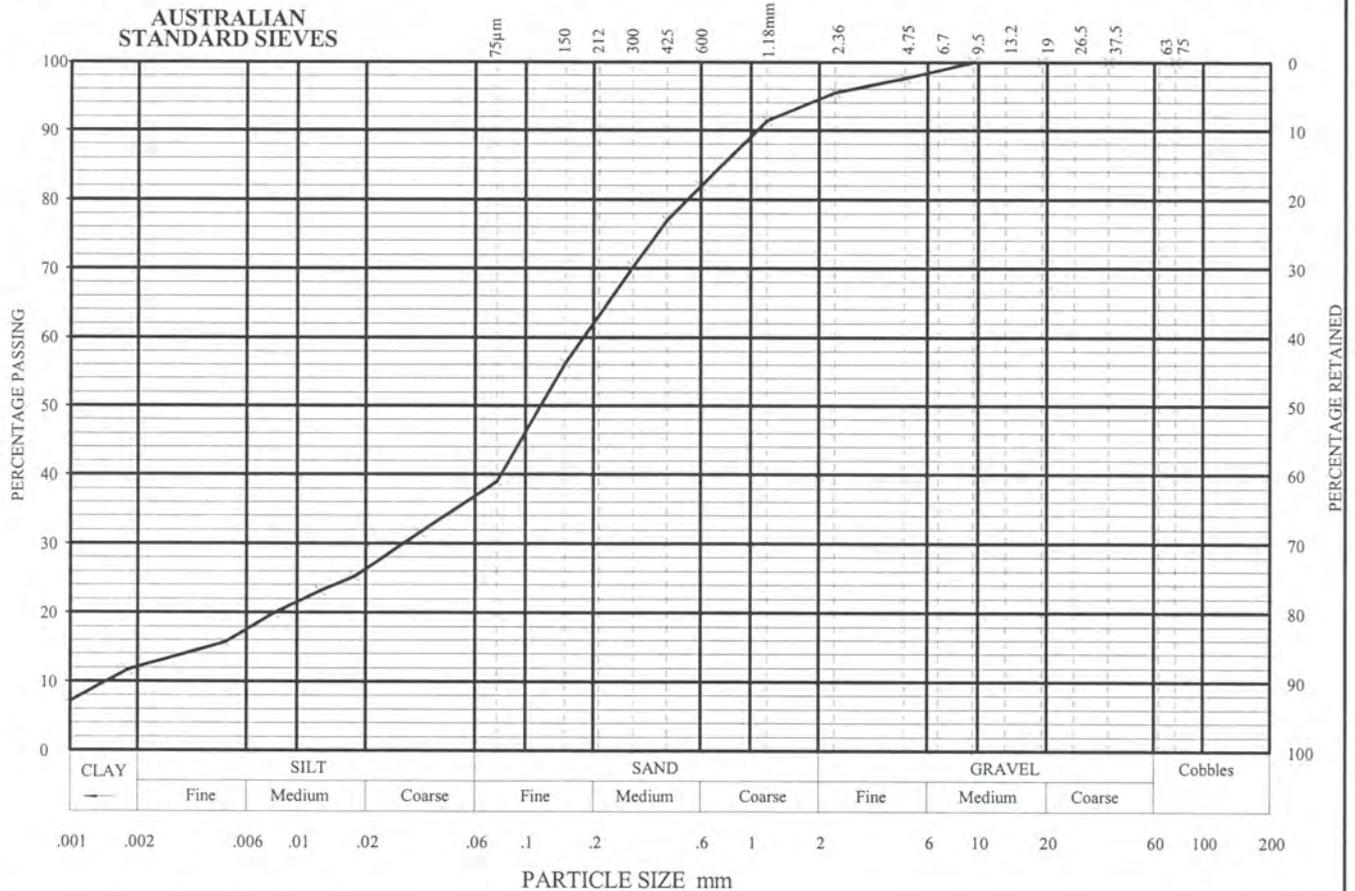
CLIENT: GEOTECHNICAL & ENVIRONMENTAL		REPORT No: 17005/7448/R1119
PARTICLE SIZE DISTRIBUTION		
PROJECT: WHITE CLIFFS WATER SUPPLY		SAMPLE No: 7448
LOCATION: WATER TREATMENT PLANT	HOLE No: B2	DEPTH (m): 0.50

PARTICLE SIZE DISTRIBUTION R1119 (ISSUE 4, 2005)

The soil tested from borehole B2 (0.5m to 0.75m depth), which classifies as an SM-SC type clayey silty sand, returned combined shrink-swell strains of 1.9%. Based on the test results and the fact that White Cliffs is located within a semi-arid climatic zone where the interpreted design depth of suction change is 4.0m, the characteristic ground surface movement is estimated to be between 35mm and 40mm, which is applicable to Class “M-D” site (moderately reactive clay site with deep-seated moisture changes), in accordance with the above Australian Standard.

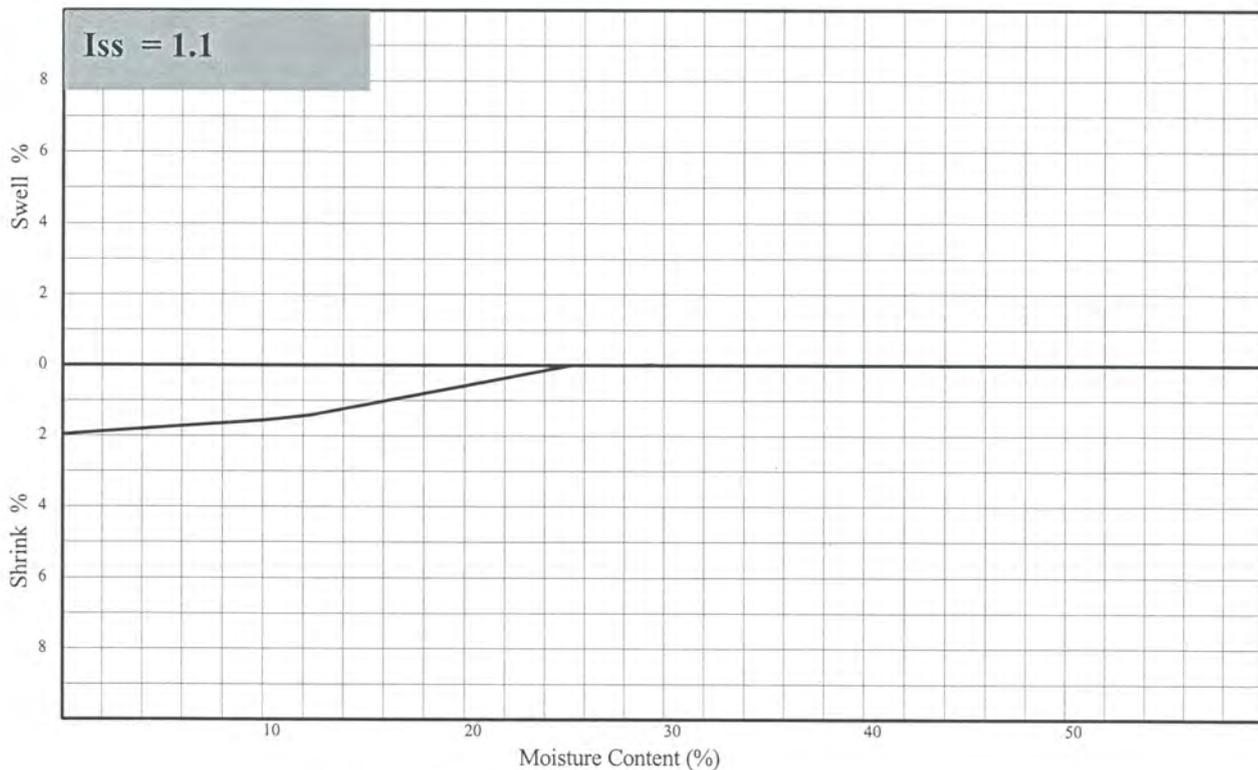
Specimen Description: Yellow Red Brown Clayey Silty Sand trace of Gravel

Test Method: AS 1289.7.1.1

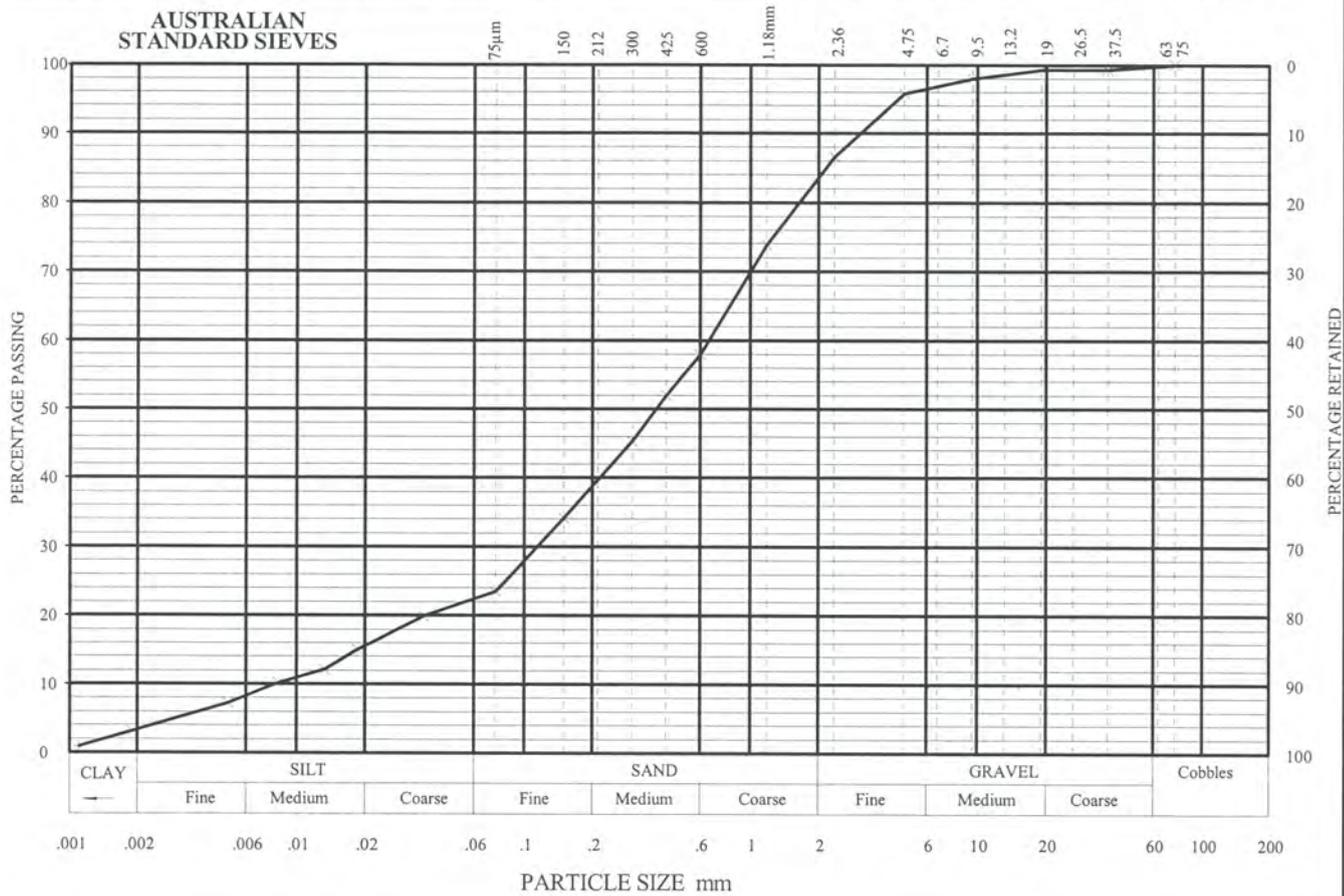
CLIENT: GEOTECHNICAL & ENVIRONMENTAL		REPORT No: 17005/7459/R1119	
PARTICLE SIZE DISTRIBUTION			
PROJECT: WHITE CLIFFS WATER SUPPLY		SAMPLE No: 7459	
LOCATION: WATER TREATMENT PLANT		HOLE No: B5	DEPTH (m): 0.30

SIZE DISTRIBUTION		Soil Particle Density: 2.65 t/m ³ (estimated for analysis)
COBBLES	0 %	Method of dispersion: End-over-end shaking
GRAVEL	17 %	Hydrometer: ASTM 152H
SAND	61 %	Dispersion chemical: Sodium hexametaphosphate + Anhydrous sodium carbonate
SILT	19 %	Notes on Test: Tested as received
CLAY	3 %	Loss in pre-treatment: 0 %
EFFECTIVE SIZE D10:	-	Test Methods:
UNIFORMITY COEFFICIENT D60/D10(Cu):	-	DPWS GM 9: Determination of the Particle Size Distribution of a Soil
CURVATURE COEFFICIENT D30 ² / (D60 x D10) (Cc):	-

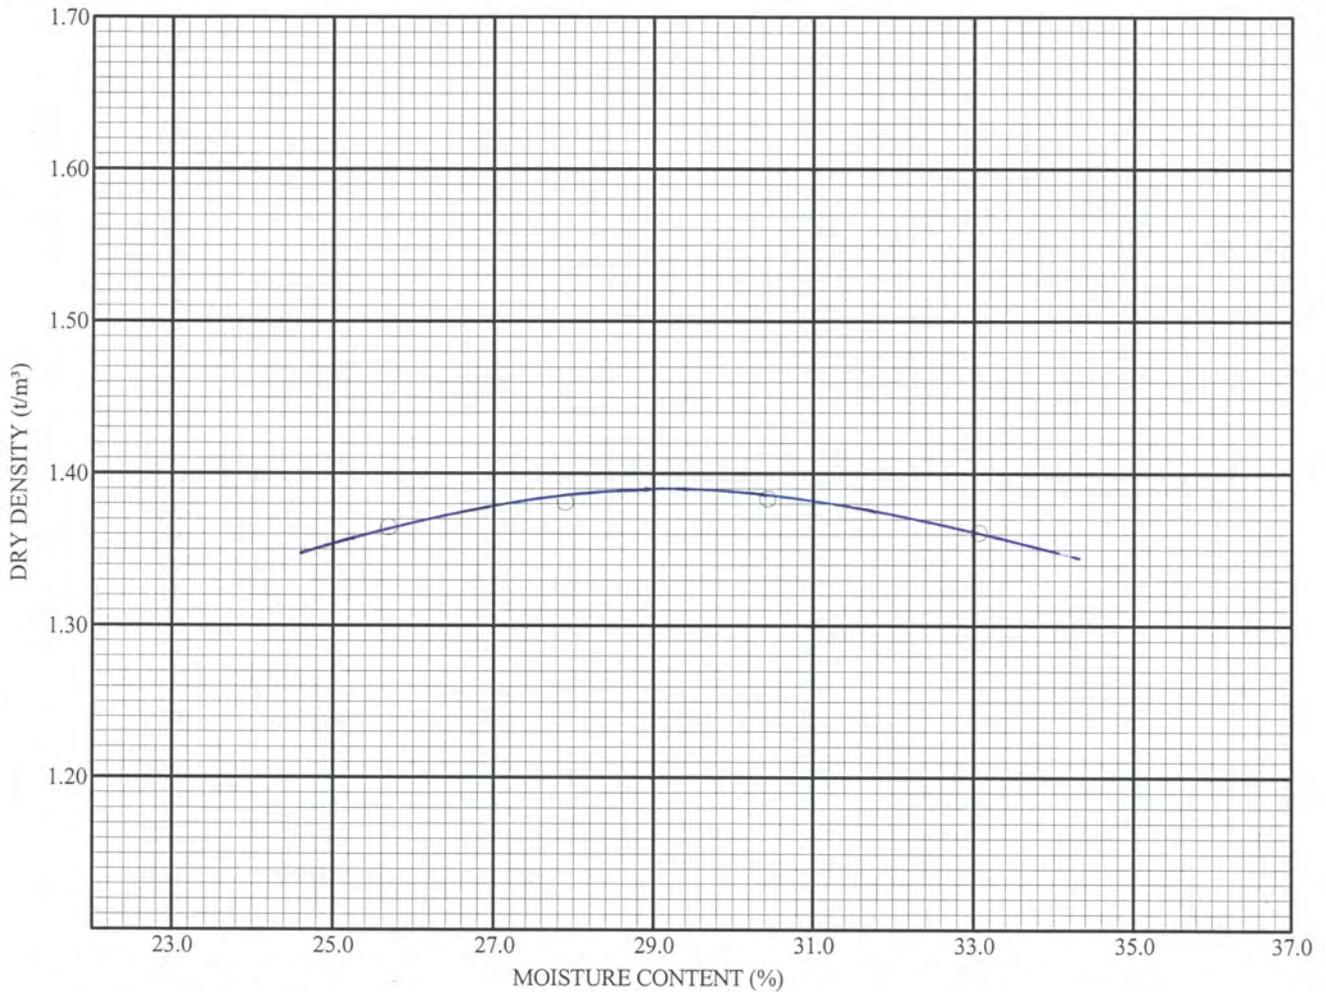
CLIENT: GEOTECHNICAL & ENVIRONMENTAL		REPORT No: 17005/7459/R1111
STANDARD COMPACTION TEST		
PROJECT: WHITE CLIFFS WATER SUPPLY		SAMPLE No: 7459
LOCATION: WATER TREATMENT PLANT	HOLE No: B5	DEPTH (m): 0.30

Standard Maximum Dry Density:	1.39 t/m ³
Standard Optimum Moisture Content:	29.0 %
Percentage of Material Retained on the 19 mm sieve	0.7 %
Notes on Test: Specimen tested as received	
Test Method: AS 1289.5.1.1	Mould: A (1 Litre) <input checked="" type="checkbox"/> B (2 Litre) <input type="checkbox"/>

The selected sample from borehole B5 graded as gravelly silty sand with trace of clay with a breakdown of 17% gravel, 49% sand, 19% silt and 15% clay. The fines are of low plasticity with a liquid limit of 45%, plasticity index of 17% and linear shrinkage of 9.0%. The sample classifies as SM in accordance with Australian Standard AS1726. The clay fraction of the tested sample is non-dispersive with an Emerson Class Number of 4. This material has a maximum dry density of 1.39t/m^3 at corresponding optimum moisture content of 29.0%.

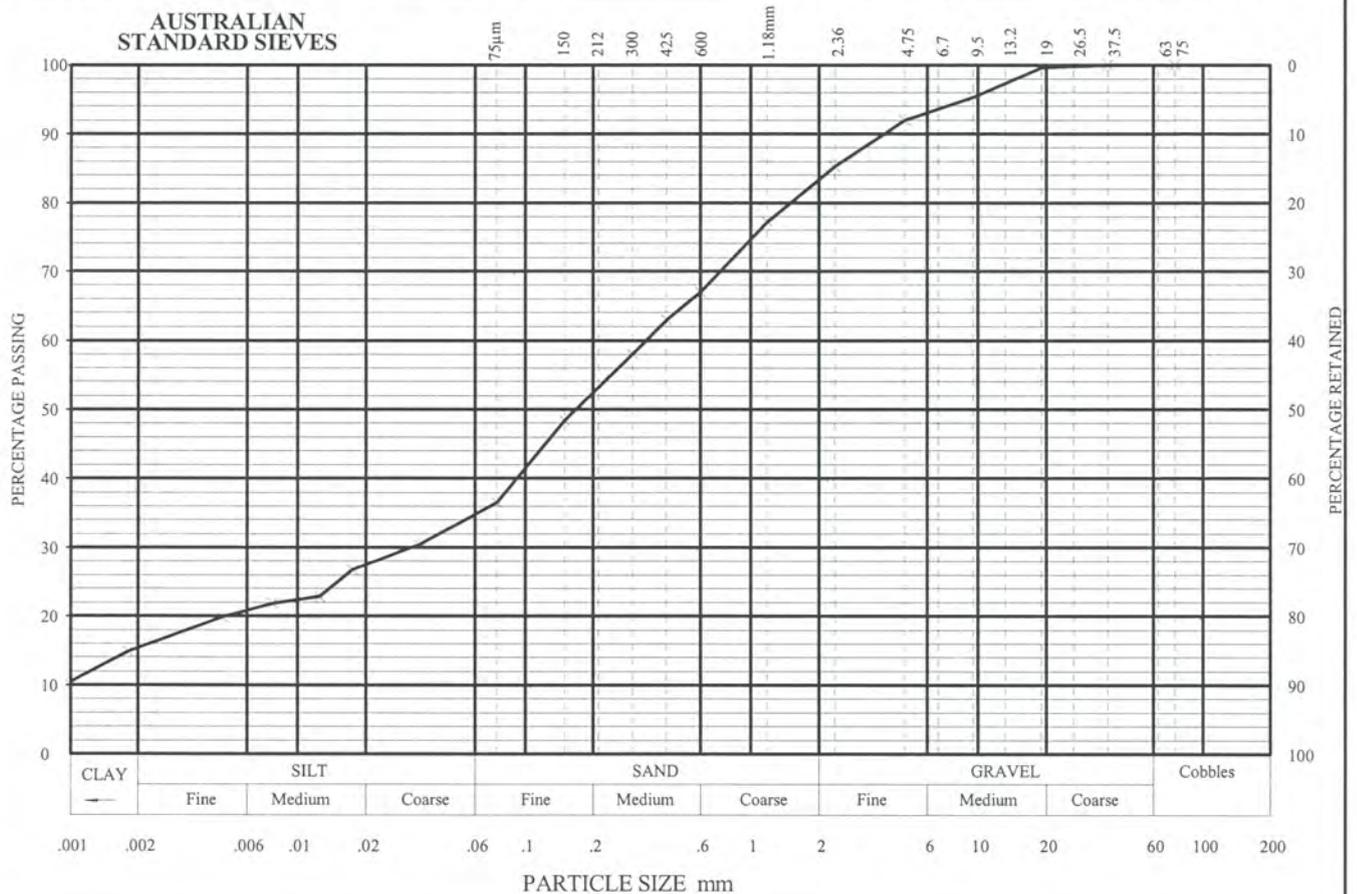
COBBLES	0 %
GRAVEL	17 %
SAND	49 %
SILT	19 %
CLAY	15 %
EFFECTIVE SIZE D10:	-
UNIFORMITY COEFFICIENT D60/D10(Cu):	-
CURVATURE COEFFICIENT D30 ² / (D60 x D10) (Cc):	-

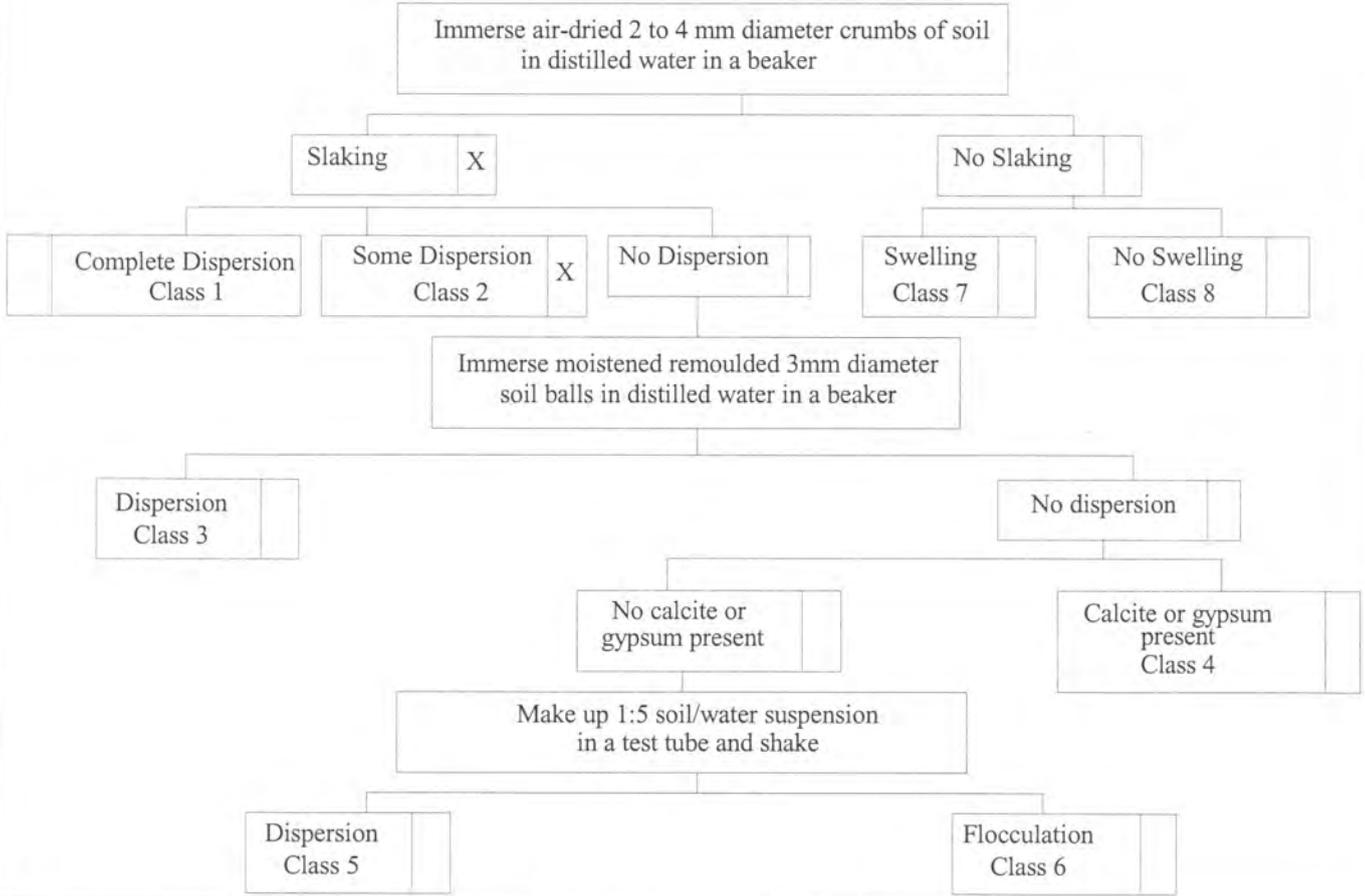
Determination of the Emerson Class Number of a soil

Emerson Class Number	(AS 1289.3.8.1)	<input type="text" value="2"/>
Percent Dispersion	(AS 1289.3.8.2)**	<input type="text" value="No Test"/>
Dispersional Index	(DPWS GM 15)	<input type="text" value="No Test"/>

Sample Description: Pinkish Grey with some Yellow Clayey Gravelly Silty Sand
 Type and temperature of water: Distilled, 22.2 °C

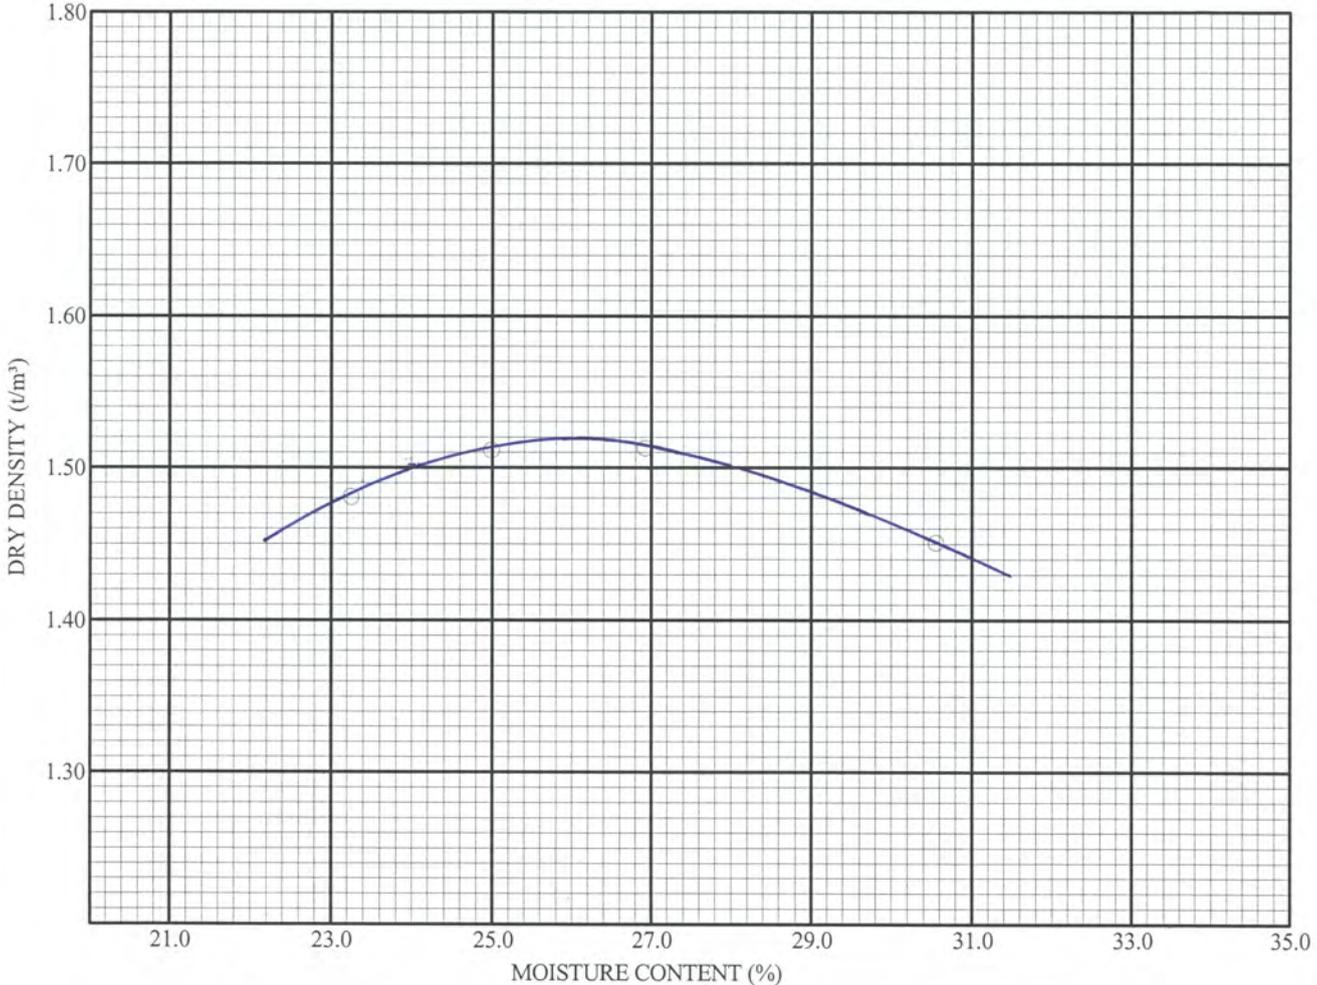
CLIENT: GEOTECHNICAL & ENVIRONMENTAL		REPORT No: 17005/7471/R1111
STANDARD COMPACTION TEST		
PROJECT: WHITE CLIFFS WATER SUPPLY		SAMPLE No: 7471
LOCATION: WATER TREATMENT PLANT	HOLE No: B8	DEPTH (m): 1.50

Standard Maximum Dry Density:	1.52 t/m ³
Standard Optimum Moisture Content:	26.0 %
Percentage of Material Retained on the 19 mm sieve	0.4 %
Notes on Test: Specimen tested as received	
Test Method: AS 1289.5.1.1	Mould: A (1 Litre) <input checked="" type="checkbox"/> B (2 Litre) <input type="checkbox"/>

The selected sample from borehole B8 graded as clayey gravelly silty sand with a breakdown of 17% gravel, 61% sand, 19% silt and 3% clay. The fines are of low plasticity with a liquid limit of 38%, plasticity index of 0% and linear shrinkage of 3.0%. The sample classifies as SM in accordance with Australian Standard AS1726. The clay fraction of the tested sample is dispersive with an Emerson Class Number of 2. This material has a maximum dry density of 1.52t/m^3 at corresponding optimum moisture content of 26.0%.
