Preliminary Site Contamination Assessment

Baaka Cultural Centre
Reid Street, Wilcannia
NSW 2836

(Our Reference:38166 ER01)

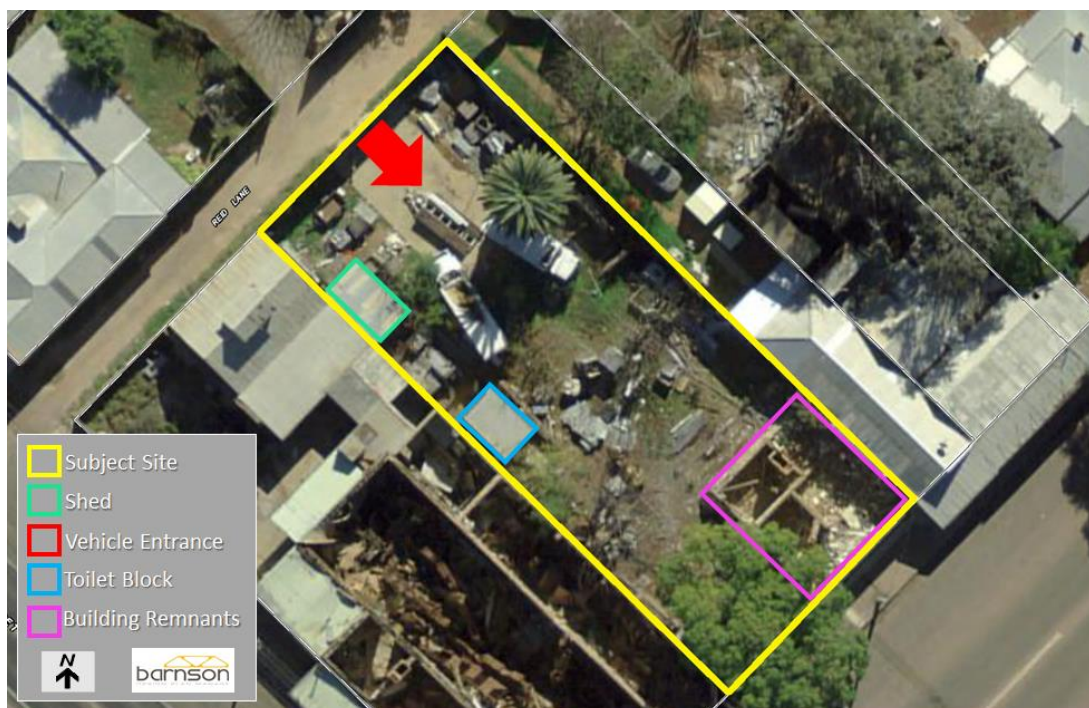
Figure 2.2: Existing Subject Site layout.

Figure 2.2 presents an aerial photo of the Subject Site with the features discussed indicated as sketch plan overlay.

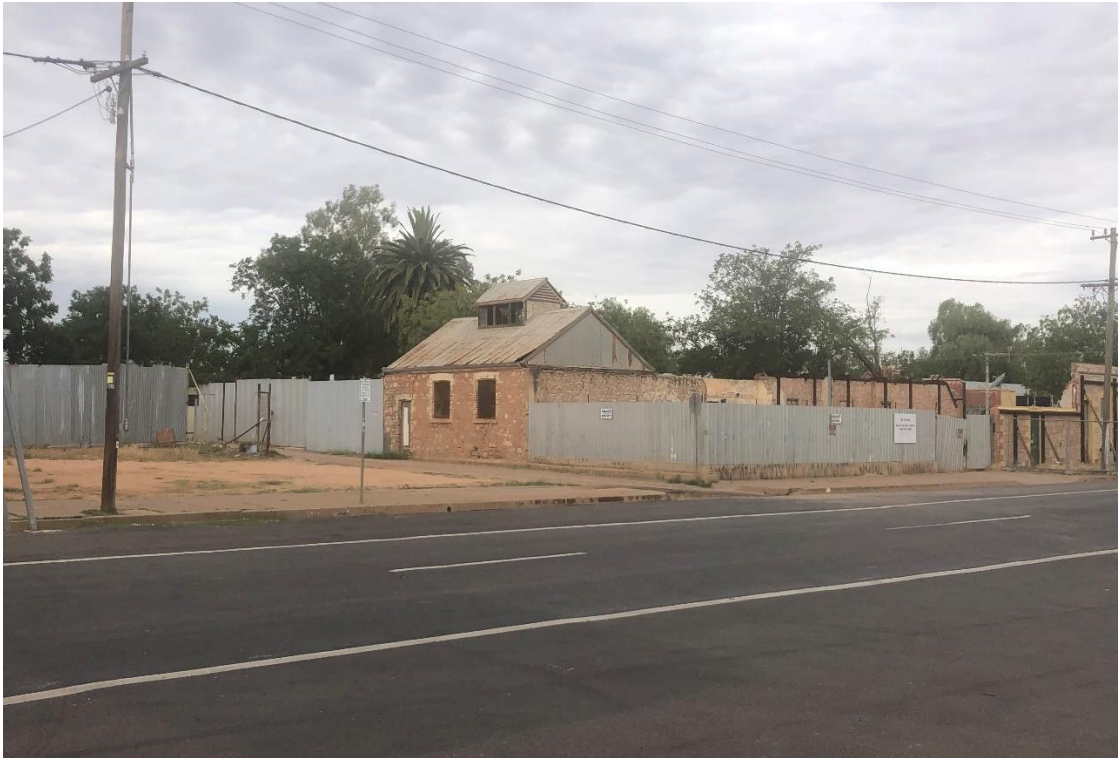
The Subject Site is enclosed with high metal fencing (see Figure 2.3). The south-west boundary of the Site is a high sandstone wall that forms part of the historical buildings on with Lot 1 Section 13 DP 759091.

Figure 2.3: View of development site from Myers Street looking west. Metal fence surrounding the site and historical sandstone building on Lot 1 Section 13 DP 759091 visible

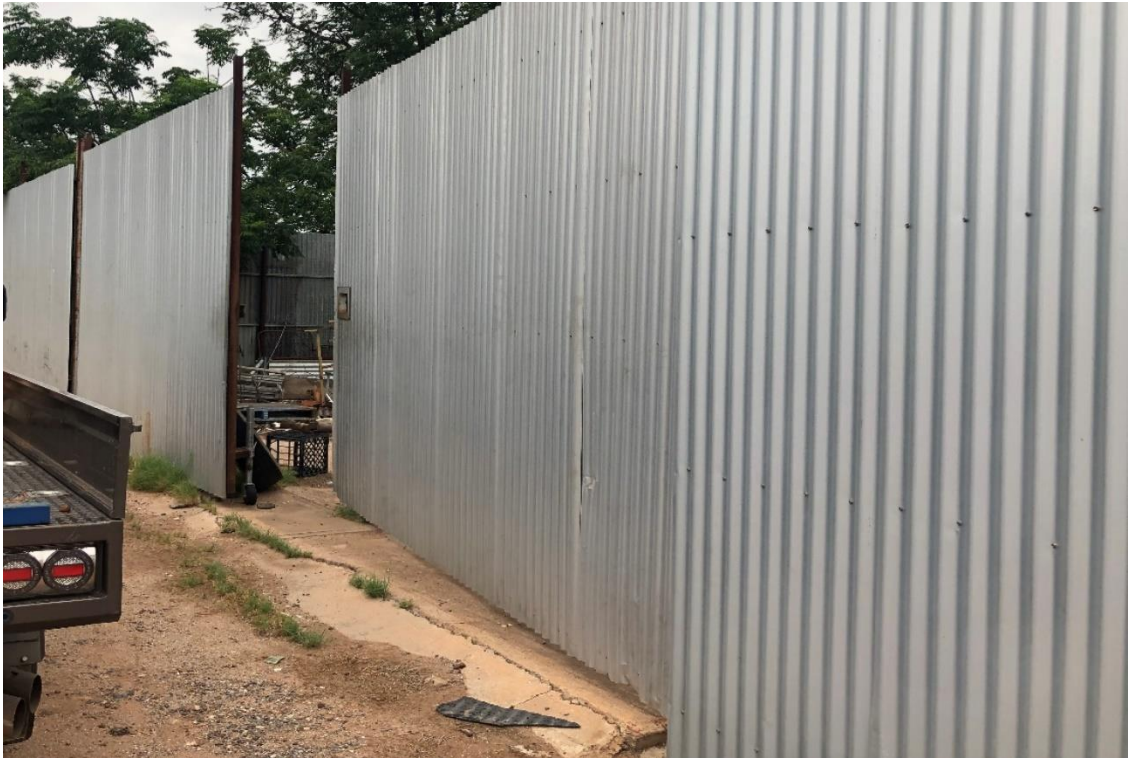
Figure 2.4: Entry gate in Reid Lane.

A gated vehicle entrance to the Subject site is located in Reid Lane to the north west (Figure 2.4), through which the site is accessed onto a concrete slab Figure 2.5.

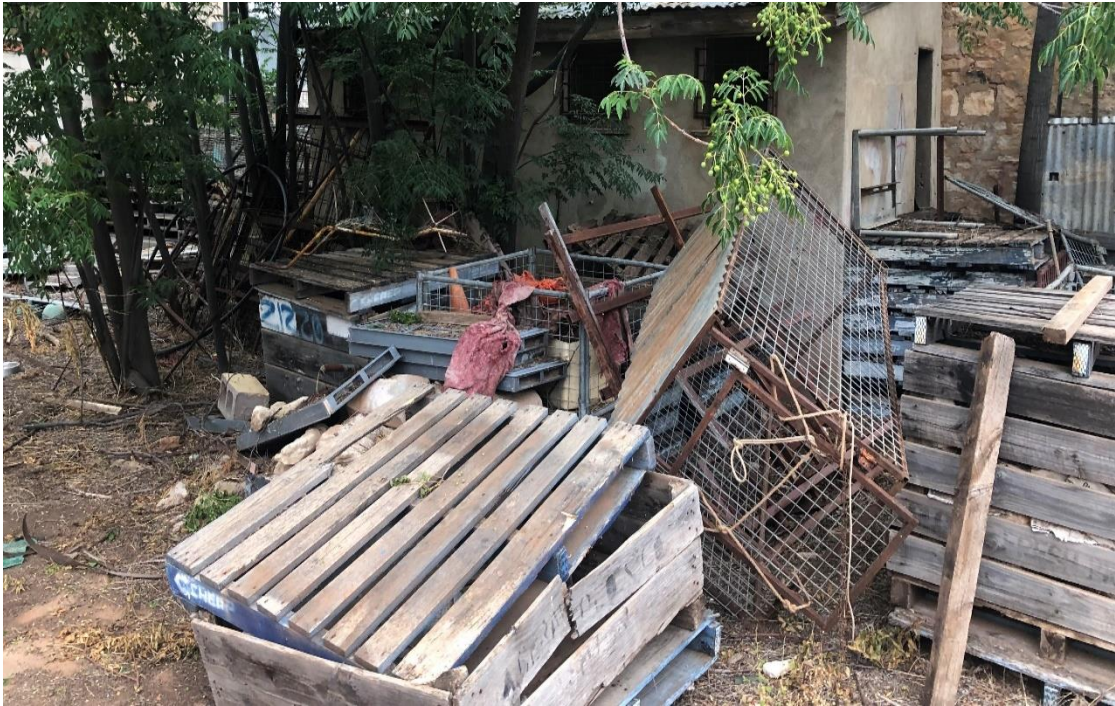
Figure 2.6: Store room building.

Along the south west boundary of the site there is a small store room building (Figure 2.6, closest to the entry) as well as a toilet block (see Figure 2.7).

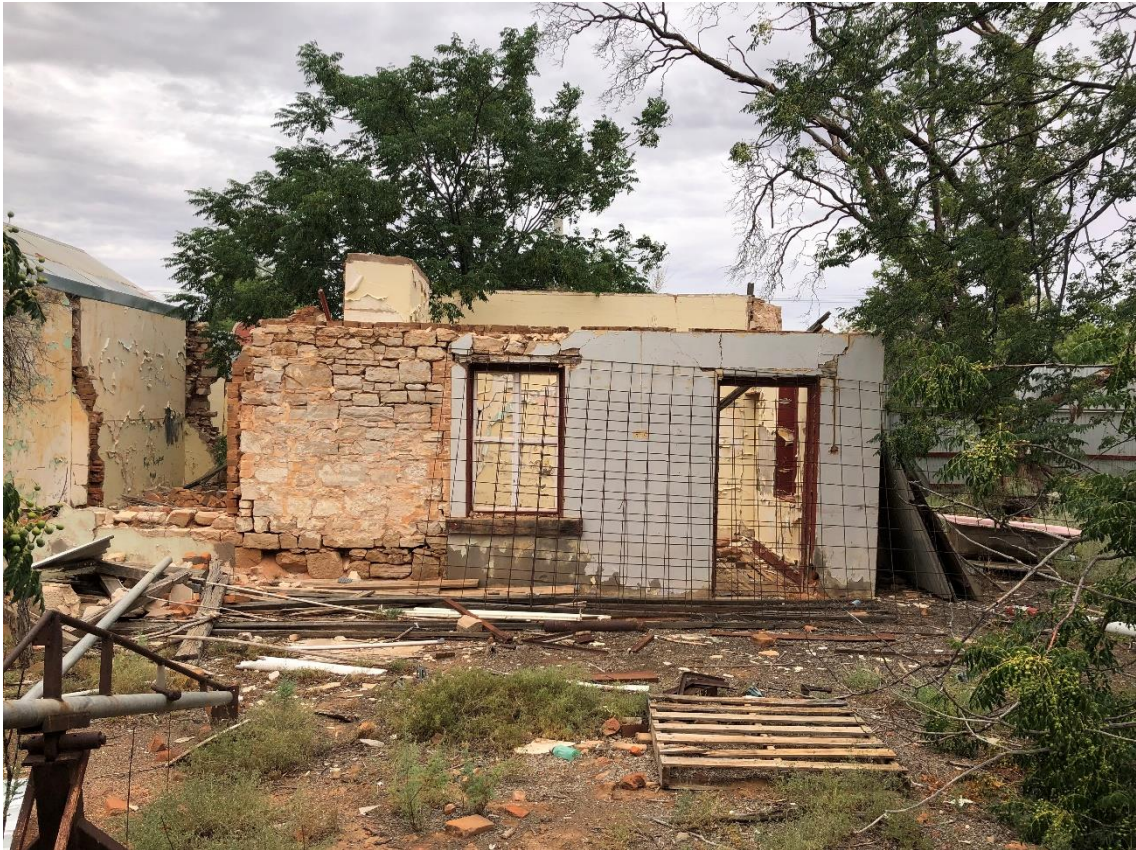
Shown in Figure 2.8 is a partially demolished residential dwelling that occupies the easternmost corner of the Subject Site.

Figure 2.8 Partially demolished residential structure in eastern corner of the Subject Site.

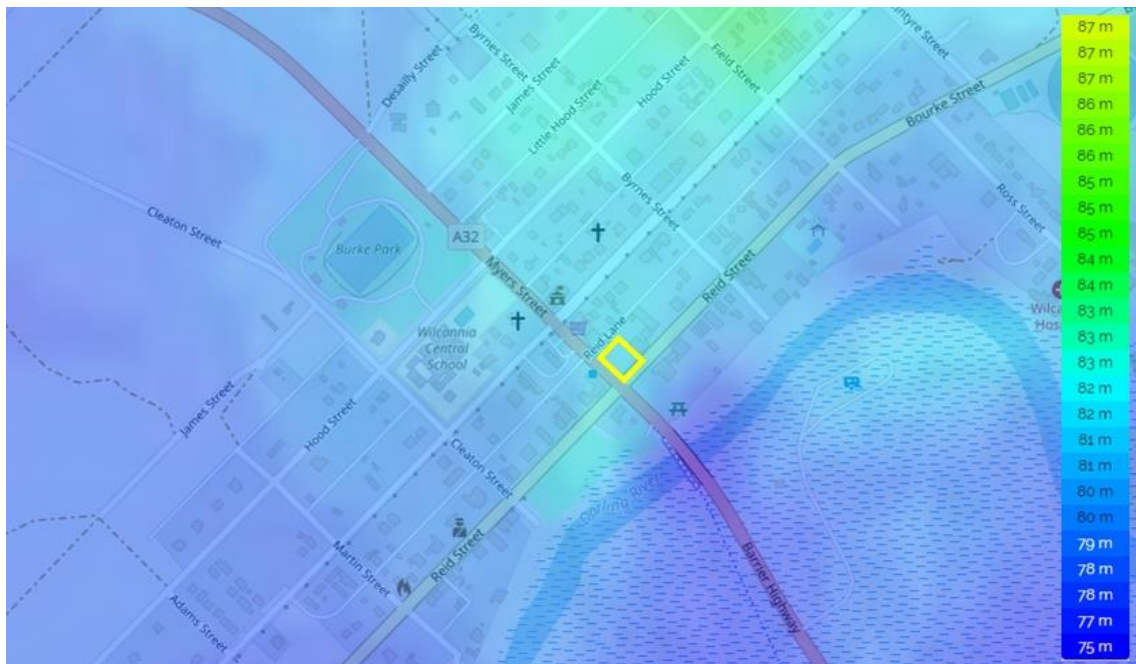
Figure 3.2: Subject Site topography.

Figure 3.2 presents topographical information overlain on the map of the Subject Site. The presented data shows that the Subject Site is relatively flat throughout. There is a gradual fall to the south-east towards the Darling River.

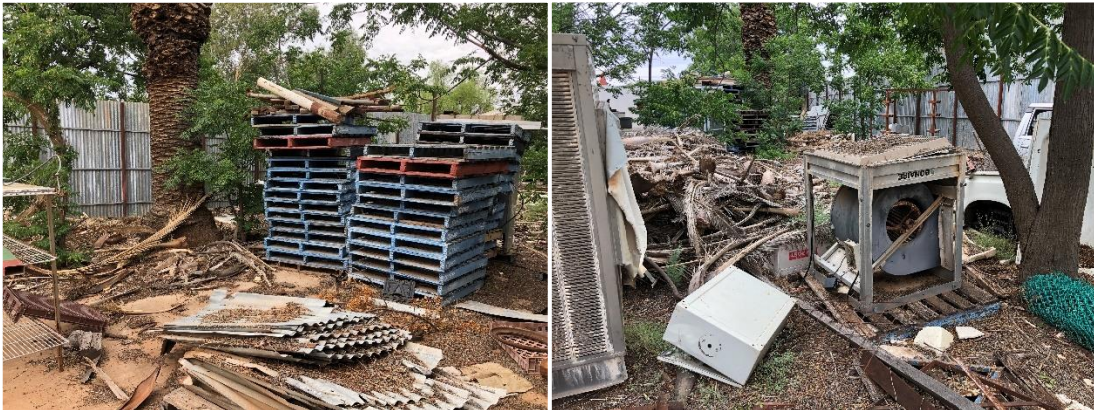
- Most of the surface area of the Subject Site is covered with stacks of timber pallets, building materials and machinery (see Figure 6.1) as well as rubble of partially demolished buildings and scrap. Less than half of the surface of the subject site is accessible for inspections.

Figure 6.1: Building materials, stacks of pallets and equipment scrap covering the surface of the Subject Site.

- It is recommended that a suitable contractor, licensed to manage and dispose hazardous materials, be appointed to remove all equipment, scrap and demolition waste from the site and complete the demolition of all buildings, which are to be removed, before commencement of any further investigation.

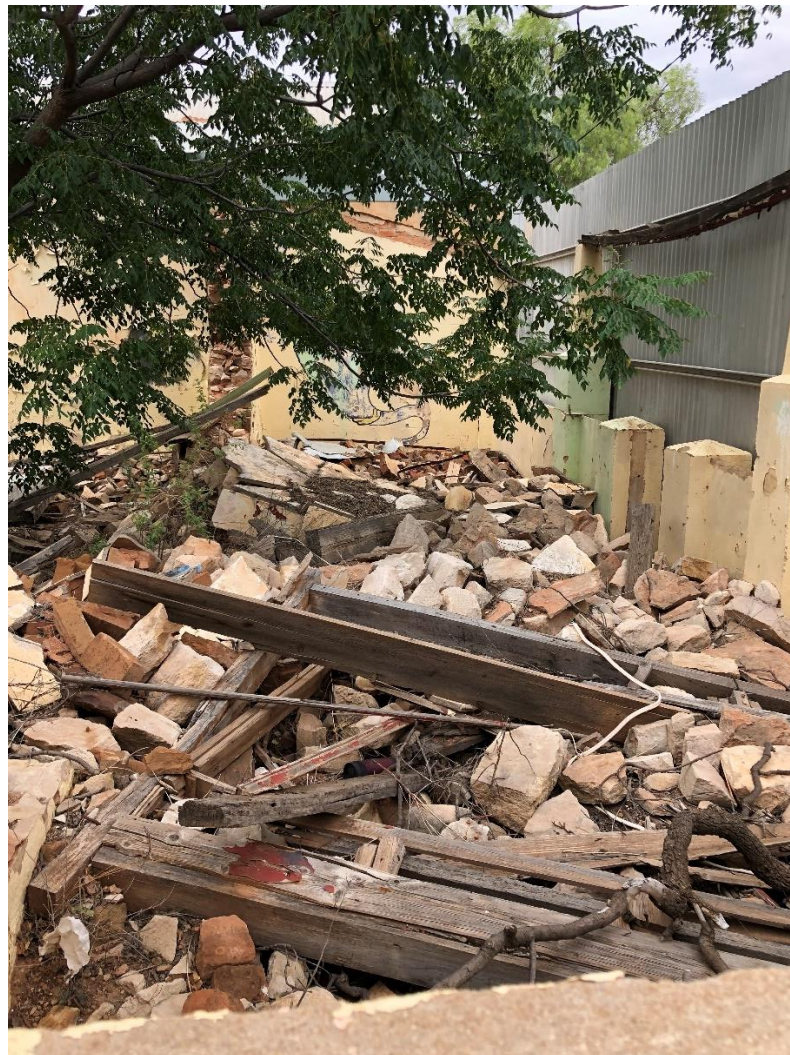
Figure 6.2: Demolition rubble and scrap.

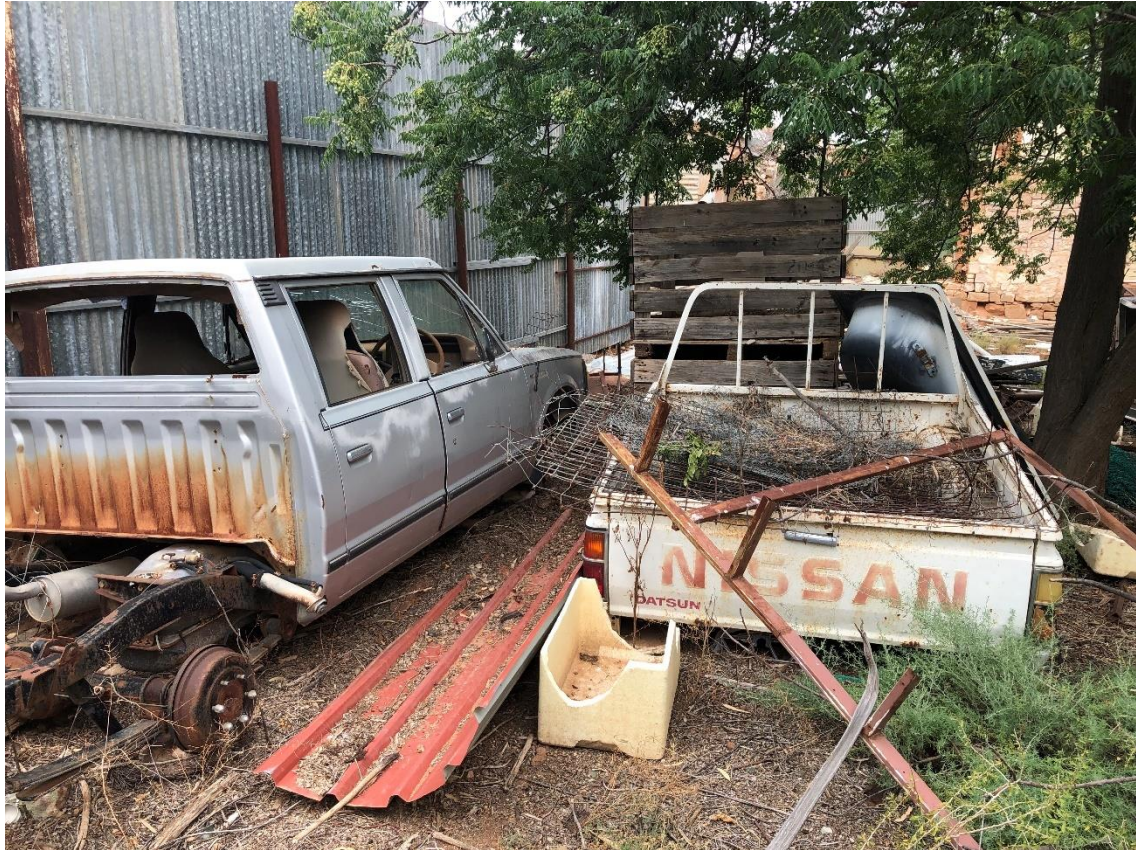
Figure 6.3: Historical demolition waste.

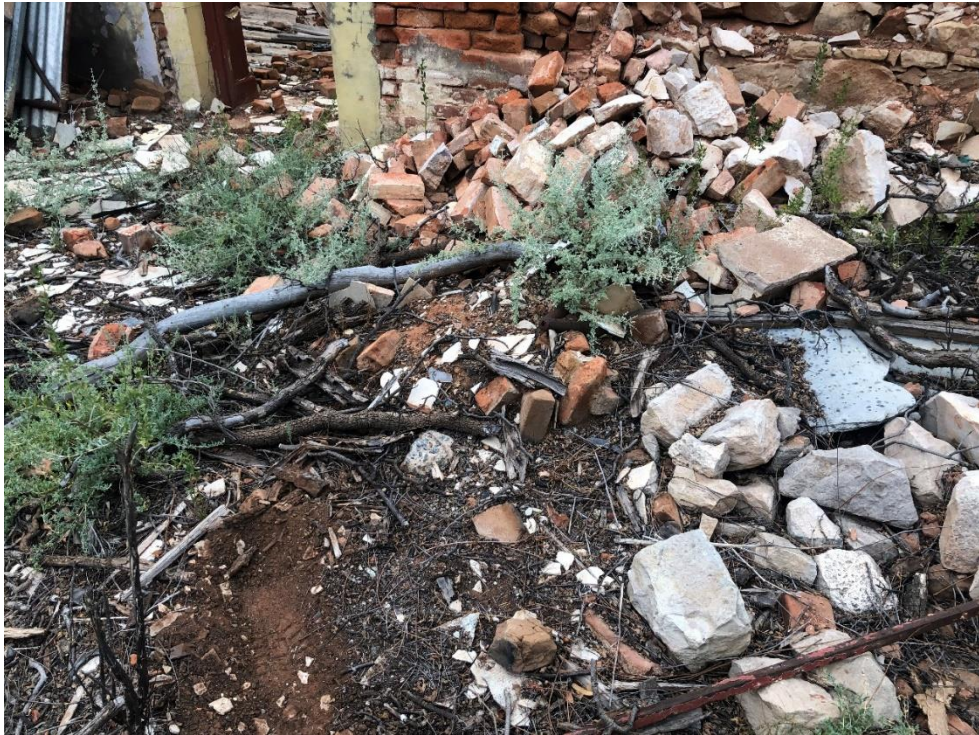
- The partially demolished structure in the eastern corner of the Subject Site is surrounded with demolition rubble. The rubble consists mainly of bricks stones and mortar, with some pieces of roof timber also visible. Fragments of fibre cement sheeting was observed amongst the rubble around the western corner and south-western edge of the partially demolished structure (see Figure 6.4). Larger pieces and a higher concentration of fibre cement sheeting was observed at the entrance to the structure as well as inside (Figure 6.5).

Figure 6.4: Fragments of fibre cement among building rubble.

- The asbestos containing material (ACM) and lead based paint identified at the Subject Site, requires specialist attention during any removal or remedial action. It is recommended that during any removal of waste from this area, the ACM be removed and transported to a landfill, licensed to accept the waste, for disposal. The removal and disposal task can be undertaken by either a competent person or a licensed asbestos removalist.

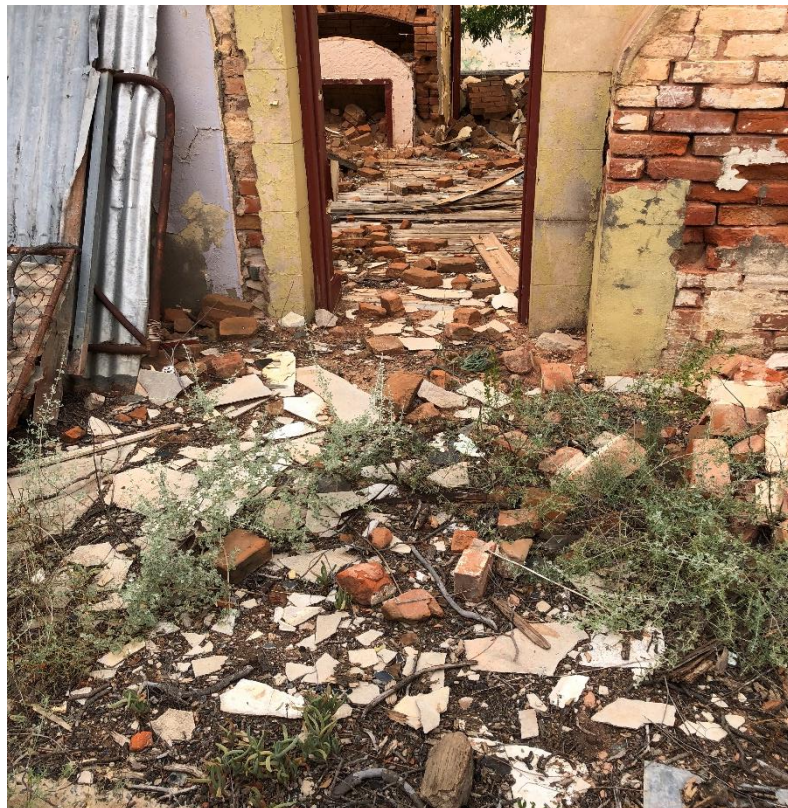
Figure 6.5: Larger pieces of fibre cement near entrance and inside the structure.

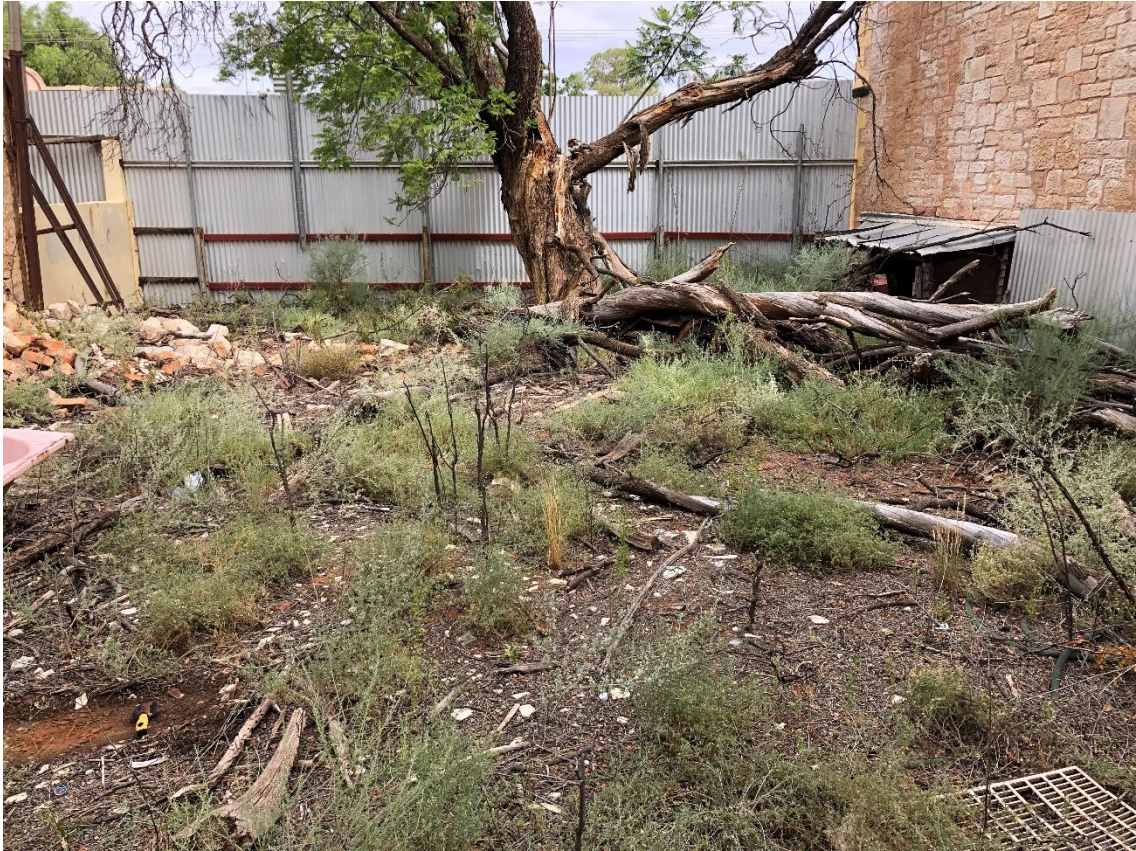
- The fibre cement fragments radiate outward from the edge of the partially demolished structure and the number of fragments visible at the surface decrease with distance from the structure (see Figure 6.6), but is clearly visible on the surface.

Figure 6.6: Fragments of fibre cement radiating out from the source are.

- The ACM observed at the Subject Site clearly originates from the partially demolished structure on site. It is considered unlikely that the ACM previously reported at the adjoining Knox and Downs Building would have been transferred to the Subject Site and in the unlikely event it has, would not make a significant contribution to the quantity of ACM fragments observed.

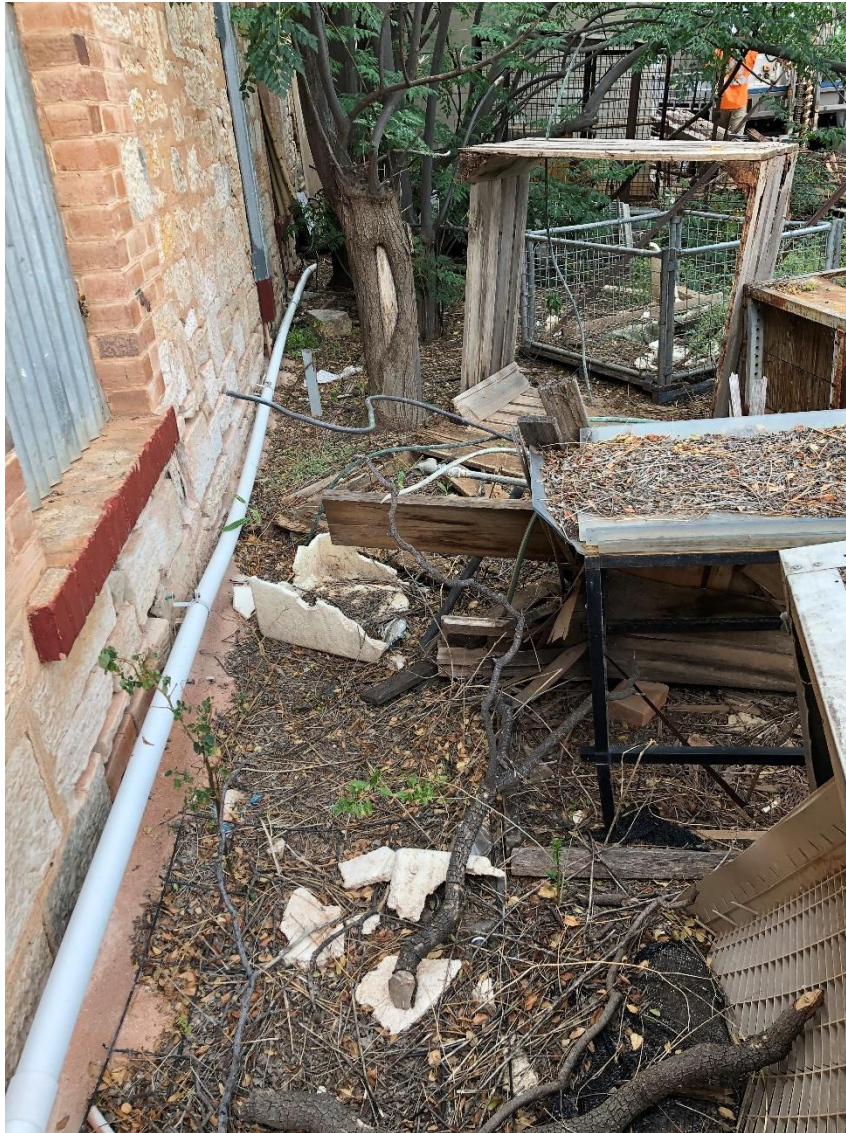
- A number of buried fragments was observed in shallow excavation into the surface material surrounding the partially demolished structure.
- The south western boundary of the Subject Site adjoining the remnants of the Knox and Downs Building was, where accessible, carefully inspected for fragments of fibre cement (see Figure 6.7). Fragments of fibre cement was observed only along the part of the boundary opposite the partially demolished residential structure. The fragments of fibre cement observed were intact and similar in appearance to the fragments radiating from the partially demolished structure. The fragments did not appear fire damaged.

Figure 6.7: Surface of ground along a section of Knox and Downs Building outer wall
