# Geotechnical Investigation Report

Assessment Site: 44 Reid Street, Wilcannia NSW

Client: Public Works Advisory - Bathurst

(Our Reference: 38166-GR01\_A)

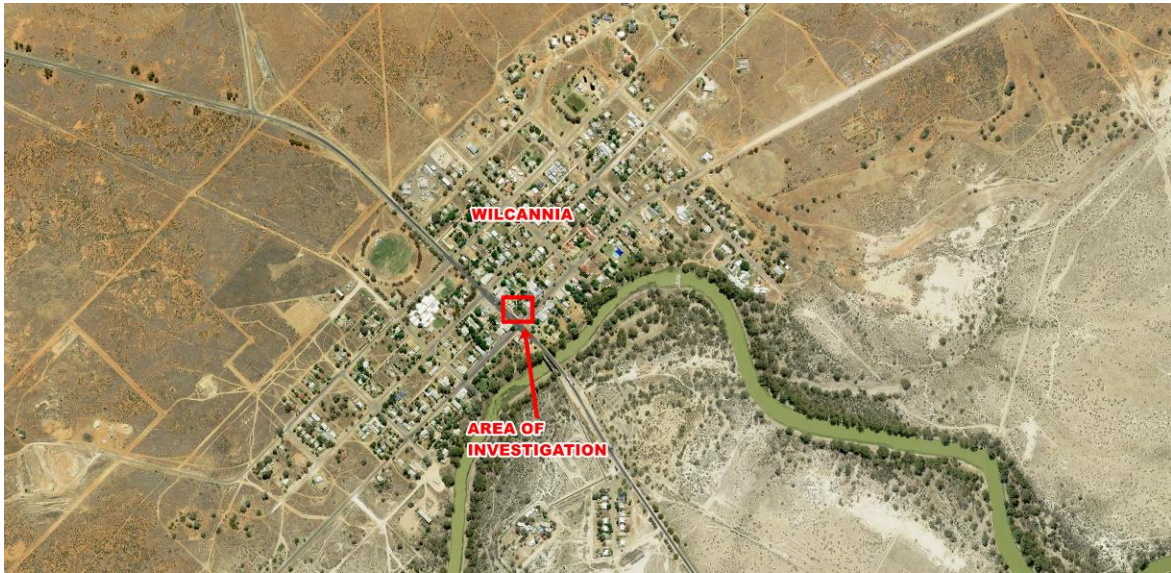
Plate 1 – Area of Investigation

Public Works Advisory is proposing to construct a Baaka Cultural Centre at 44 Reid Street, Wilcannia NSW. The proposed site features that are covered by this investigation are as follows;

The investigation comprised of three (3) boreholes together with field mapping near the site. Details of the field work and laboratory testing are given in the report together with comments relevant to design and construction practice.

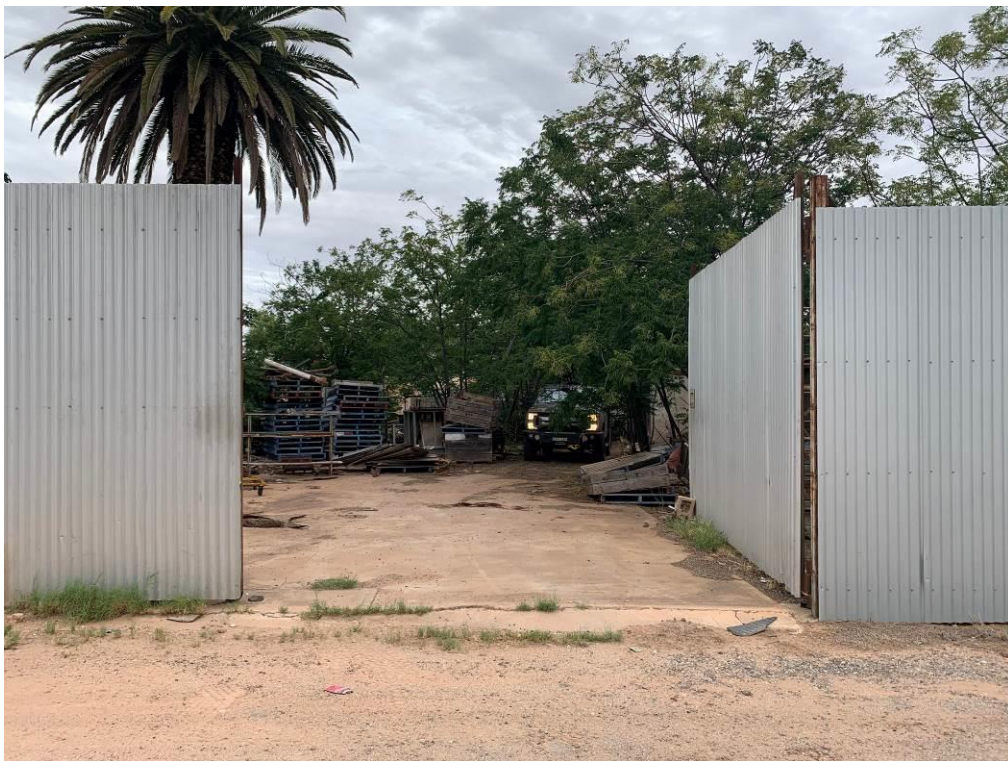
Plate 2 – General view of the site facing southeast.

The site is situated in a residential area in the centre of Wilcannia NSW.

The site consists of light scattered grass and weed cover with mature trees scattered over the site.

The site is sloping is relatively flat. There are existing houses, industrial and commercial premises in the vicinity.
