STATEMENT OF ENVIRONMENTAL EFFECTS

Dual occupancy (detached) – moveable dwellings

65-67 Columbus Street, Ivanhoe

Site and Soil Assessment for On-site Effluent Management System

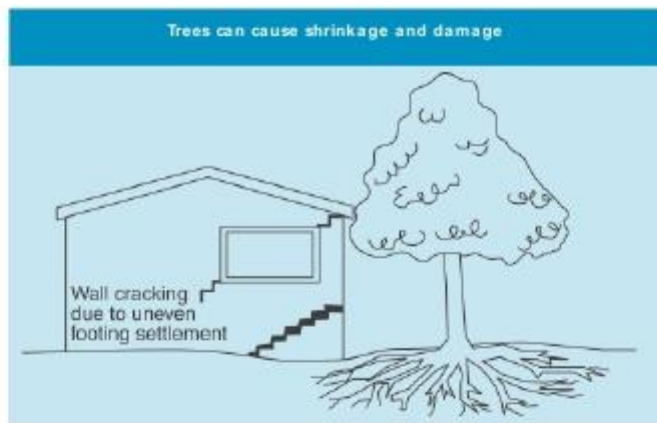
As the moisture absorption process completes its journey to the innermost areas of the building, the internal footings will rise. If the spread of moisture is roughly even, it may be that the symptoms will temporarily disappear, but it is more likely that swelling will be uneven, creating a difference rather than a disappearance in symptoms. In buildings with timber flooring supported by bearers and joists, the isolated piers will rise more easily than the strip footings or piers under walls, creating noticeable doming of flooring.

As the weather pattern changes and the soil begins to dry out, the external footings will be first affected, beginning with the locations where the sun's effect is strongest. This has the effect of lowering the external footings. The doming is accentuated and cracking reduces or disappears where it occurred because of dishing, but other cracks open up. The roof lines may become convex.
