# STATEMENT OF ENVIRONMENTAL EFFECTS

**Dual occupancy (detached) – moveable dwellings**

**65-67 Columbus Street, Ivanhoe**

# Site and Soil Assessment for On-site Effluent Management System

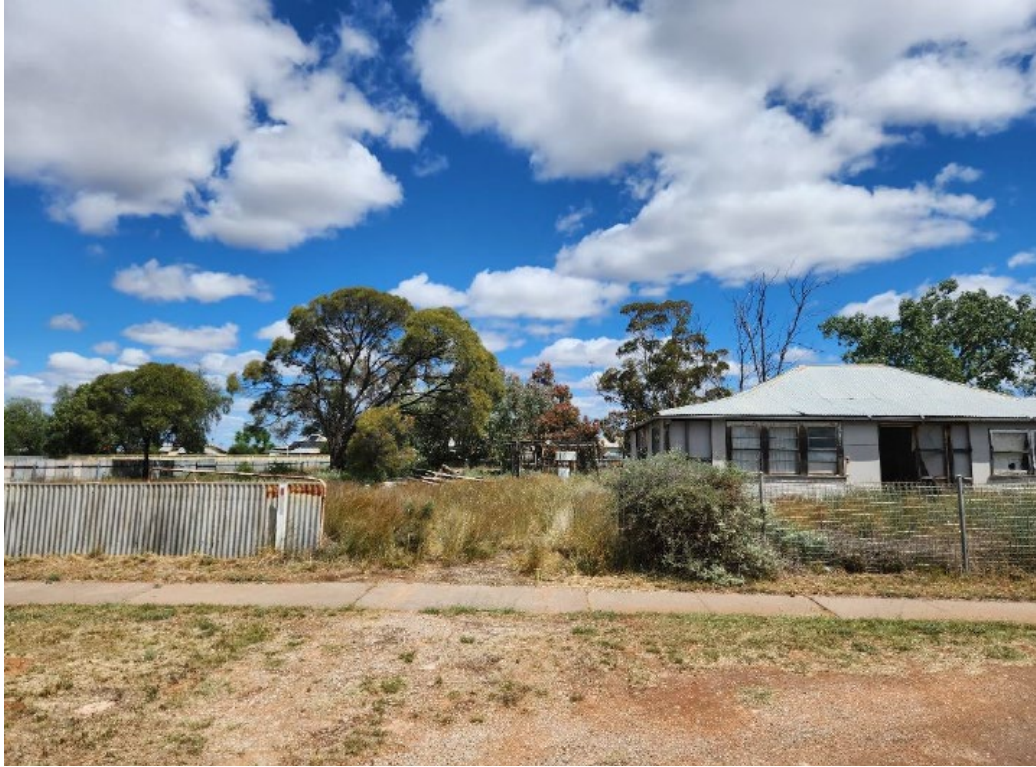
The site is occupied by a single-storey dilapidated fibre-cement dwelling with a pitched roof and a shed/carport along the southern boundary and a pathway from the house to the main street (see Figure 4 and 5 below). The building has an existing gross floor area of approximately 103m<sup>2</sup>.

*Figure 4: Facade fronting Columbus Street (Oct 2023)*

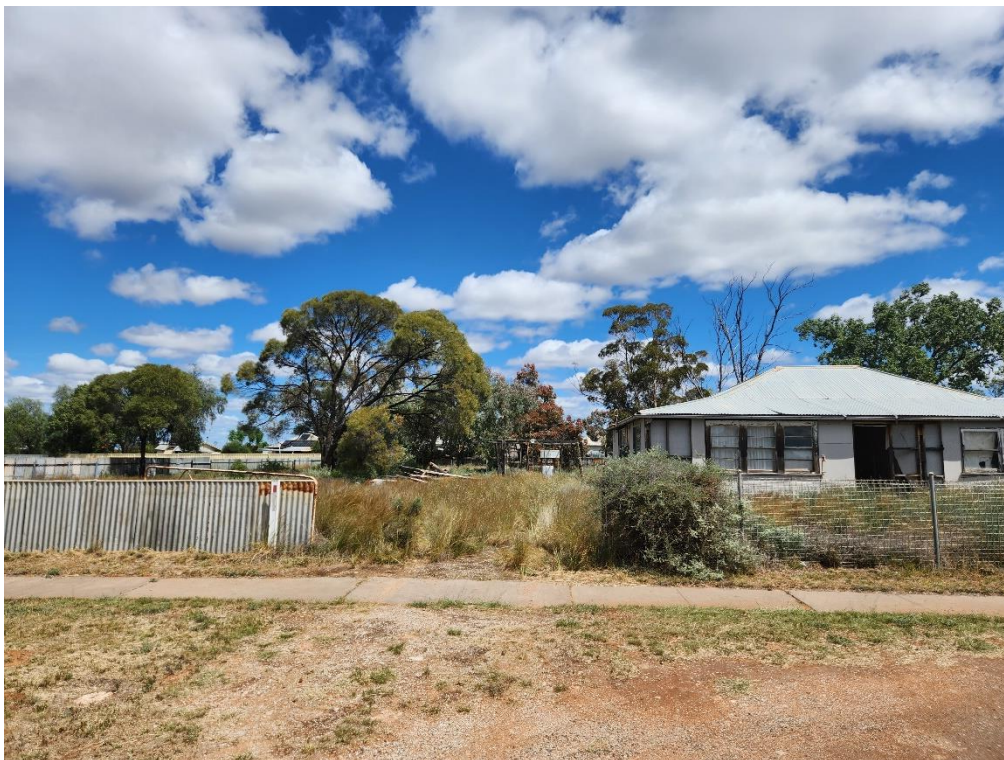
Plate 1 – West facing view

The site is relatively flat. The block has existing buildings and vacant blocks in the vicinity.

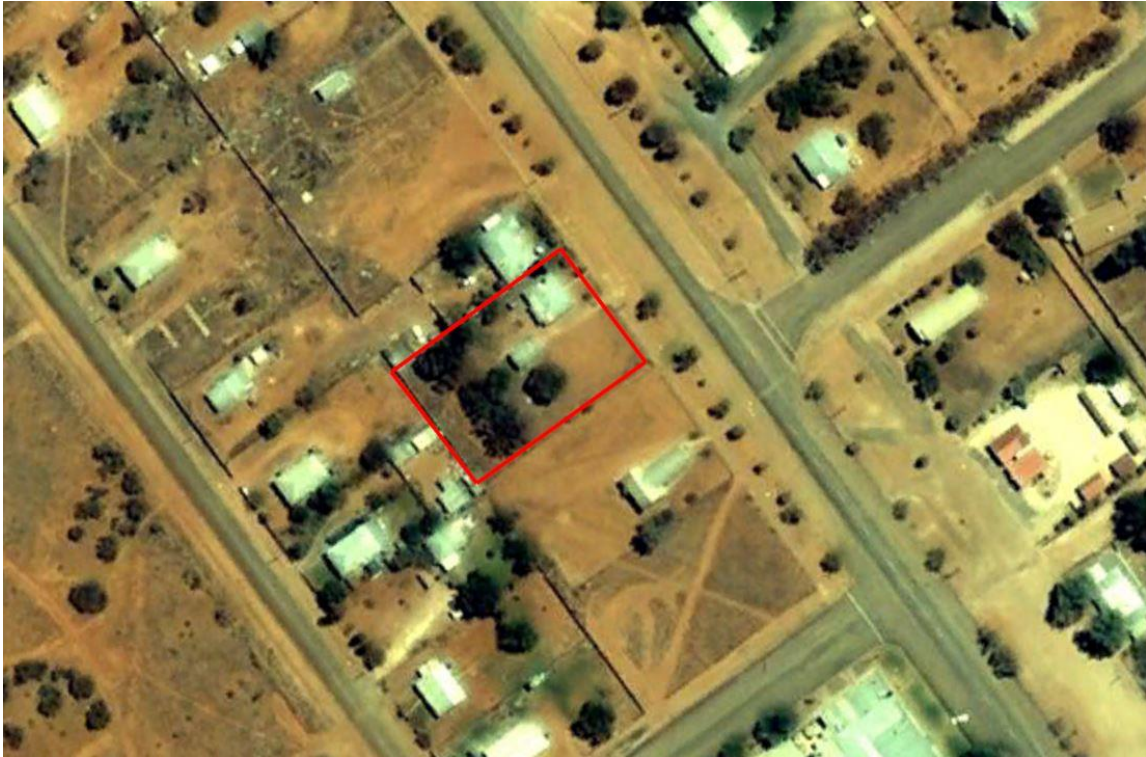
Plate 2 – Aerial Image 2002, Courtesy Google Earth.

A review of Google Earth imagery of the site indicates that the site is in similar condition as to when an image was taken in 2002. The site is therefore assumed to be natural ground with no recent tree removal or fill placed. Images exist back to 1985, yet the image is not clear enough to determine what was on the site. See 2002 aerial image below:

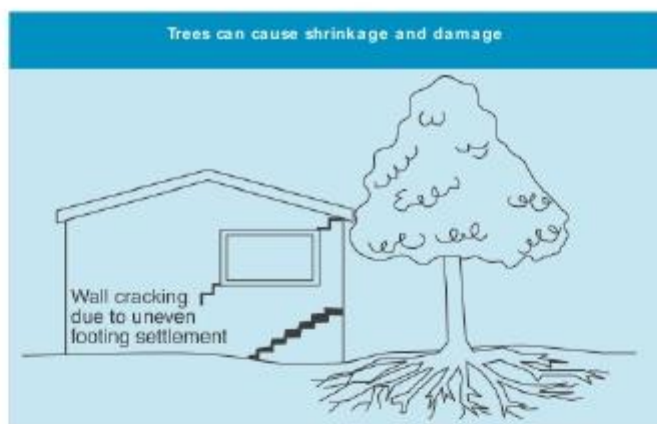
As the moisture absorption process completes its journey to the innermost areas of the building, the internal footings will rise. If the spread of moisture is roughly even, it may be that the symptoms will temporarily disappear, but it is more likely that swelling will be uneven, creating a difference rather than a disappearance in symptoms. In buildings with timber flooring supported by bearers and joists, the isolated piers will rise more easily than the strip footings or piers under walls, creating noticeable doming of flooring.

As the weather pattern changes and the soil begins to dry out, the external footings will be first affected, beginning with the locations where the sun's effect is strongest. This has the effect of lowering the external footings. The doming is accentuated and cracking reduces or disappears where it occurred because of dishing, but other cracks open up. The roof lines may become convex.
