RE: 'Knox and Downs Building' Reid Street, Wilcannia NSW 2836

FRIABLE ASBESTOS CLEARANCE

Fire Damaged Building

Report Reference: CLR22458R01

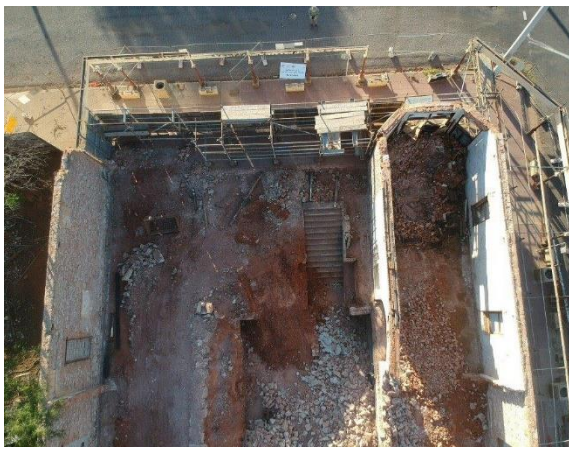
Image 15: During Remediation of South-East Footpath and Front Windows

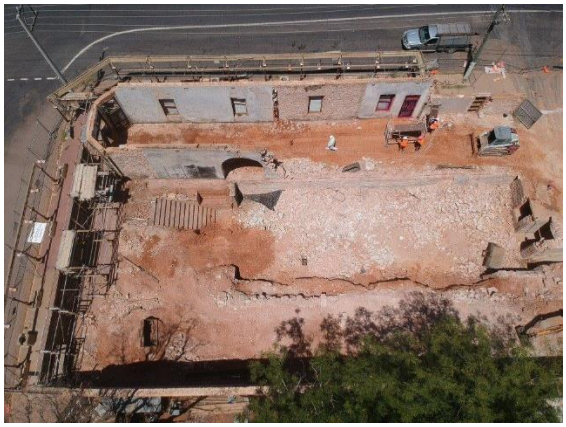
Image 35: Following Removal Subfloor Contamination at North corner of main Cellar in North East Section
