Residential Site Investigation Report

Site Address: 42 Adams Street, Wilcannia NSW 2836

Project Name:	42 Adams Street, Wilcannia NSW 2836
Client:	Martina Boktor
Project No.	33026
Report Reference	33026-GR02_A
Date:	17.07.2020
Revision:	Revision A

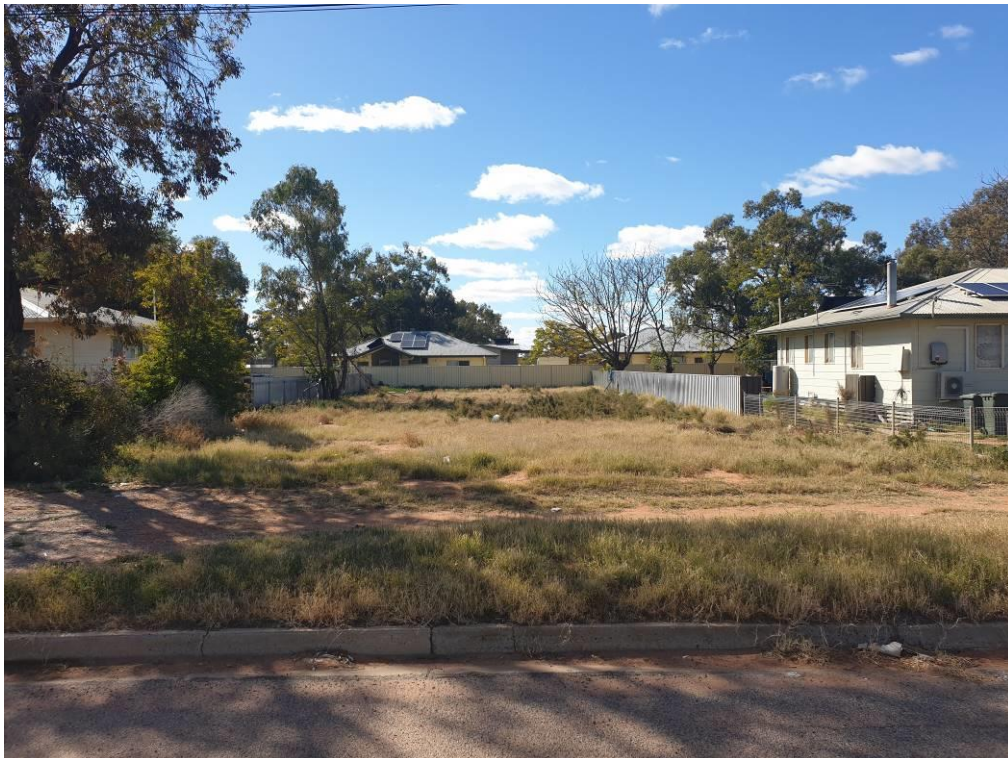
The site is relatively flat. The block has existing buildings and established houses in the vicinity.

Plate 1 – North facing view

Plate 1 –	North facing view.....	5
-----------	------------------------	---

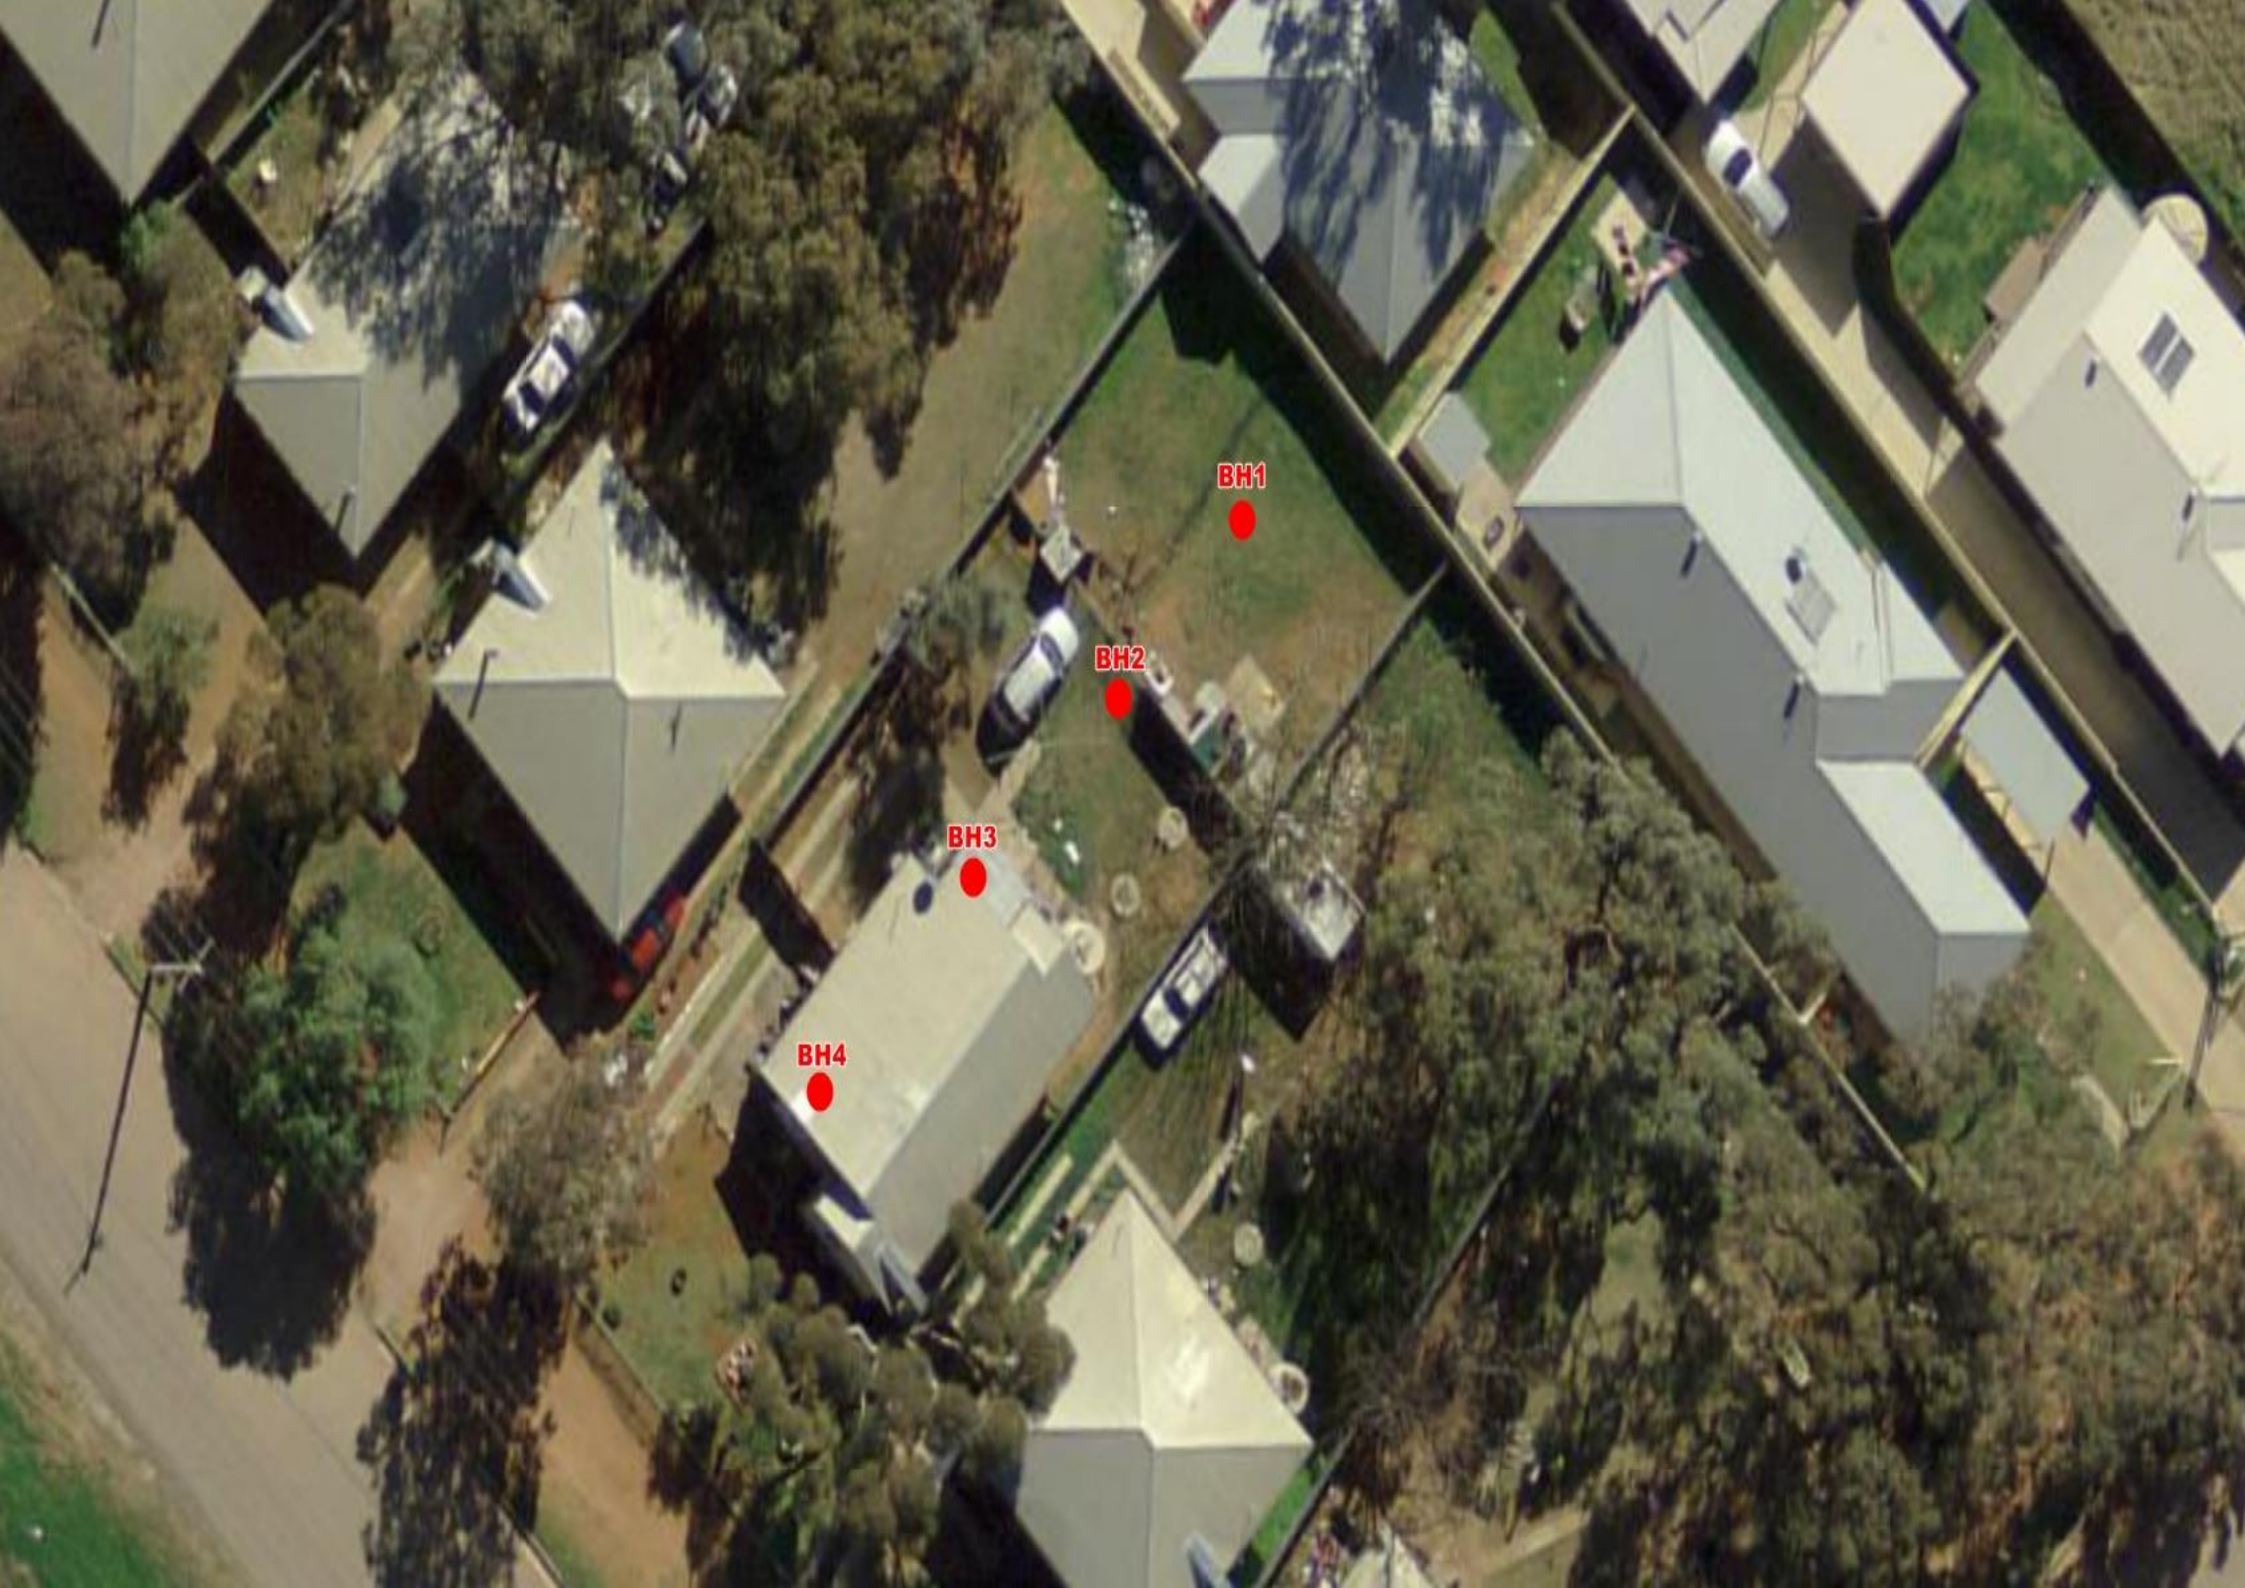
Appendix B - Site Plan with Borehole Location

BH1

BH2

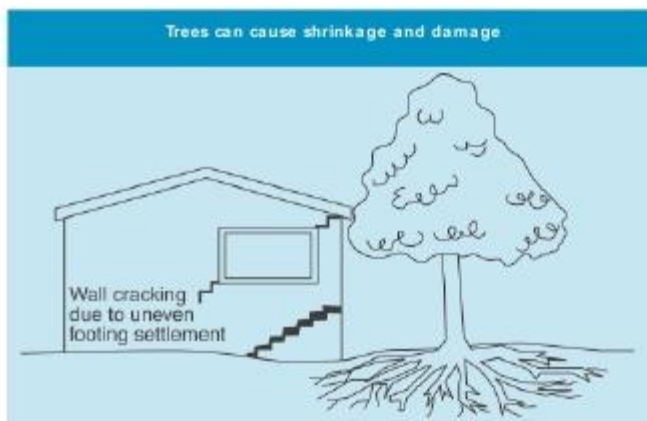
As the moisture absorption process completes its journey to the innermost areas of the building, the internal footings will rise. If the spread of moisture is roughly even, it may be that the symptoms will temporarily disappear, but it is more likely that swelling will be uneven, creating a difference rather than a disappearance in symptoms. In buildings with timber flooring supported by bearers and joists, the isolated piers will rise more easily than the strip footings or piers under walls, creating noticeable doming of flooring.

As the weather pattern changes and the soil begins to dry out, the external footings will be first affected, beginning with the locations where the sun's effect is strongest. This has the effect of lowering the external footings. The doming is accentuated and cracking reduces or disappears where it occurred because of dishing, but other cracks open up. The roof lines may become convex.
